Department of Mines, Industry Regulation and Safety

Wheal Ellen Mine Shafts and Open Pits Geotechnical Assessment and Remediation Methodology (DMIRS750620) Geotechnical Report

September 2020

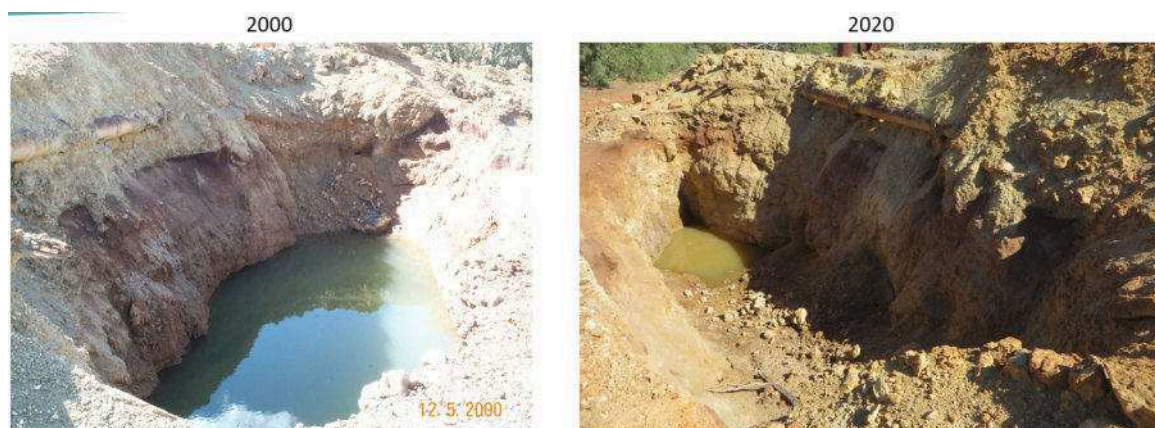
Image 7 S0113143: 2000 and 2020 comparison photos (DMIRS)

As shown in the below images, minor deterioration of spoil around the feature has occurred over the past 20 years. The main difference in these photos is the amount of water present. The water depth observed by GHD in August 2020 being similar to the 2000 image.

The unstable material around this feature, particularly along the pipe make it more hazardous. However, the feature is of limited depth and not so steep sided to make climbing out of it difficult.

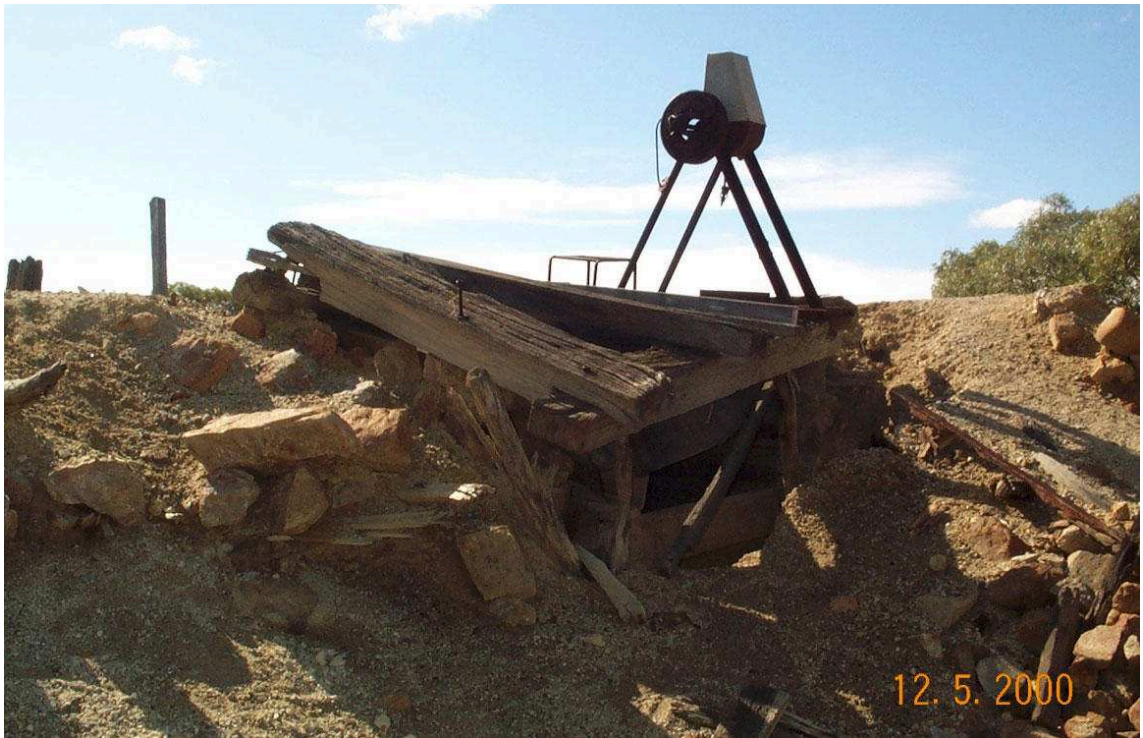
Image 8 S0113145: 2000 photo (DMIRS)

The shaft was partially collapsed with wooden beams at 3.2 m depth and loose spoil around the collar. Water was present at 3.1 m depth, measured from the void crest. The feature was dipped using a weighted tape to confirm the base where it was obscured by water. The backfilling in the shaft is at the same level as the adjacent pit (S0113143).

As shown in the below image from 2000 in comparison to the 2020 photos in Appendix C, the timber around the shaft collar has been removed or collapsed and the surrounding spoil fallen into the shaft to form a crater shape. Timber and steel remain in the upper portion of the shaft.

The unstable spoil material around this feature make it particularly hazardous and climbing out of it would be very difficult.

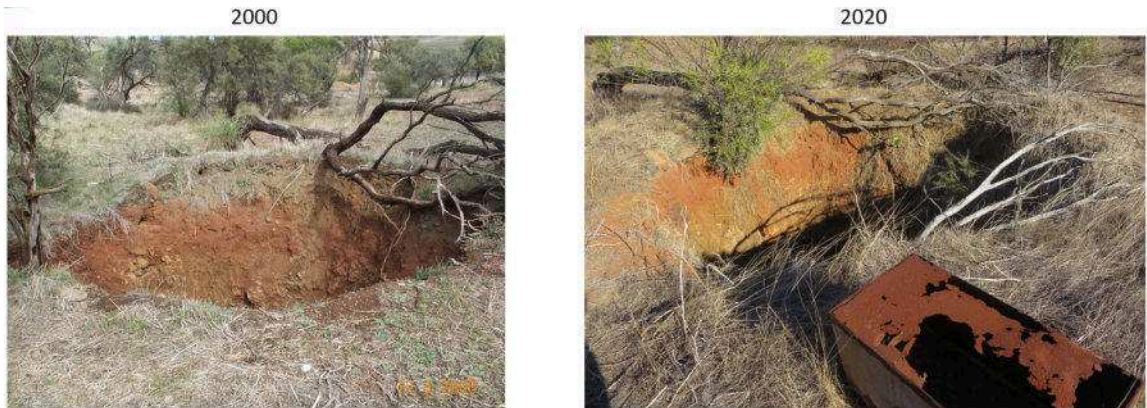
Image 11 S0113103: 2000 and 2020 comparison photos (DMIRS)

The pass has collapsed or been filled to a depth not exceeding 4.5 m. Erosion caused by surface water has resulted in the feature increasing slightly in size over the past 20 years although the sides have remained steep and the crest abrupt.

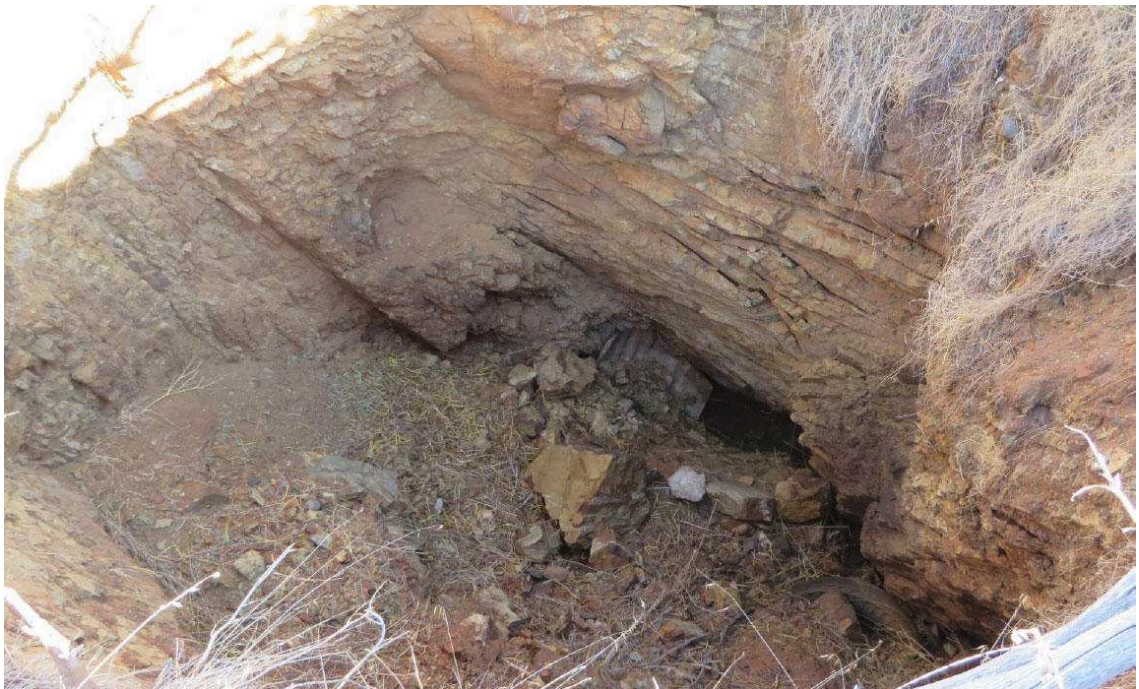
Image 12 S0113103: 2020 photo (DMIRS)

The dip of the lode can be seen in the below image with fretting of blocks from the hanging wall. Between the hanging wall and debris is a deeper area which was surveyed to about 5 m depth. It is likely this connects with deeper voids. The lack of fine grained sediment indicates water does not pond in the feature and there is strong hydraulic connection to voids below.

While an attempt to fill this pass may have been made, the fill appears to have washed underground. The resulting feature is likely to be the surface expression of the collapsed stope.

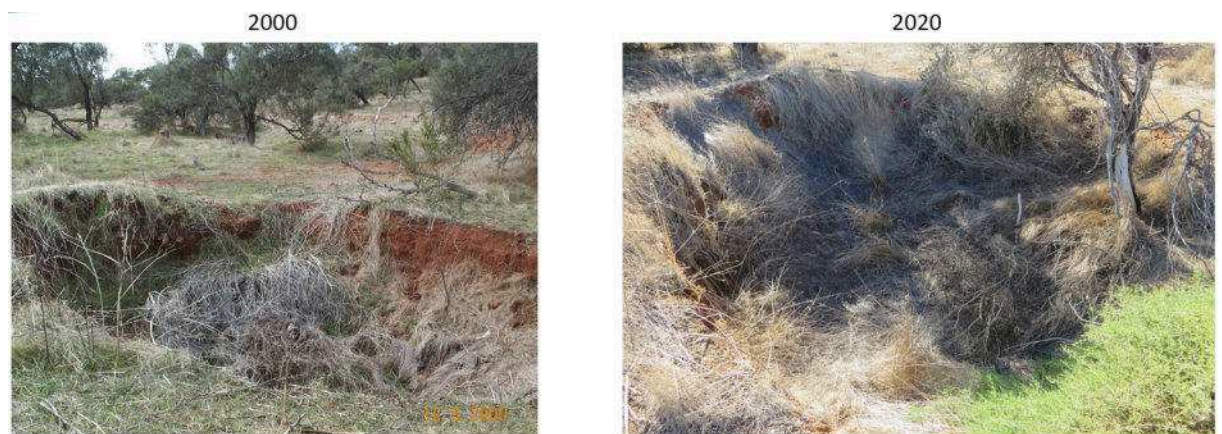
Image 13 S0113163: 2000 and 2020 comparison photos (DMIRS)

The pass has subsided to a depth of 1.1 m. Little evidence of surface erosion was observed during the walkover and comparison between the 2000 and 2020 images below show little change other than vegetation.

It appears this pass has been backfilled and the backfill subsided to form a depression with steep sides. Further subsidence or erosion of the fill does not appear to be occurring.

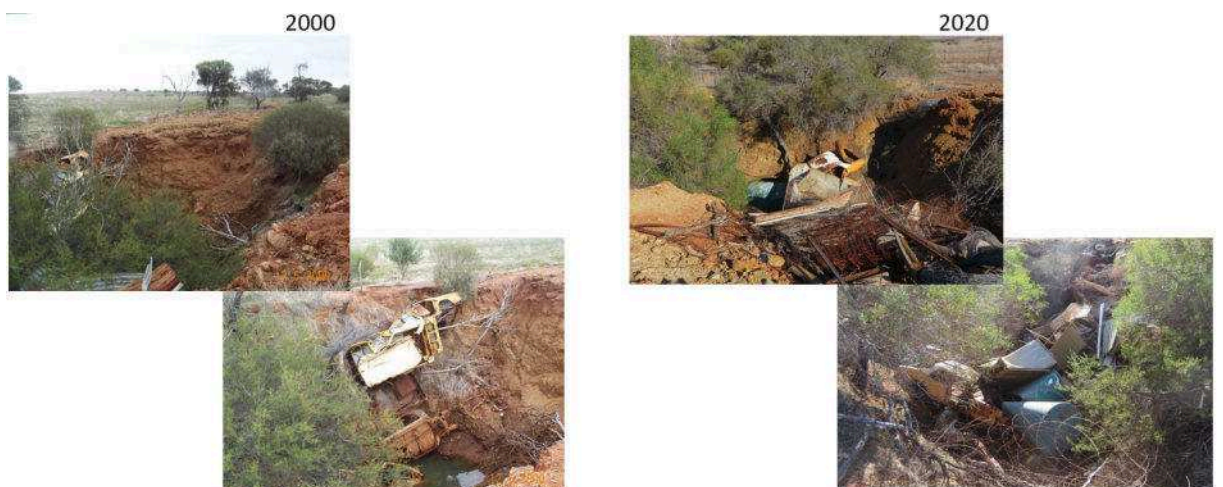
Image 15 S0113151: 2000 and 2020 comparison photos (DMIRS)

The base of the pit was obscured by waste such as sheet metal and car bodies. A small amount of water was observed in the base.

A tension crack about 10 m long was observed along the northern wall of the pit indicating instability of that wall. The crack may have been deepened and widened by erosion.

Comparison between photos from 2000 to 2020 show an increase in waste but generally not much change. The 2000 photo shows water in the base of the pit.

Given the depth of the pit and position along the lode sub-crop, it's likely the pit was excavated as an open cut and has not been backfilled. If connections to underground voids are present, they would be along the western wall (hanging wall) where the car bodies are piled in the 2000 photo above.

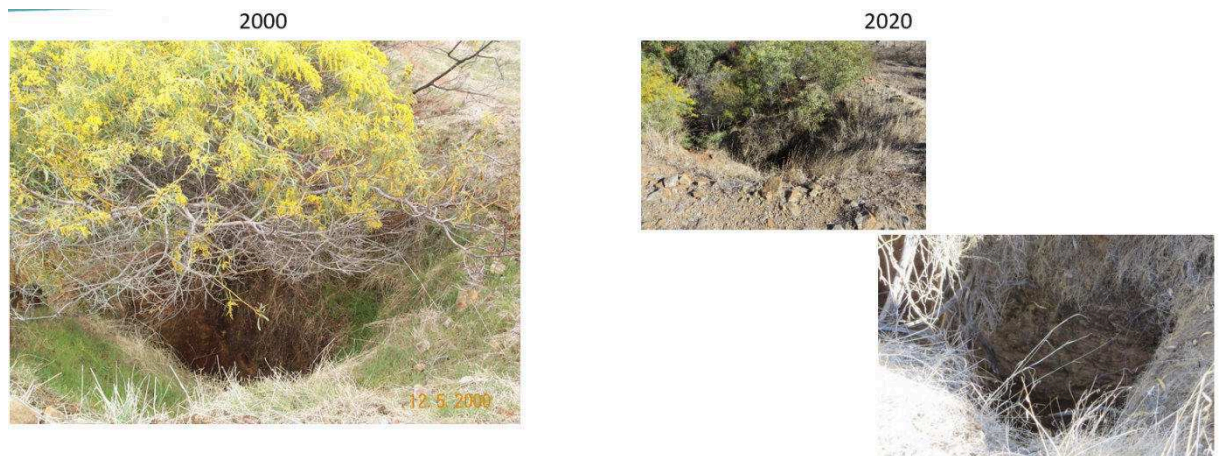
Image 16 S0113149: 2000 and 2020 comparison photos (DMIRS)

At S0113097 evidence of surface erosion caused by water runoff from the east is present with finer materials being washed to the base.

A comparison of the below photos between 2000 and 2020 shows little change at either feature other than vegetation.

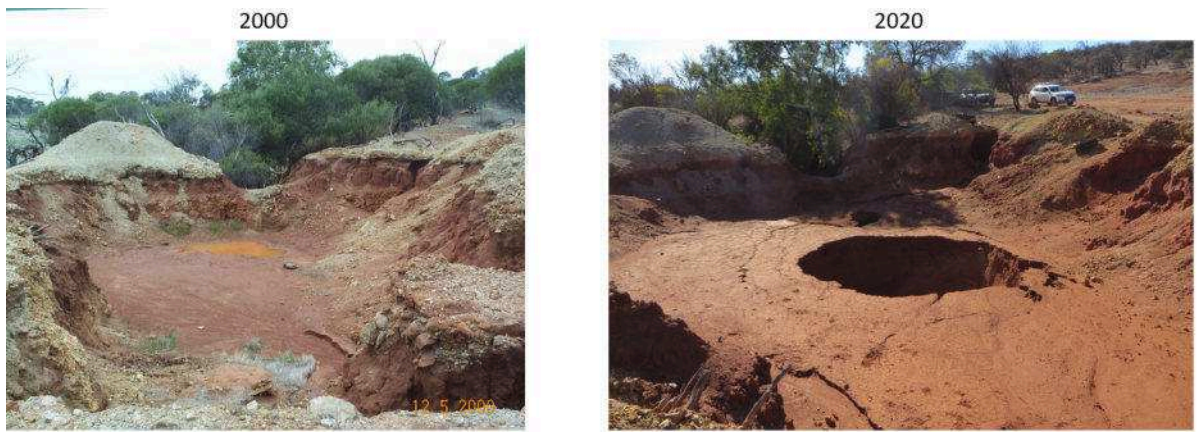
Image 20 S0113147: 2000 and 2020 comparison photos (DMIRS)

A comparison of the below photos between 2000 and 2020 shows a sinkhole formed within the fines since 2000.

As shown in the August 2020 photo in Appendix C, surface runoff from the east has caused significant surface erosion which has extended to the adjacent road. Despite this additional erosion, the sinkhole does not appear to have deepened significantly but rather increased in plan area. The 2020 drone footage shows only ponded water partially across the sinkhole base.

Based on the observed sinkhole formation and behaviour since, it appears that soil fines migrated into underground voids under the action of hydraulic gradient due to water ponding in the pit and seeping through the fines. The resulting piping failure allowed the pit to drain into the workings, providing relief from the hydraulic gradient and return to unsaturated conditions with the accompanying suctions increasing strength and halting growth of the sinkhole. Reoccurrence of the sinkhole would be expected with inundation of the pit.

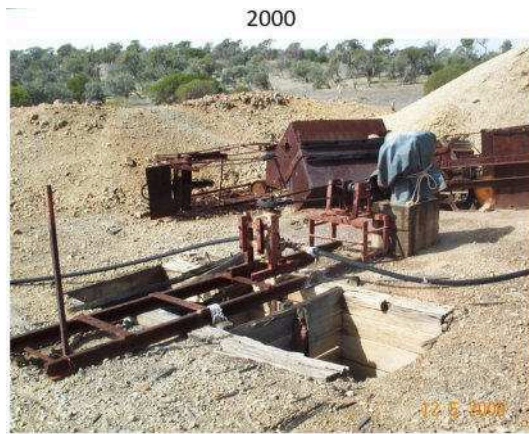
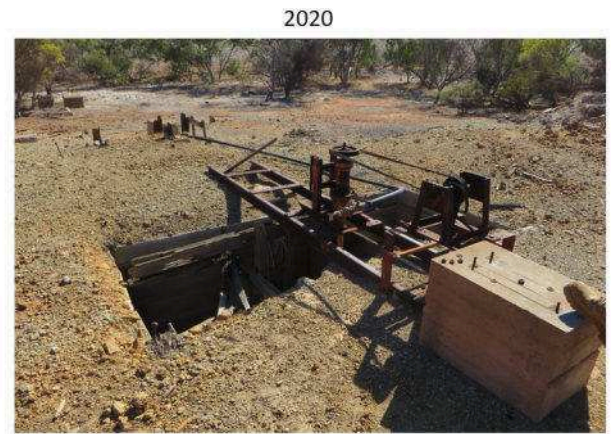
Image 21 S0113158: 2000 and 2020 comparison photos (DMIRS)

The condition of the shaft collar appears to have changed little from 2000 to 2020 as shown in the below photos.

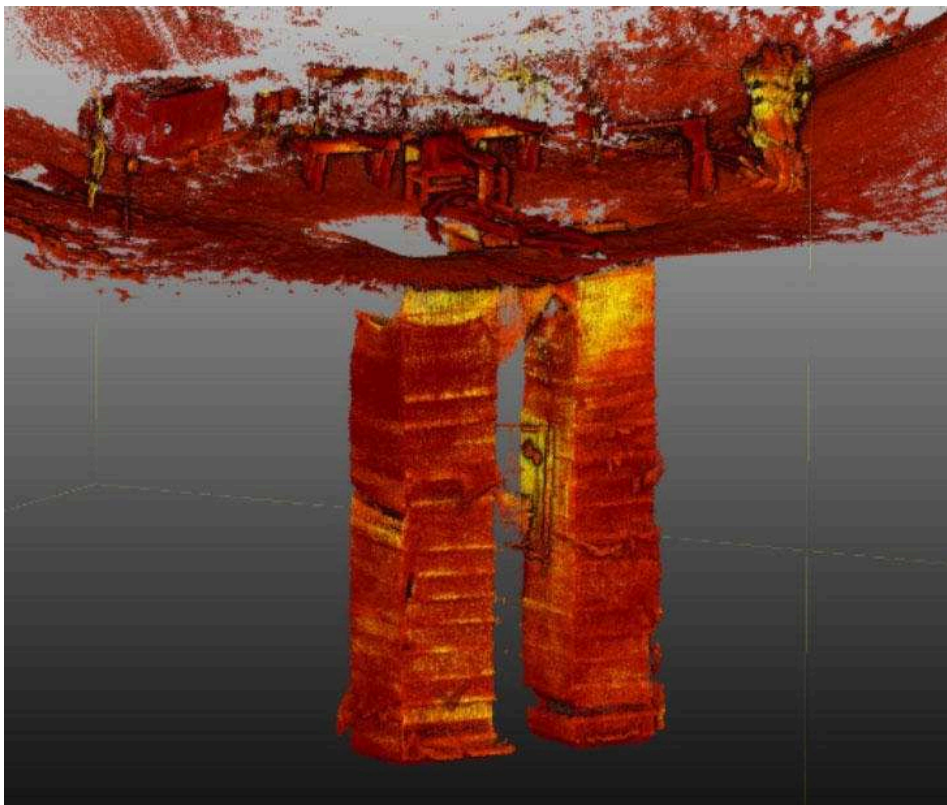
Image 22 Main Shaft (S0113158) point cloud

The three chambers are visible but the filling is not and is assumed to have subsided. A laser point cloud and video within both the western and eastern chambers shows timber boards extending to the water. Some of the boards have fallen away to reveal the rock behind.

The western and eastern chambers are open and unobstructed whereas the central chamber is partially obstructed with cross supports, pipe and hoses. Some of these obstructions are visible in the above point cloud image.

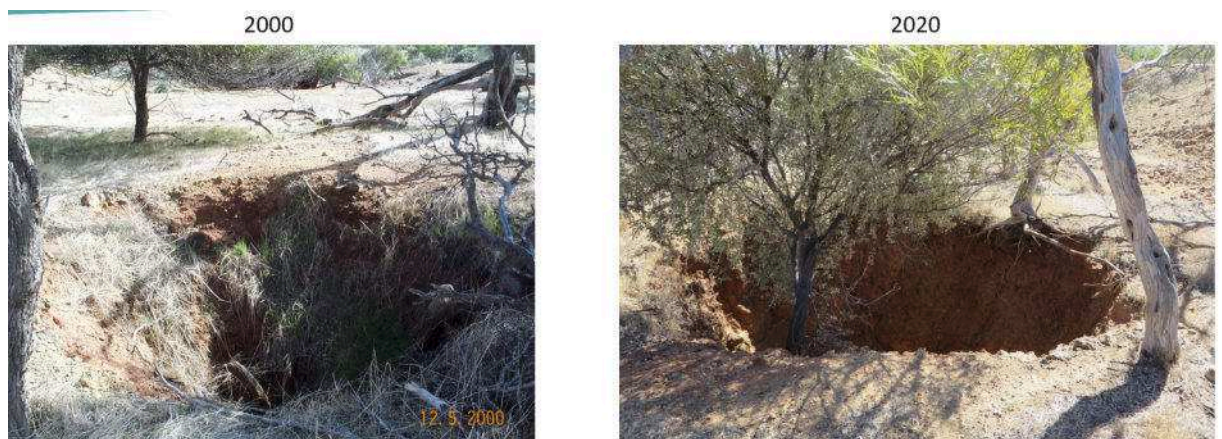
Image 23 S0113130: 2000 and 2020 comparison photos (DMIRS)

While only about 2.5 m in diameter, it is currently about 7 m deep with vertical sides and no water in the base. Erosion caused by surface water and fretting appears to have increased the diameter of the pass near the ground surface, making the crest more distinct and less vegetated as shown in the below image.

It appears that backfilling of the pass has subsided with the 2020 plan dimensions likely to be similar to the original pass.

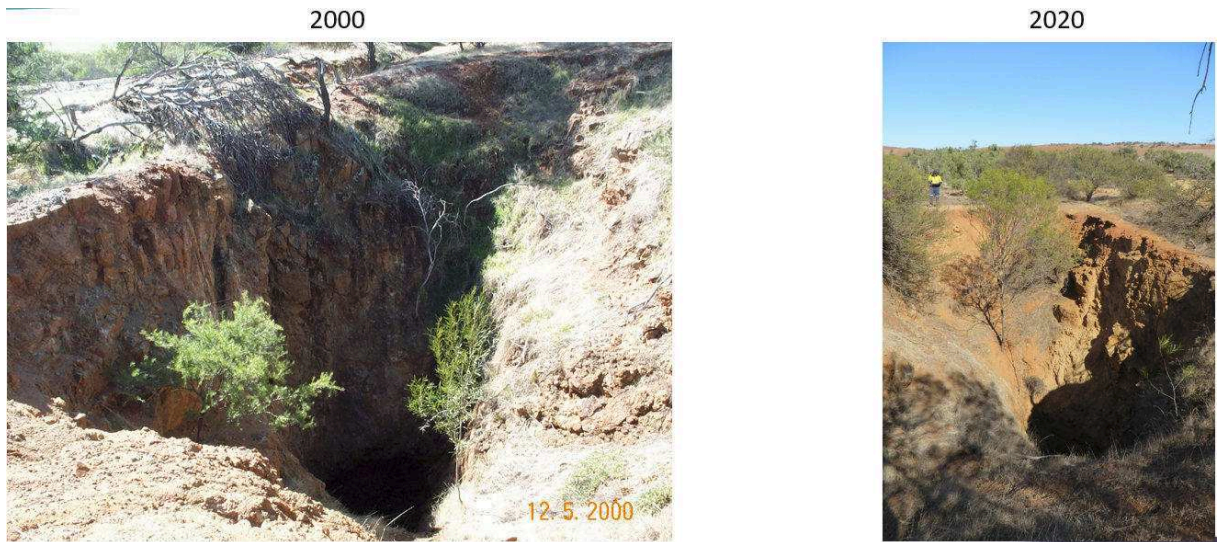
Image 24 S0113141: 2000 and 2020 comparison photos (DMIRS)

Evidence of surface erosion caused by water runoff from the east is present with finer materials being washed to the base of the feature. However, comparison of the below 2000 and 2020 images indicates only minor erosion.

It appears that backfilling of the pass has subsided although it is not clear to what extent the open cut was previously filled, if at all.

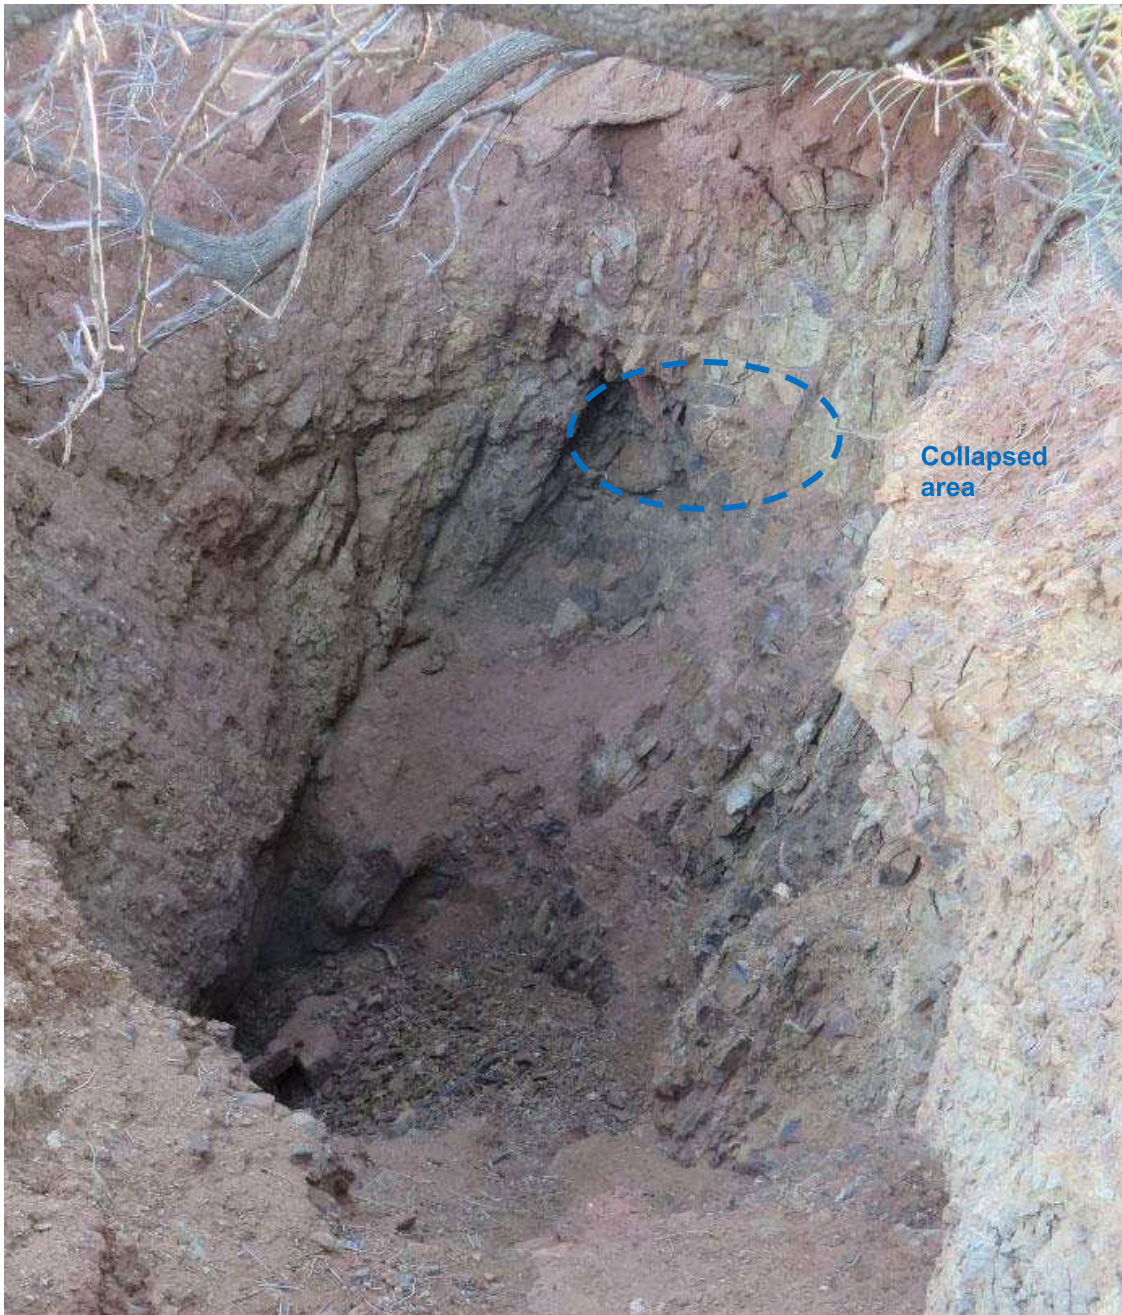
Image 30 S0113122: 2020 photo (DMIRS)

The pass may have been backfilled but this material has since subsided or been washed into a stope below. The resulting feature is likely the surface expression of the stope.
