Mines Safety Significant Incident Report No. 176

Light vehicle collides with stationary loader

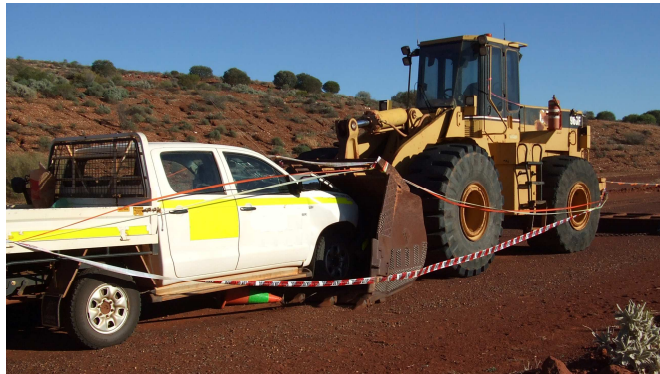
A worker was returning to a mine site in the mid-afternoon, after completing work off site. He was driving a light vehicle along a straight well-formed gravel road, having just made a 90° left turn. His next recollection was waking up while crashing into a stationary loader. The loader had broken down several weeks earlier and could not be moved off the road. Its location was delineated with orange traffic cones.

Incident scene (flagging tape added after the incident)

- From the incident description, it is possible that the worker experienced a micro-sleep.

There are many causal factors that may increase the likelihood of experiencing micro-sleep episodes. Employers and employees need to be aware of such causal factors.
