Significant Incident Report No. 206

Subject: Forklift struck by truck while unloading

Date: 22 September 2014

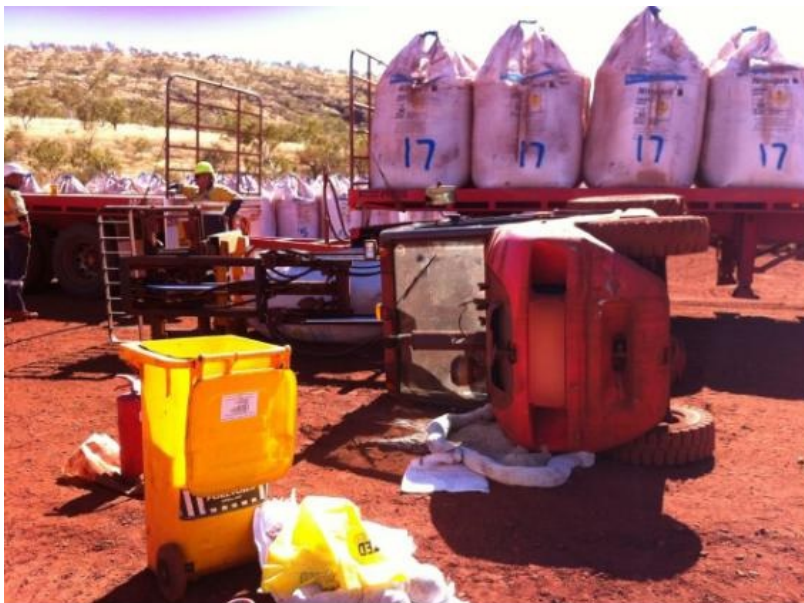
Two forklift operators were tasked with unloading 1.2 tonne ammonium nitrate bulka bags from a triple roadtrain. As one of the forklift operators was unloading the final bulka bag from the second trailer, the roadtrain was moved forward at the request of the other forklift operator. The rear gate of the second trailer collided with the bulka bag and forklift tynes, and the forklift rolled onto its side.

The forklift operator was wearing his seat belt and, fortunately, received only minor injuries.

- The roadtrain was moved while being unloaded.

- The forklift was in the roadtrain's path.
- A communications protocol had not been established between the roadtrain driver and the forklift operators, and between individual forklift operators.
- The forklift operators did not comply with the site's standard work procedures (SWPs) for unloading a roadtrain.
- The roadtrain driver had not been site inducted.

Mine operators and supervisors are reminded of the importance of maintaining safe work procedures for tasks involving mobile plant. They should ensure that:

- communication is maintained when using mobile plant for loading and unloading tasks
- site SWPs are reviewed and training is provided for tasks relating to loading and unloading of delivery trucks
- contractors are inducted before undertaking work on site.
