## Significant Incident Report No. 266

**Subject:** Underground operator struck on the head by a high pressure air line

**Date:** 23 August 2018

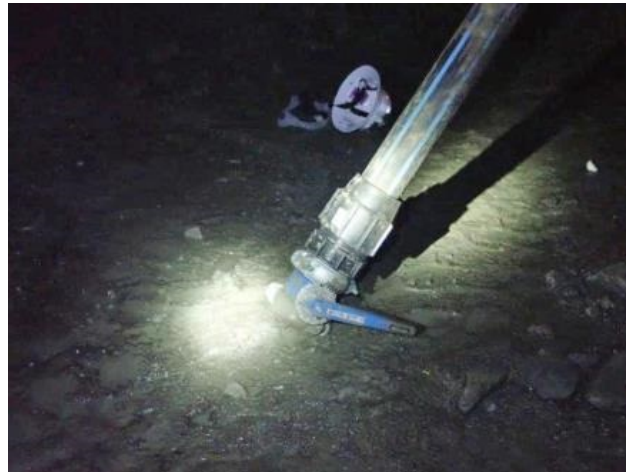
The operator was in the line of fire when the coupling on the air line failed.

View of the failed coupling.

- The coupling used to connect the poly pipe was not fit-for-purpose.
- The coupling supplier could not provide the requested coupling normally used and recommended an alternative as being fit-for-purpose with the fittings and adapters in use. The recommendation was made without adequate assessment.

- Review couplings currently in use for connecting services to confirm they are fit-for-purpose.
- Review procurement policies and procedures to confirm that new plant is assessed as fit-for-purpose by a competent person before being made available for use.
- Confirm services are adequately secured to prevent their uncontrolled release.
- Remind workers to raise any concerns about equipment, particularly if it is new to the site.
- Research sources of information for past incidents, product alerts and worker reports when conducting hazard identification and risk management.

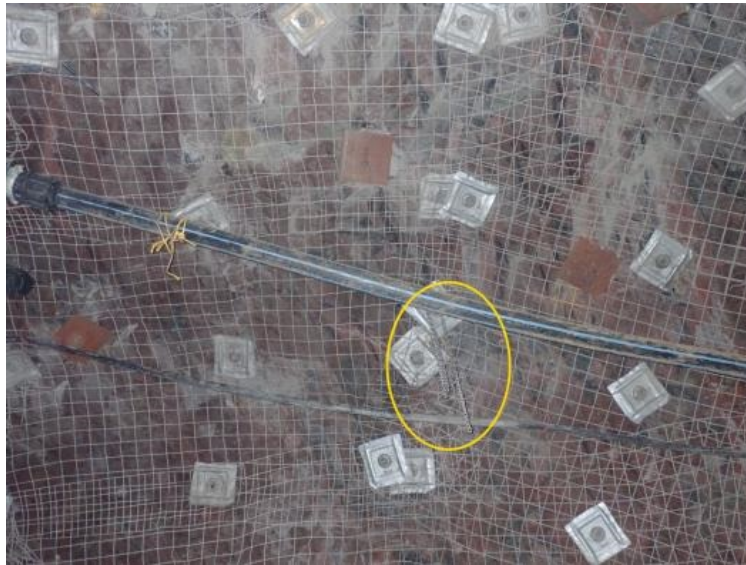
- When the coupling failed, a large section of the line started to whip around with sufficient force to break the holding chain. Early investigations indicate that the chain may have been installed too far back from the end of the pipe.
- Underground operators reportedly noticed problems with the coupling before the incident, but did not report their concerns to their supervisors.

View of the failed chain installed to secure the air line to the backs.
