DEPARTMENT OF  
MINERALS AND ENERGY  
WESTERN AUSTRALIA

# MINESAFE

MINING OPERATIONS DIVISION

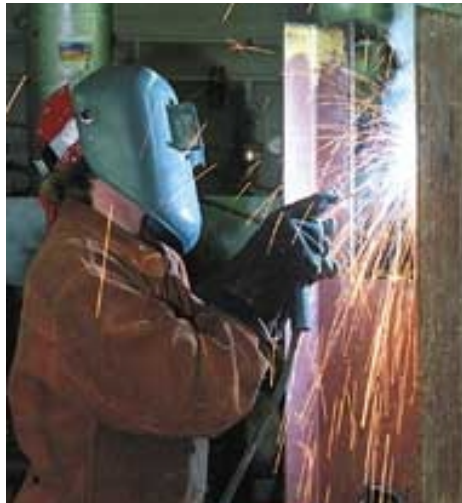
The deceased had been using a standard manual metal arc welding machine to effect repairs in the lower internal parts of a ship. It was found that the deceased had been working in the confined space for almost 3 hours. The outside ambient temperature was 37° C and the workplace temperature may have been as high as 60°C.

When found, the deceased's clothing and gloves were wet with perspiration. His welding helmet was in the raised position and a new electrode rod had been fitted in the electrode holder.

A pathologist's report gave the cause of death as being 'consistent with electrocution'.

Welding electrocutions keep happening even though they can easily be prevented by using a commercially available safeguard called a welding 'Voltage Reducing Device'.

A welding VRD is a safety device that monitors the electrical resistance of the output welding circuit and only allows full welding voltage to be applied when resistance becomes low as an attempt is made to 'strike an arc'. Similarly, a VRD reduces the open-circuit electrode voltage to a safe level within seconds of welding ceasing.

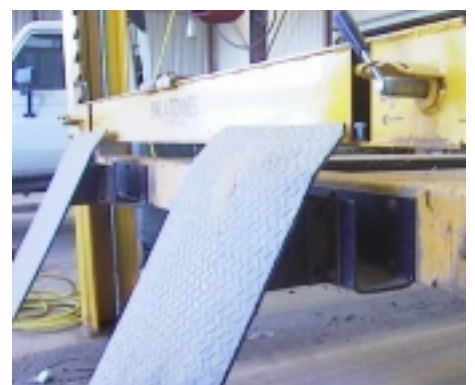
The cause of the problem was that one of the safety support locking pawls had not engaged properly. 'Dirt' had accumulated in the support channel (see photo), altering the vertical position of that pawl, and preventing it from locking correctly in place.

*Close up view of support channel*

each locking pawl is 100% engaged before releasing the hoisting platform and working underneath the hoist.

Any defect that prevents any safety lock from working correctly must be repaired before the hoist is put in full use.

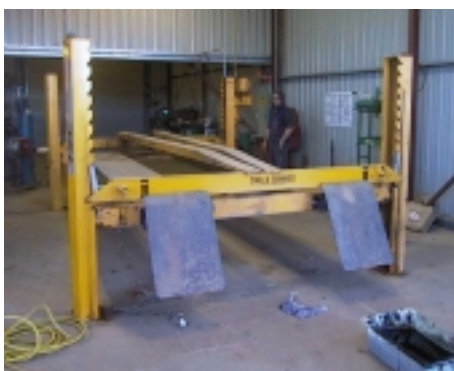
to work in 'wheels - free' mode. A short time afterwards one of the locking pawls slipped, tilting the vehicle and destabilising the hoist. The support frame bounced down the ratched posts, the vehicle slid off the hoist, and rolled out the workshop door. The hoist was significantly damaged. The worker took quick evasive action to avoid injury.

*Overall view of a 4-post hoist*

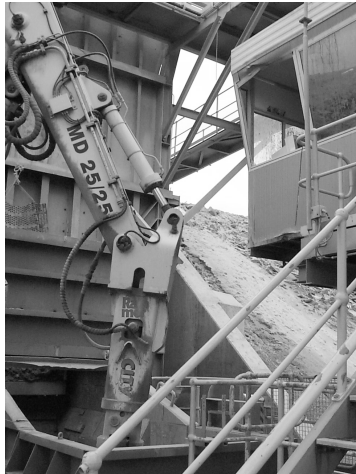
In mid-November 2000, at a surface gold operation in the Eastern Goldfields, a crusher operator was lucky to escape serious injury when a 40kg ripper boot that had detached from a large dozer and got into the crusher ore stream was “fired” from the jaws of the primary jaw crusher. The ripper boot was projected with sufficient force to enter the control cabin of the crusher several metres away and hit the ceiling. It landed on the floor immediately in front of the operator’s desk. The operator heard a noise from the jaws and saw an object bounce within the jaw enclosure. The next thing she knew there was a blur passing through her field of vision as she threw herself back to the rear of the cabin, narrowly evading being struck by the ripper boot as it passed through the window. She was not physically hurt, but needed

*Rock breaker, jaw crusher and control cabin*

A protective grate has since been installed to prevent this from recurring.

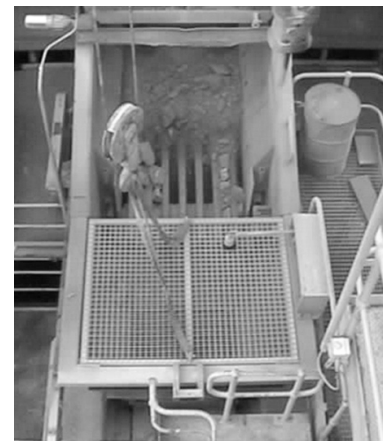
*Protective grate being lowered into position over the jaw crusher*

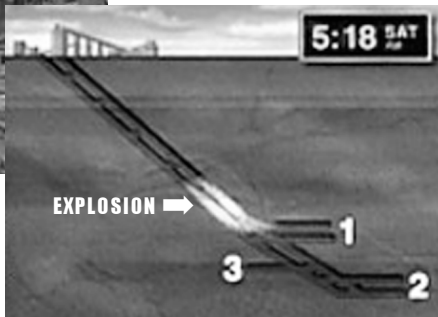
The immediate cause of the disaster was a methane/coal dust explosion. The transport machinery of a mine, in particular the belt conveyors, create accumulations of fine coal dust in the 'roadways'. If this material mixes with air an explosive mixture is formed. For well over 120 years it has been part of coal mining knowledge that a localised methane explosion can 'lift' the coal dust into the mine atmosphere, which if ignited explodes with extreme violence. If dust accumulations are kept low and ground stone dust is provided to 'dilute' the coal dust, the hazard can be controlled. To use a common expression; "this is not rocket science", nonetheless a methane/coal dust explosion killed 26 people at Westray on May 9, 1992. It is also worldwide coal mining practice to drain as much

Schematic view of the working levels underground and the primary explosion site.

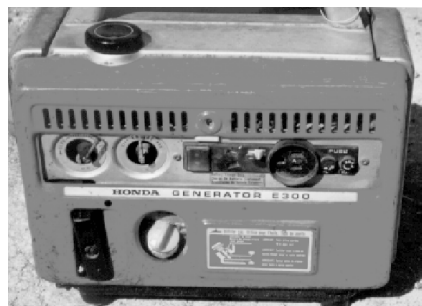
A farmer attempted to recharge the batteries of a truck using a 12 Volt charging lead and portable generator. The generator incorporated a 12 Volt DC socket-outlet for battery charging purposes and a 240 Volt AC socket-outlet for the supply of 'mains' voltage appliances. The pin configuration of the 12 Volt charging lead plug did not prevent insertion into the generator 240 Volt outlet, and the farmer was electrocuted after inadvertently making this tragic mistake and trying to connect the charging lead to the battery.

The prohibition notice specifically applies to the following equipment and prohibits the sale, hire or use of these items until the modifications specified in the notice have been effected by an authorised electrical repair agent:

MINESAFE urges responsible persons to immediately arrange a close examination of the pin connection arrangements for portable generators. Similarly, the connecting plugs and socket-outlets of all other electrical equipment intended to supply or operate at extra-low voltage should also be checked to ensure this extreme hazard will not arise.

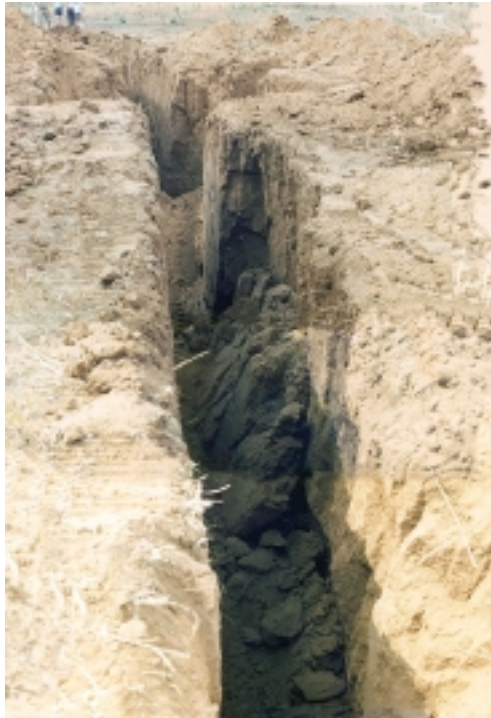
View of the costean wall collapse that fatally injured an exploration worker in 1986.

In a similar event in 1986, one of two exploration workers perished after the walls of a costean in which they were working collapsed (see photo).
