Significant Incident Report No. 267

Subject: Haul truck operator loses control descending ramp on haul road - fatal accident

Date: 07 September 2018

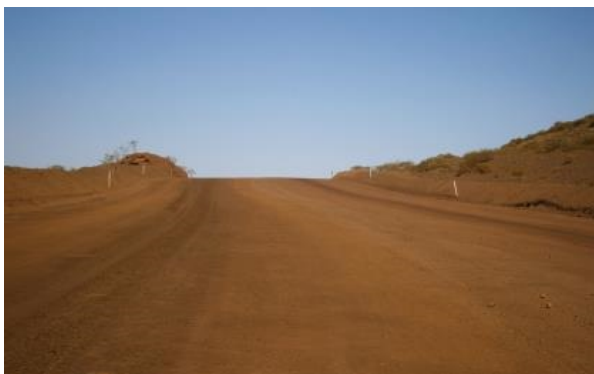
The ramp was part of the haul road from the pit operations to the crusher. The ramp was inclined with a down grade between 8% and 10%, and a length from crest to toe of 1250 m. There was a gradual right hand curve at the toe of the ramp.

Haul road. Left: Approach to ramp crest. Right: Approach to bend at toe of ramp.

- The truck exceeded the speed at which the electric braking system could stop it.
- The service or mechanical brake was not engaged for an emergency stop.
- The truck was fully loaded descending a long slope.
- Immediately preceding the crest of this long slope there was another crest followed by a short downhill and then an uphill section in the form of a saddleback.

- Conduct a risk assessment for each ramp to determine the safe operating parameters for the truck in accordance with original equipment manufacturer (OEM) standards.
- Consider installing a road feature such as a chicane or an intersection ahead of the crest as an engineering control to force the operator to slow down before the ramp.
- Evaluate the location and type of speed warning devices.
- Retard speed control devices should be engaged during the ramp descent.
- Training programs should emphasise the importance of activating the service brake to stop a truck as soon as it passes the electrical braking capability.

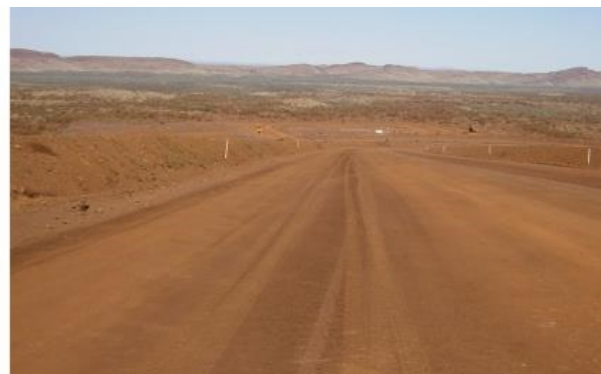
The operator lost control of the truck while descending the ramp. The truck was going too fast to negotiate the gradual turn at the bottom and crashed into the windrow.
