## Significant Incident Report No. 285

**Subject:** Near miss when an excavator fell from crane during lifting operation

**Date:** 03 March 2021

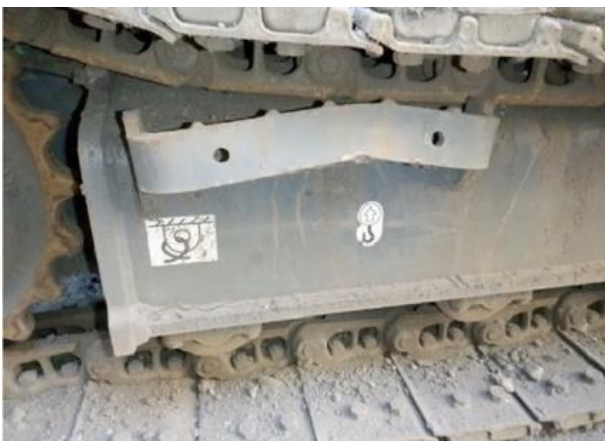
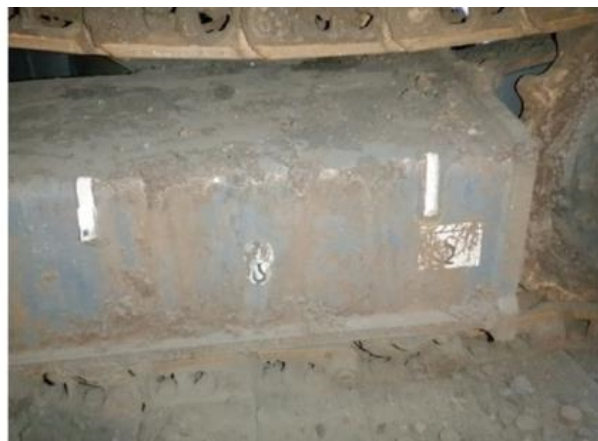
During the lift, the weld attaching the step failed, resulting in the excavator falling approximately 10 metres to the floor of the crusher vault. Two workers were in the bottom of the vault at the time the excavator fell.

Left: Damaged step used as a lifting point with lifting point signage. Right: Rear track frame with failed step weld.

The weld attaching the access step to the rear track frame separated, resulting in a loss of control of the load, and subsequent failure of the chain slings attached to the excavator.

- The rigging arrangement was not configured as per the original equipment manufacturer's (OEM) recommendations, which required the use of a spreader beam and lifting slings installed below the track frame between the lower track rollers.
- The task job hazard analysis (JHA), detailed job plan and lift study did not require the workers to refer to the OEM's manual for the correct lifting procedure for the equipment.

- The excavator has signage attached to the track frame below the access steps indicating the location of the lifting point; however, this signage does not clearly identify or display the approved lifting method.
- The rigger who attached the lifting chains to the excavator believed that the signage located near the excavator access steps indicated that the step was the approved lifting point.

- ensure workers involved in lifting operations review and follow the OEM's lifting procedure
- ensure the task-based risk assessment (e.g. SWMS, JSA, JHA, THA or lift study) is reviewed, assessed and approved by the supervisor
- confirm that the persons conducting dogging and rigging operations have the appropriate high risk work licences and have been assessed as competent
- confirm all lifting equipment used for the lift has been inspected and is suitable for the task
- isolate the hazard from the people while conducting lifts (e.g. use exclusion zones).

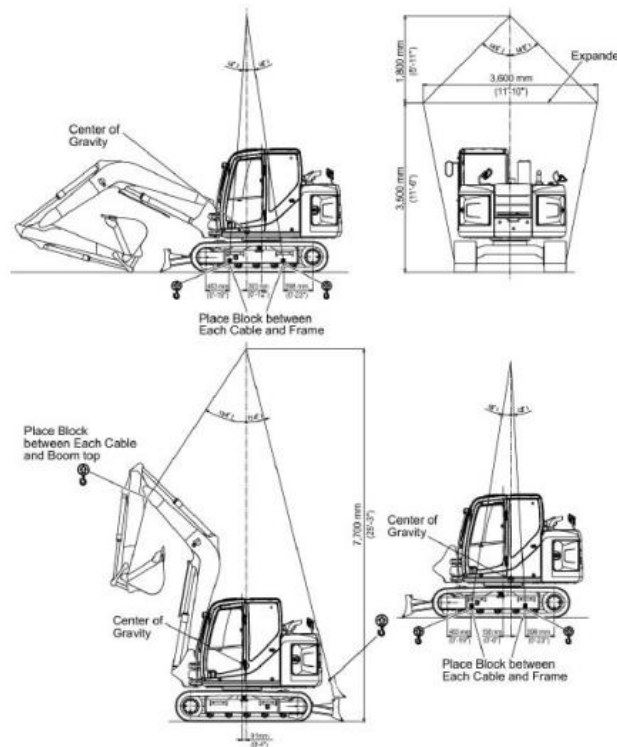
Lifting and rigging configuration as per OEM's recommendations.
