INCIDENT INVESTIGATION REPORT

# Fuel tanker fire at Maddington 15 May 2009

Government of Western Australia  
Department of Mines and Petroleum  
Resources Safety

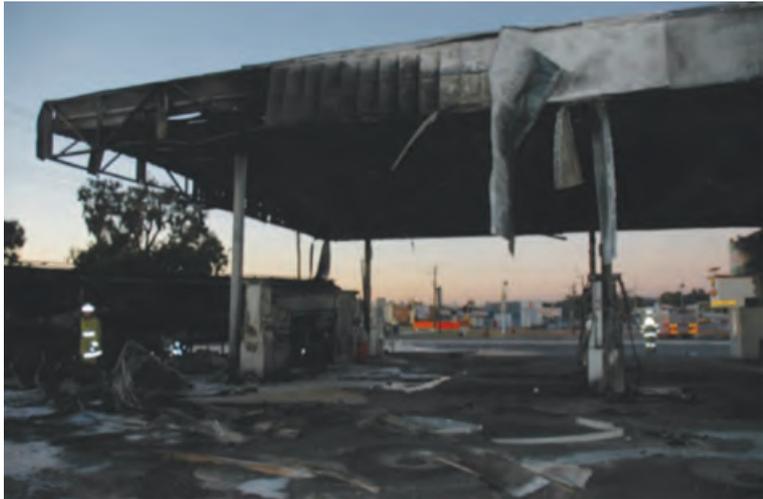
- The site was secured with temporary fencing and access was controlled by a security guard.
- The fuel dispensers, service station canopy and shop building were extensively damaged by the fire (Figure 22). There was no evidence of blast damage.
- The fill points of the underground fuel storage tanks showed signs of fire damage (Figures 23 to 25). The fill points for tanks 2 and 3 appeared to have collapsed or fallen into the fill point containment sump directly underneath the fill box.
- The LP Gas cylinder cage (for 9 kg exchange cylinders) was extensively damaged by the fire (Figure 26).
- The 7.5 kL bulk LP Gas tank at the rear of the site was intact and showed no signs of fire damage.

Figure 22 Extensive damage to the service station canopy and fuel dispensers

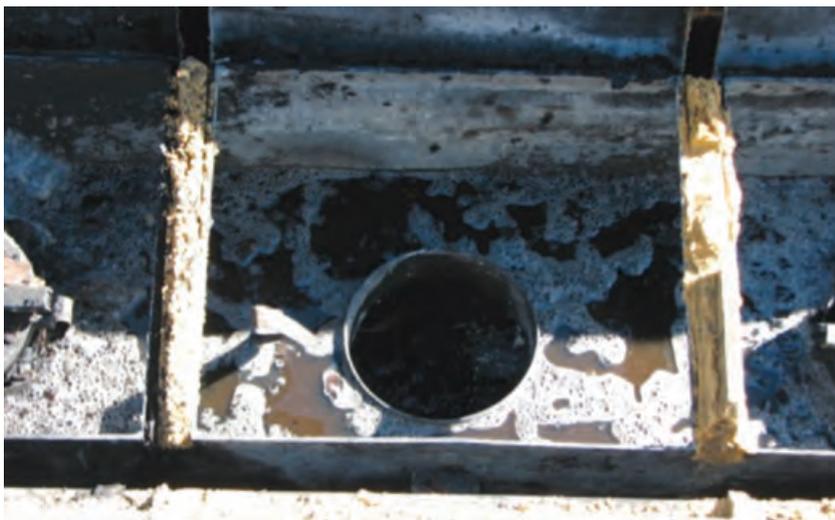
**Figure 25** Tank 3 fill point with missing fill point

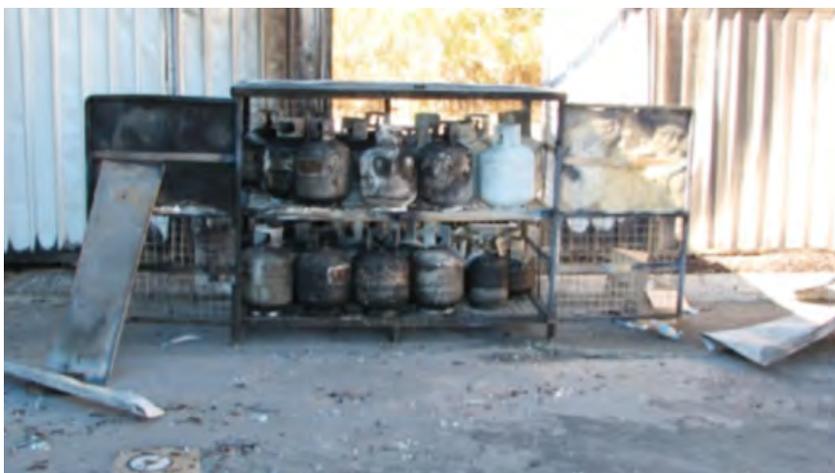
**Figure 26** Fire-damaged LP Gas exchange cylinder cage

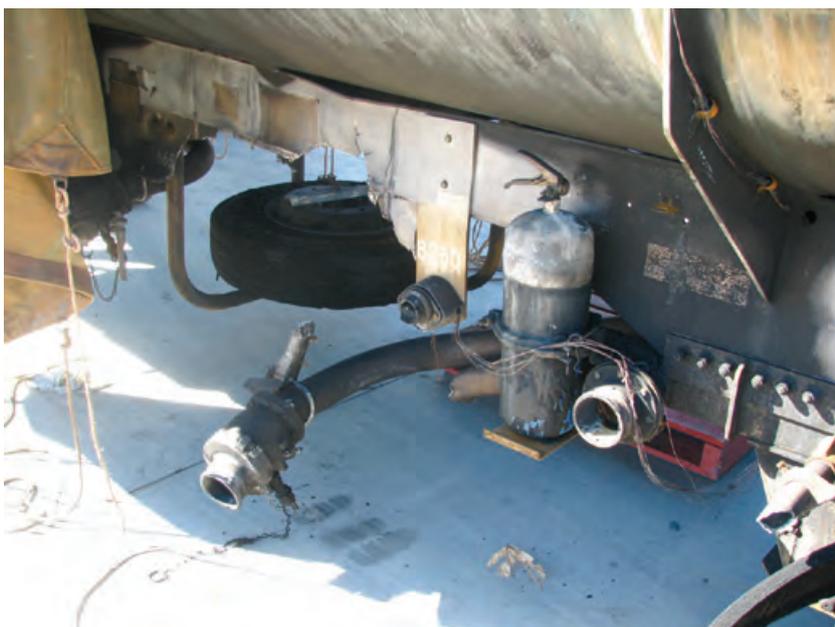
- Two fire extinguishers mounted on the mid-section of the tanker were fire damaged. One was near the outlet valves, and the other was on the side opposite the outlet valves (Figure 27).

**Figure 27** Damaged fire extinguisher beside the vapour recovery point, and one outlet valve still attached to the product line

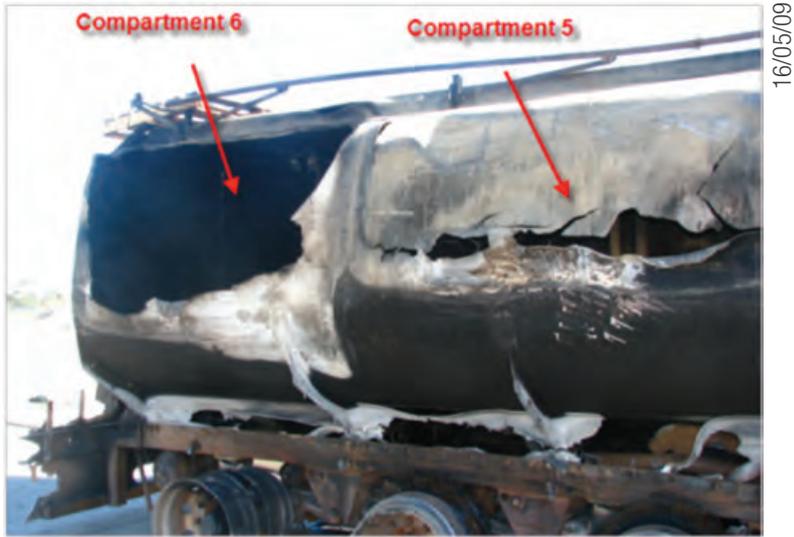
- Two rear compartments (5 and 6, driver side rear) of the tanker vehicle had ruptured (Figure 28).
- Of the six tanker outlet valves and product lines, only the two at the front of the tanker (compartments 1 and 2) were intact. Some of the product lines were deformed by the fire.

**Figure 28** Ruptured compartments on the rear driver side of the fuel tanker

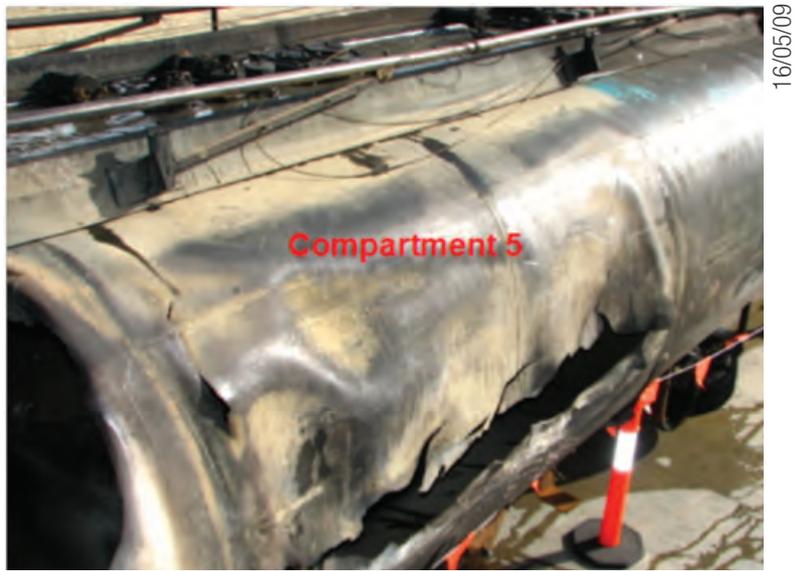
- The internal shut-off valves for compartments 5 and 6 were in the closed position.
- A section about 1.5 m long of the tank wall of compartment 6 (rear section of tank shell, driver side) was missing (Figure 29).

**Figure 29** Side view of the ruptured section of compartment 5

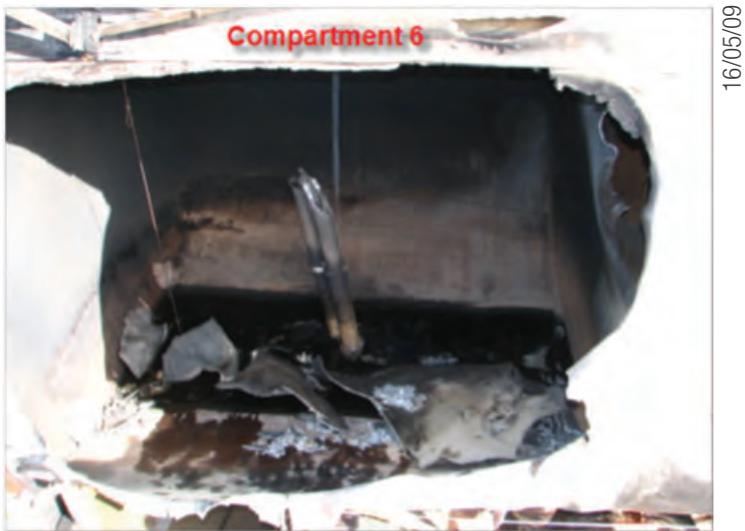
- Compartment 5 (mid-section of tank shell, driver side) was cracked, with the largest gap being about 200 mm wide (Figure 30).
- Compartment 6 (rear, passenger side) had a narrow crack (Figure 31).

**Figure 30** View inside compartment 6

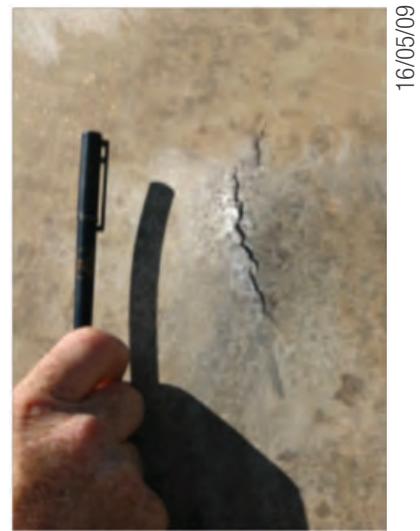
**Figure 31** Fine crack on the tank shell of compartment 6 (passenger side)

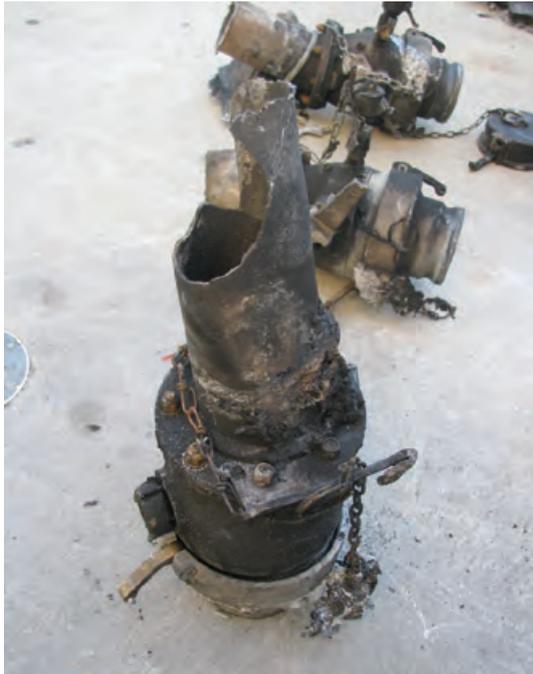
- Three of the tanker product outlet valves had become detached from the product pipe work when it melted (Figure 32).
- All of the outlet valves were in the closed position.
- Sight glasses on the fill elbows for the underground tank fill points had melted (Figure 33).
- The three tanker hoses (two product hoses and one vapour hose) in use at the time of the fire were destroyed. The only remnants were the metal wire coils that surrounded the original hoses and the hose couplings (Figure 34).

**Figure 32** Detached tanker outlet valves

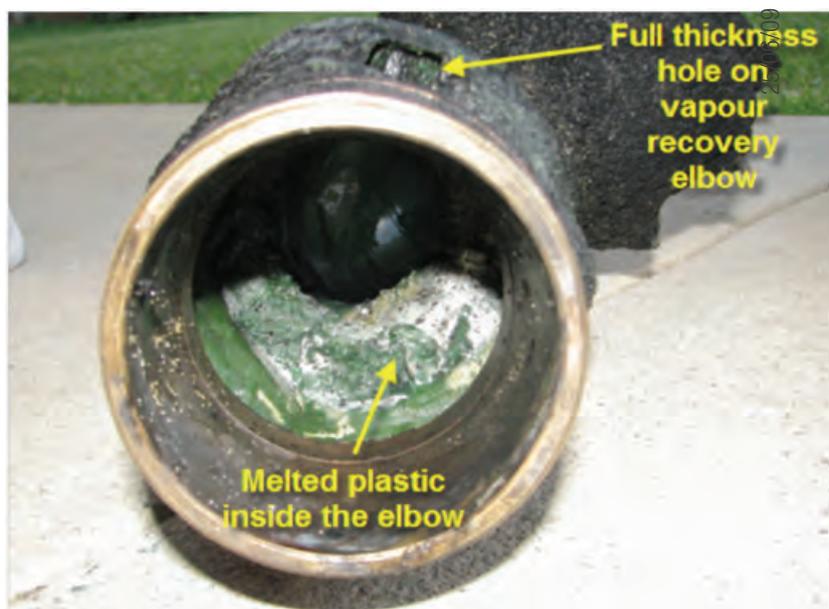
**Figure 38** Top section of vapour recovery elbow pipe, the hole in the elbow and melted plastic inside the pipe

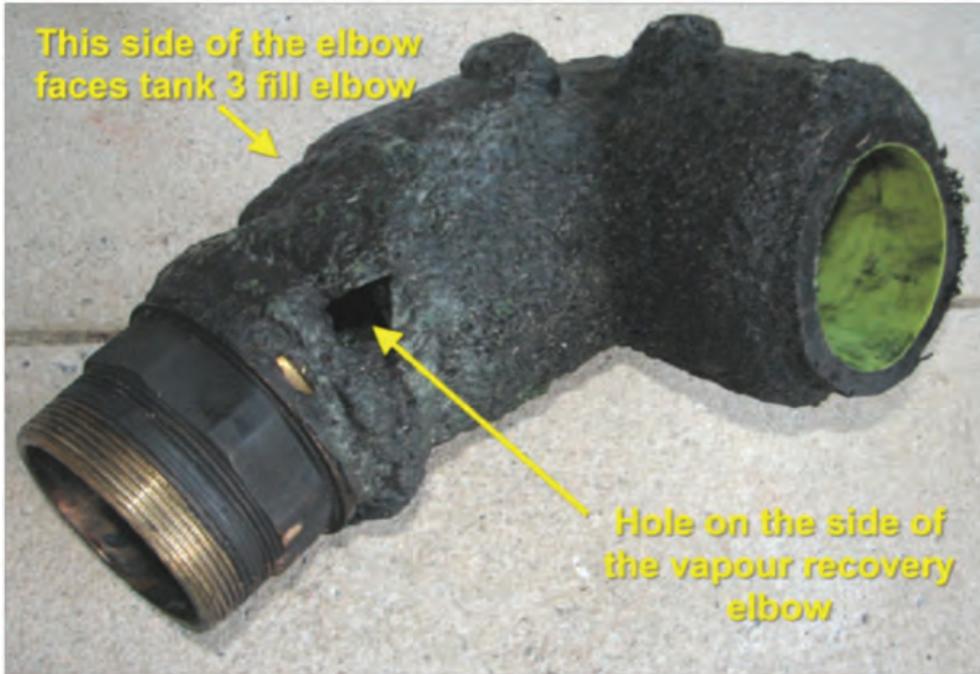
**Figure 39** *Hole in vapour recovery elbow pipe and location relative to tank 3*

Although there was a hole in the vapour recovery elbow, this appeared to be caused by the fire and there is no evidence to suggest that there was leakage prior to the fire.

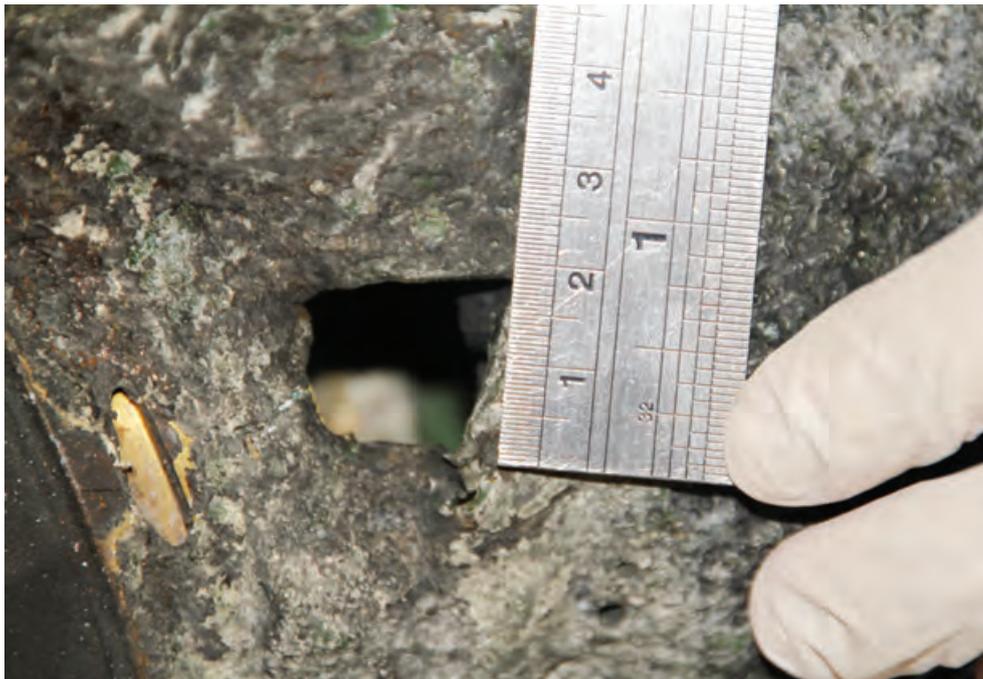
**Figure 40** *Close up of hole in vapour recovery elbow pipe*

- There was very little fire damage to the fill point elbow for tank 1 (Figures 43 to 45). No holes were visible on the elbow.
- There was moderate fire damage to the fill point elbow for tank 2 (Figure 46 to 48). No holes were visible on the elbow.
- There was major fire damage to the fill point elbow for tank 3 (Figures 49 to 51). The fire was so intense that the plastic fill line (to the underground tank) that attached to this elbow had softened and elongated. A hole was initially identified on a section of the fill point elbow but when this section was cut off for further examination, it was clear that the hole did not penetrate the inner wall of the fill line.
- The fill point elbow for tank 4 sustained major damage, with the elbow point softened and deformed by the fire (Figures 52 to 55).
- The vapour recovery elbow sustained major fire damage (Figure 40).

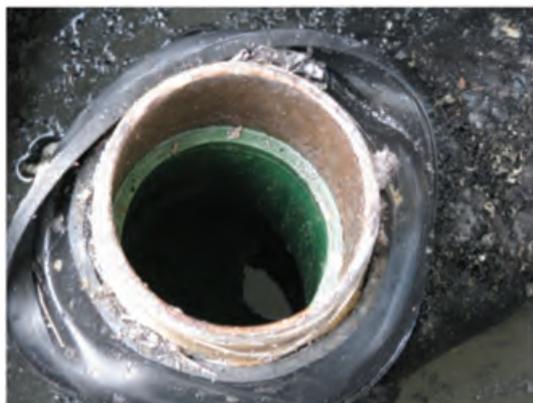
**Figure 43** Tank 1 fill point opening — no melting of green plastic pipe

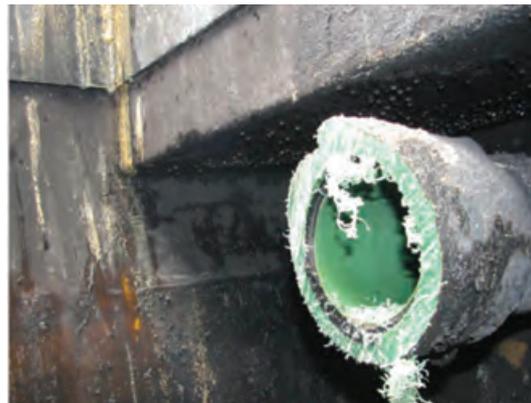
**Figure 44** Tank 1 fill pipe inside containment sump — fill pipe is in good condition

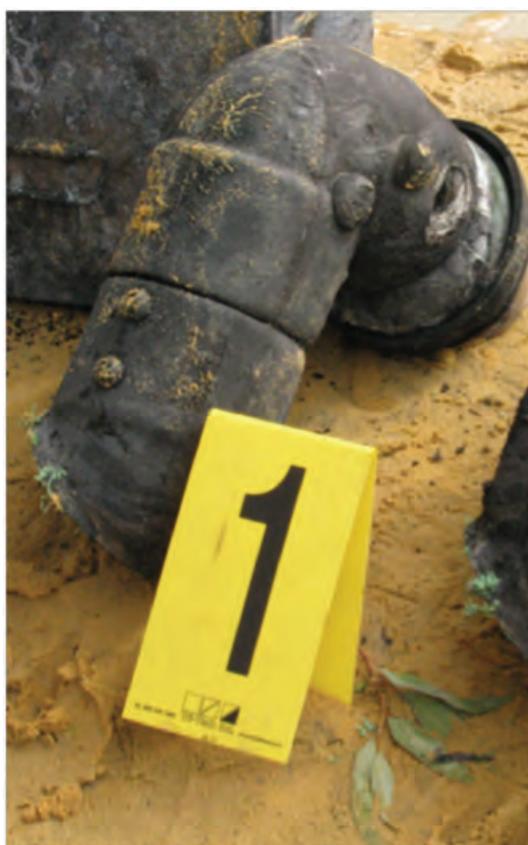
**Figure 45** Fill pipe elbow of tank 1 — pipe is not significantly fire affected

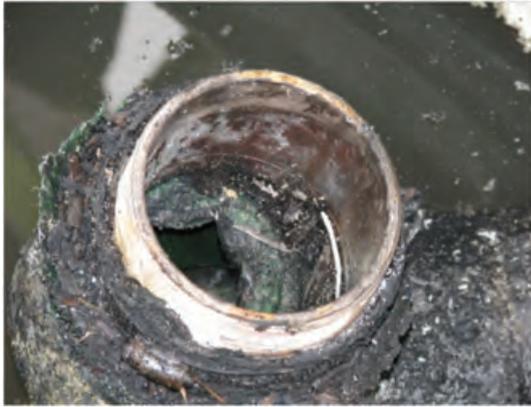
**Figure 46** *Fill point opening of tank 2 — significant melting of green plastic pipe*

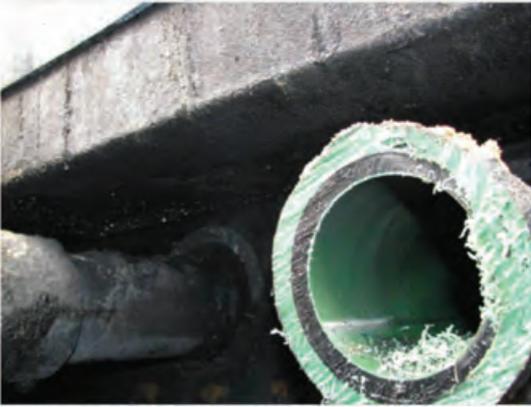
**Figure 47** *Tank 2 fill pipe inside containment sump — fill pipe is fire affected*

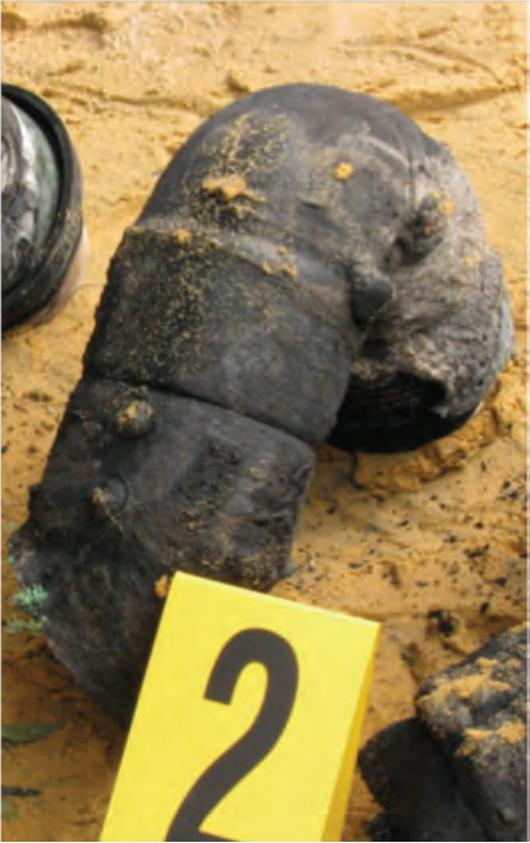
**Figure 48** *Fill pipe elbow of tank 2 — pipe is fire affected*

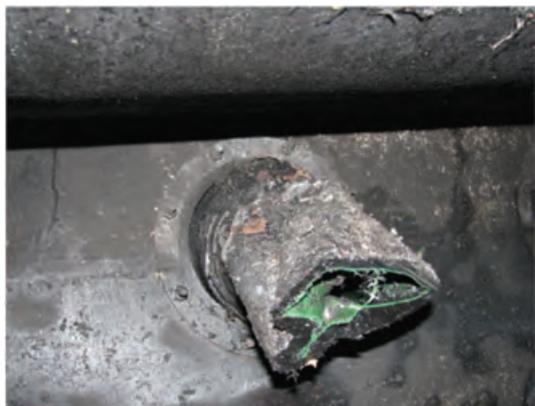
**Figure 49** Tank 3 fill pipe inside containment sump — fill pipe is significantly fire affected

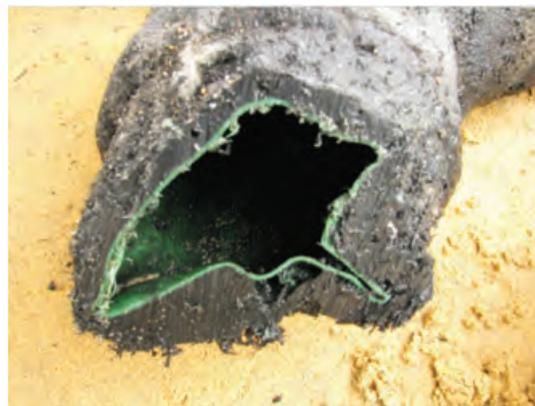
**Figure 50** Deformed fill pipe elbow of tank 3 after it was cut from the fill pipe

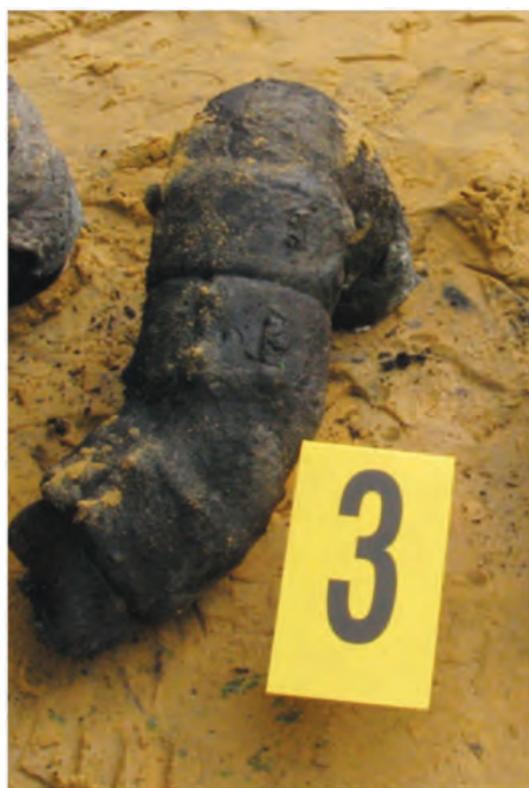
**Figure 51** Fill pipe elbow of tank 3 — elbow is significantly fire affected, as shown in Figure 48

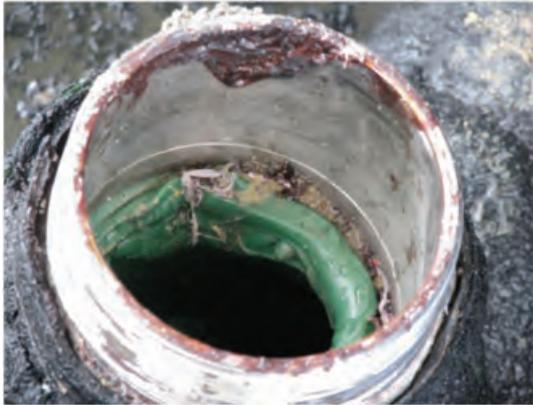
**Figure 52** Fill point opening of tank 4 — noticeable melting of green plastic pipe

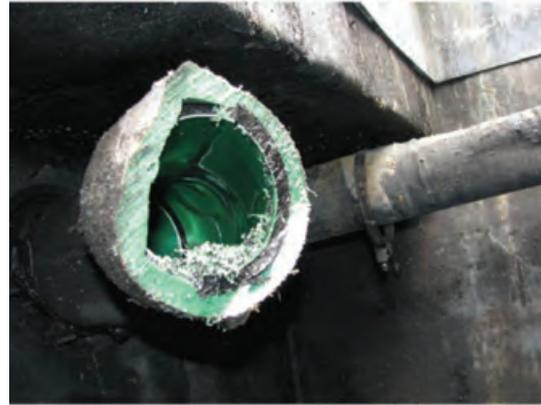
**Figure 53** Tank 4 fill pipe inside containment sump — fill pipe is partially fire affected

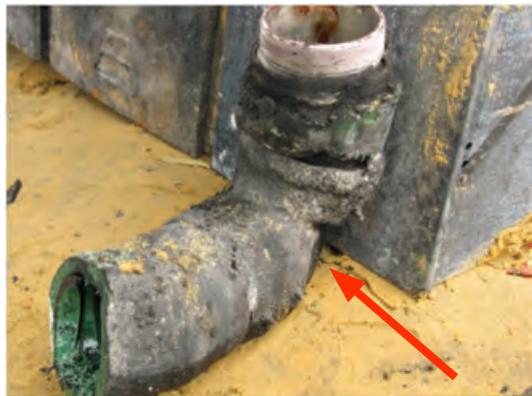
**Figure 54** Fill pipe elbow of tank 4 — elbow section is significantly fire affected, as shown in Figure 64

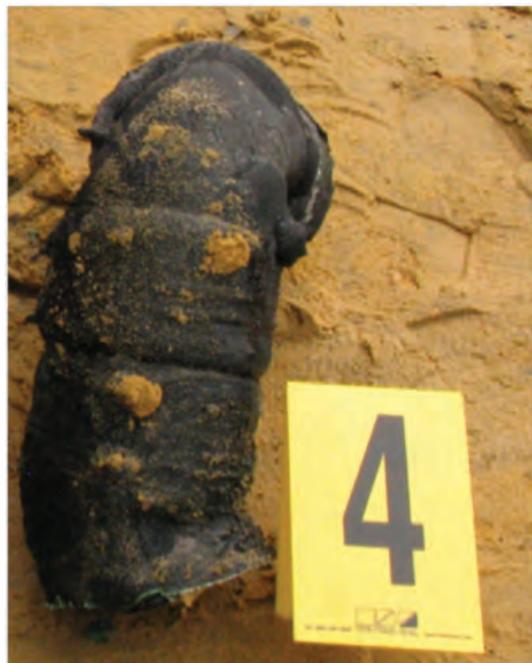
**Figure 55** Fill pipe elbow of tank 4 — elbow section is significantly fire affected

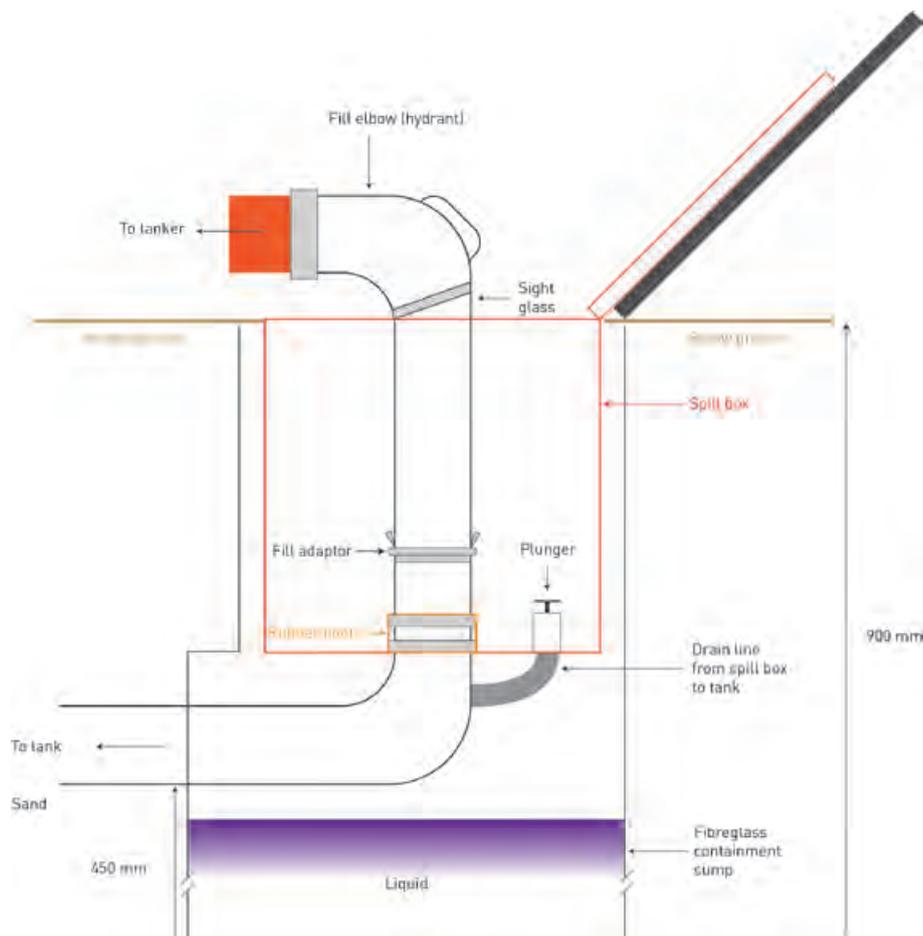
Discussions with tanker drivers and petroleum tank installation companies during the investigation indicated that leaks are known to occur at the fill points (e.g. from the fill adaptor; see Figure 62) and fuel from these leaks find its way into the containment sump under the spill box. However, it is unlikely there was any leakage from the fill lines when the fuel transfer commenced on 15 May 2009 because the driver reported that everything appeared normal at the time. It is possible that there was a leak from one of the fill point elbows because, being covered by the metal spill box, they were not visible to the driver during the filling process. The vapour recovery elbow would have been visible to the driver.

**Figure 62** Cross section showing fill box assembly and containment sump typical of modern service stations in Western Australia.  
*Note: Figure is diagrammatic and not to scale*

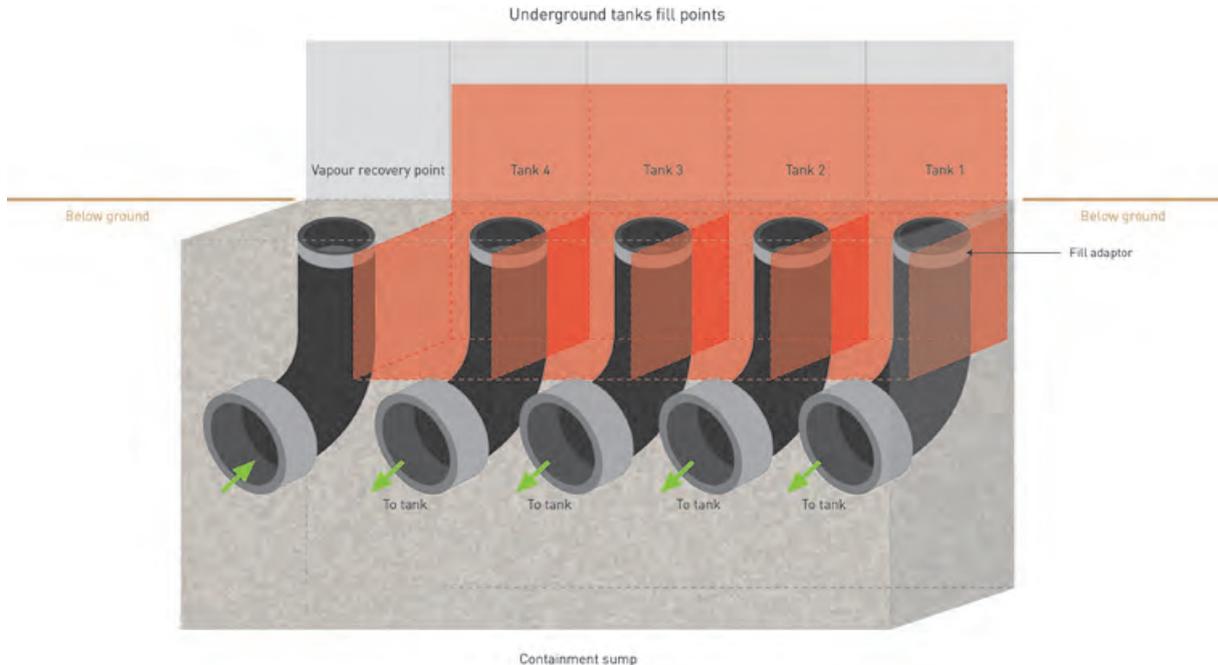
**Figure 63** Sketch of a fill box assembly sitting above a containment sump. The vapour recovery area and containment sump are back-filled with soil or crushed rock. Red box indicates one metal box (spill box) for fill point spill containment. Note: Figure is diagrammatic and not to scale

- Provide additional engineering controls by redesigning the containment sump so that liquid can be detected or removed, at the same time minimising the exposed surface area where flammable liquid or vapour may be present.
- Regularly check to ensure fill points are clean and free of liquids, in both the spill boxes and sump.
