Report on Shaft Condition Assessment

Donnybrook Shaft Remediation Goodwood Road, Upper Capel

Prepared for Department of Mines, Industry Regulation & Safety

> Project 96721.02 April 2022

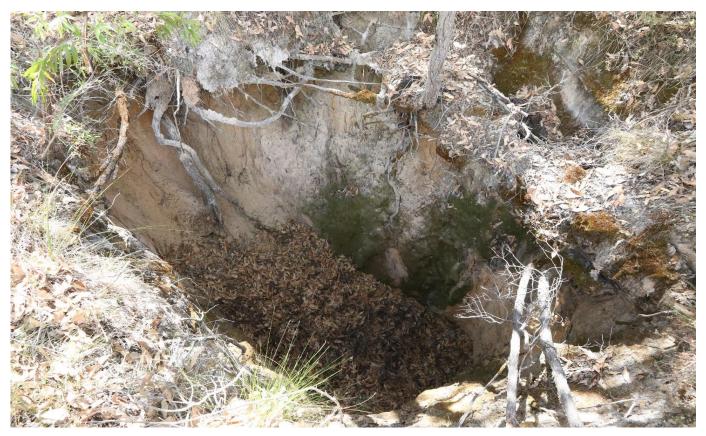
Photograph 1: Feature 101

Feature	Description
101	Approximately 4.3 m deep and 3 m by 3 m in plan. Base of feature obscured by collapsed material. Probing the base of the feature indicates competent material at the base, approximately 0.3 m below the surface of the collapsed vegetation and branches. The volume of stockpiled material around this feature is estimated to exceed the excavated volume of the feature and therefore, is anticipated to comprise spoil from the excavation of multiple features in the vicinity. No evidence of lateral workings.
102	A roughly circular excavation, with a diameter of 3.3 m and approximately 1.5 m deep. Probing the base of the feature indicates competent material at the base, approximately 0.25 m below the surface of the fallen vegetation.
103	A trench, approximately 0.5 m to 1 m deep, 27 m long and 0.7 m wide with one notable feature near the mid-point of the trench alignment, measuring approximately 1.5 m deep and 3 m by 2 m in plan. Probing the base of the trench at regular intervals along the alignment, indicated that competent material was present within 0.3 m below the surface of the soil and fallen vegetation.

The 15 mine features assessed are generally in good condition and considered overall stable. Some limited collapse of the walls of some features (e.g. 101, 102, 106a, 112) is evident, essentially from shallow depth, i.e. where the ground profile comprises soil rather than rock surrounding the features.

It is considered that the risk of sudden collapse of the features, specifically those that could be described as vertical shafts (e.g. 101, 105, 108, 110 and 113) or their lateral extensions is very low. This risk allocation considers the following:

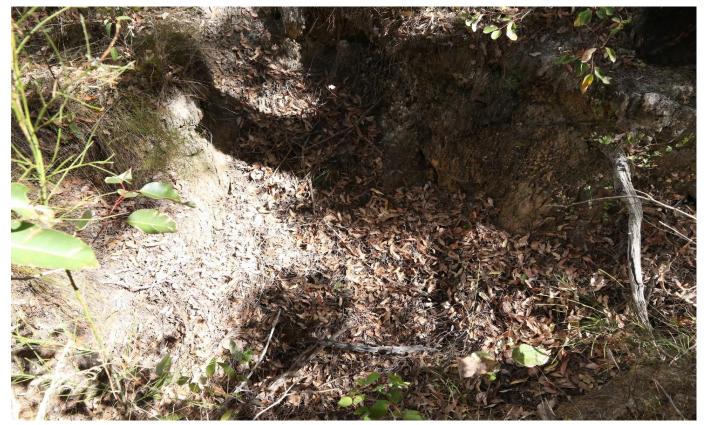
Photograph 4: Feature 104 - central excavation

104	A trench, approximately 0.5 m to 1 m deep, 12 m long and 1.5 m wide with one notable feature near the mid-point measuring approximately 1.2 m deep and 2.5 m by 2.5 m in plan. Probing the base of the trench at regular intervals along the alignment indicated that competent material was present within 0.3 m below the surface of the soil and fallen vegetation.
105	Approximately 4 m deep and 1.5 m by 1.0 m in plan. Probing the base of the feature indicates competent material at the base, approximately 0.3 m below the surface of the fallen vegetation. No evidence of lateral workings.
106a	The southern-most feature of three closely grouped features. Approximately 1.5 m deep and 2.0 m by 1.3 m in plan. Probing the base of the feature indicates competent material at the base, approximately 0.5 m to 1.0 m below the surface of the fallen vegetation. No evidence of lateral workings.
106b	The central feature of three closely grouped features. This feature comprises a lateral working from surface, heading in a northwest direction (up-hill direction). The entrance to the working is approximately 0.7 m high and 2 m wide. Through this entrance, the working opens up to an excavated room approximately 1.5 m high, 3.5 m wide and 5 m long. A lateral working, approximately 1 m wide and less than 1 m high continues in a northwest direction, from the opposite side of the room. The working slopes downwards at a slope of approximately 1 horizontal:0.3 vertical. The total lateral extent of this working was beyond the reach of camera and lidar equipment, however it is estimated to be at least 12 m in horizontal length.

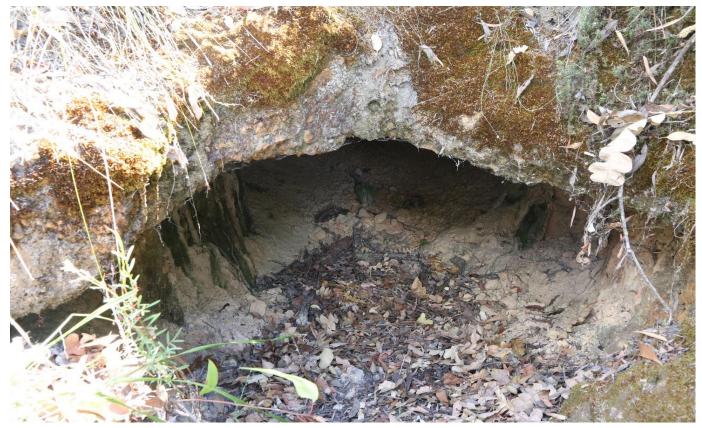
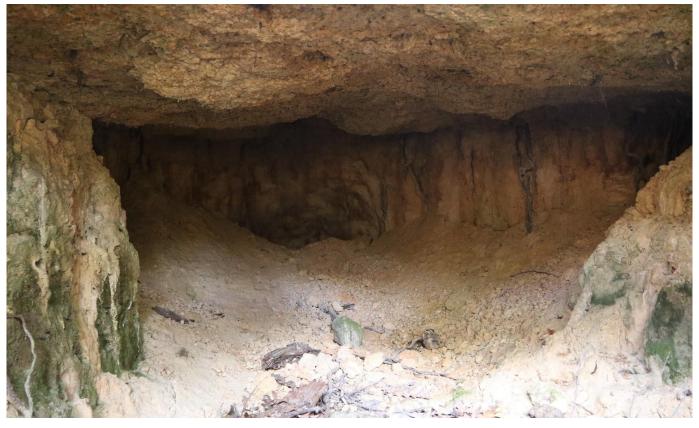
Photograph 9: Feature 106b - entrance

The assessment of the total lateral extent of Feature 106b was beyond the maximum range of the equipment. It does however progress at a dip and direction that would only increase the thickness of ground cover above the lateral working and therefore, the section of 106b that was beyond inspection range is not considered to pose any risk of collapse that would warrant further investigation. It is noted that the bearing of Feature 106b heads towards Feature 104 in plan view, however, the difference of level between the two features appears to discard any connection between these features (refer to Drawing 7, Appendix B). It is considered that the portion of 106b posing the greatest risk for collapse is the opening of the feature, immediately west of its entrance as this section is where it is widest and with the least amount of cover to the surface. This section however, is also considered to be low risk to pedestrians and other similar light loads other than vehicles and heavier equipment.

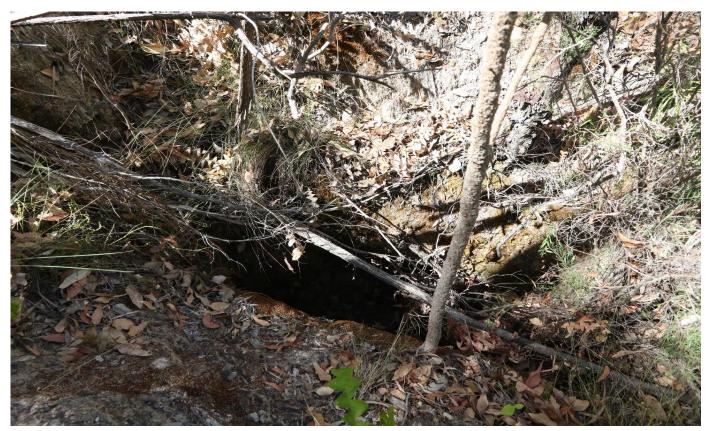
Photograph 11: Feature 106c

106c	The northern-most feature of three closely grouped features. Approximately 2 m deep and 1.8 m by 1.1 m in plan. Probing the base of the feature indicates competent material at the base, approximately 0.4 m below the surface of the fallen vegetation. No evidence of lateral workings.
107	Approximately 1.3 m deep and 2.0 m by 1.5 m in plan. Probing the base of the feature indicates competent material at the base, approximately 1.0 m below the surface of the fallen vegetation. A small lateral working, observed at the base, on the northern side of the feature. Lateral working is approximately 0.3 m in height and video footage from the base of the feature suggests the lateral extent of the working not more than 0.5 m.

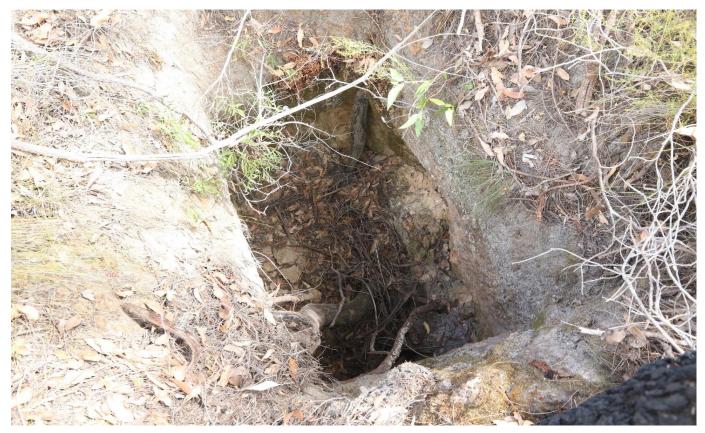
Photograph 13: Feature 108

Feature	Comments
108	Approximately 2.9 m deep and 2.5 m by 1.5 m in plan. Probing the base of the feature indicates competent material at the base, approximately 0.5 m below the surface of the fallen vegetation. No evidence of lateral workings.
109	Small depression, less than 0.3 m deep with evidence of manual excavation. Probing the base of the feature indicates competent material, approximately 0.5 m below the surface.
110	A vertical shaft, approximately 9.5 m deep and 1.5 m by 1.2 m in plan. Lateral workings extend in four directions (generally, north, east, south and west) from the base of the shaft. Based on the LiDAR data, the detected horizontal extent of the lateral workings is generally 1 m to 3 m. It is anticipated that the working heading in a southerly direction is longer than the detected extent. The extent of the workings in the north, east and west direction is uncertain however there is a possibility that they are only as long as their detected extent. The working in a southerly 1 horizontal:0.35 vertical and the other workings are roughly horizontal or angles downwards slightly.

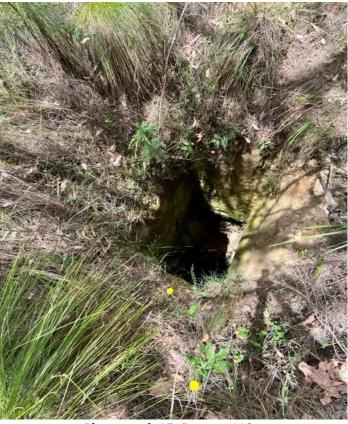
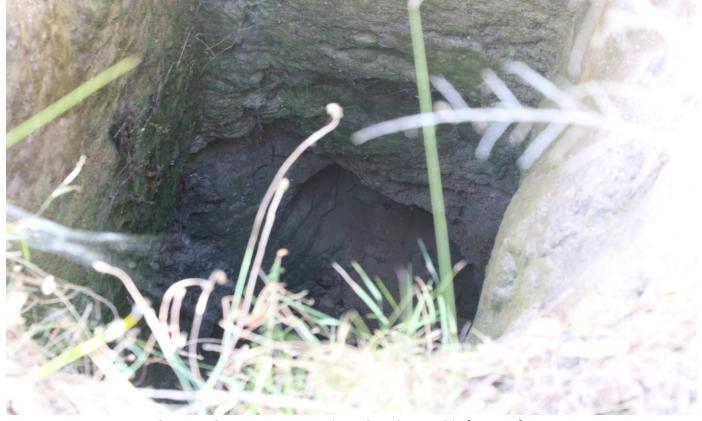
Photograph 15: Feature 110

Feature 110 contains lateral workings, including one heading in a southerly direction towards Feature 103 located about 10 m away. The limited LiDAR data collected on the southerly working and the lack of evidence of any lateral continuation from Features 103 however make it difficult to extrapolate the significance of the south-heading lateral working from Feature 110 past its investigated length. Regardless, owing to the depth of the lateral workings from Feature 110, they are not considered to be a risk.

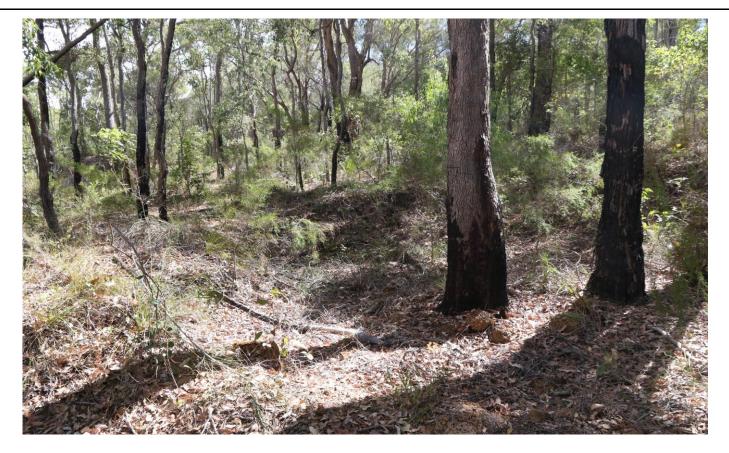
Photograph 17: Feature 111

111	An area of ground disturbance beside the forest access track measuring approximately 20 m by 8 m, where evidence of cutting into the slope is observed on the western edge, thereby creating a flatter area on the naturally slopping surface. Dynamic cone penetrometer testing within the footprint of the area indicated hard ground within 0.15 m of the surface level.
112	A roughly circular excavation at surface becoming rectangular, with side support (constructed from wood and sheet metal) near the base. The excavation is approximately 3.0 m in diameter at the surface and the rectangular part near the base is approximately 1.5 m by 1.0 m in plan. The feature has a total depth of approximately 2.0 m. Probing the base of the feature indicates competent material at the base, within 0.3 m below the surface of the fallen vegetation. No evidence of lateral workings.
113	Approximately 4.7 m deep and 2.5 m by 1.5 m in plan. Probing the base of the feature indicates competent material at the base, approximately 0.3 m below the surface of the fallen vegetation. No evidence of lateral workings.
