## Significant Incident Report No. 283

**Subject:** Manned loader falls into open stope – fatal accident

**Date:** 07 September 2020

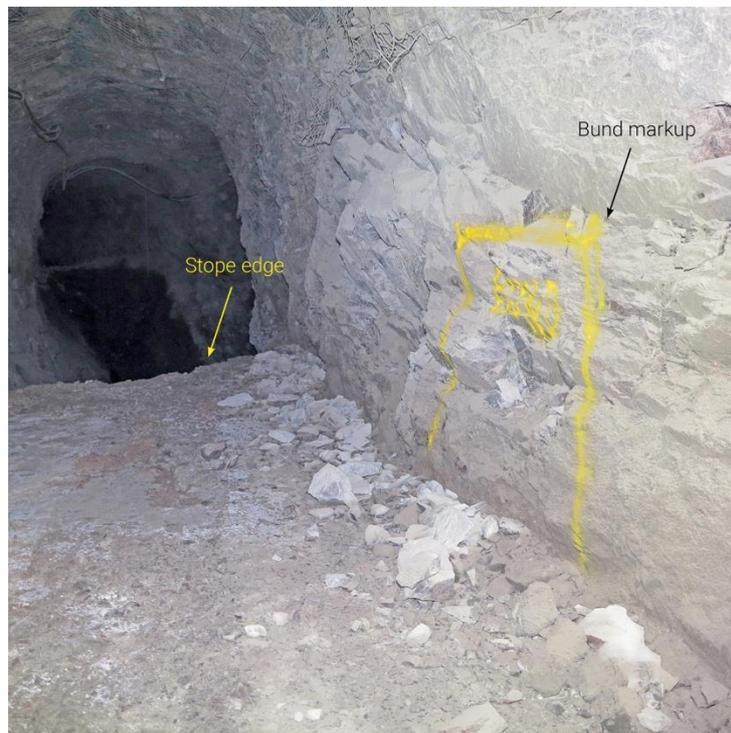
Photograph of bund marking and stope edge

There was no physical barrier to prevent the LHD entering the stope.

When operating an LHD, the operator's forward visibility is limited by the configuration of the machine. This can have implications on an operator's capacity to see the edge of the open stope as they approach.

There were no effective visual wall markings or delineators to aid the driver in judging the distance to the open stope edge.

- use a physical barrier such as a rock bund, engineered steel or concrete barrier, or steel bollards to prevent LHDs and other manned machines entering open stope voids
- a physical barrier must be erected before the open stope is created or changed by firing, and maintained thereafter to prevent access
- develop a safe system of work to place one or more barriers as the stope is mined
- position the physical barrier at an appropriate distance from the stope such that the operator is not exposed to the hazard of going over the edge
- place visual markings and/or delineators on the walls or backs to identify the distance to the stope edge
- use remote LHDs or other types of loaders with better forward visibility, instead of manned LHDs.
