Mines Safety Bulletin No. 93

Date: 19 November 2010

Subject: Lowering and raising of bottom guards on dozers — fatal accidents

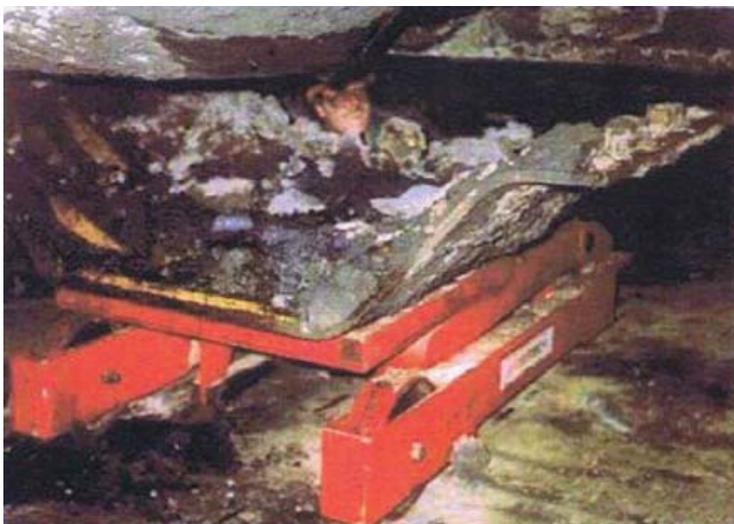
Figure 1 Example of a fit-for-purpose component handler positioned to support the bottom guard (photo courtesy of Direct Mining & Industrial International Pty Ltd)

- Information on bottom guard lowering and raising provided and updated by the OEM should be readily available for review by employees.
- Bottom guard lowering and raising work should be undertaken in a workshop environment with the aid of fit-for-purpose lifting and lowering equipment to control the movement of the guard (see example in Figure 1).
