Mines Safety Bulletin No. 133

Subject: Unloading of poly pipe from vehicles or trailers

Date: 30 November 2016

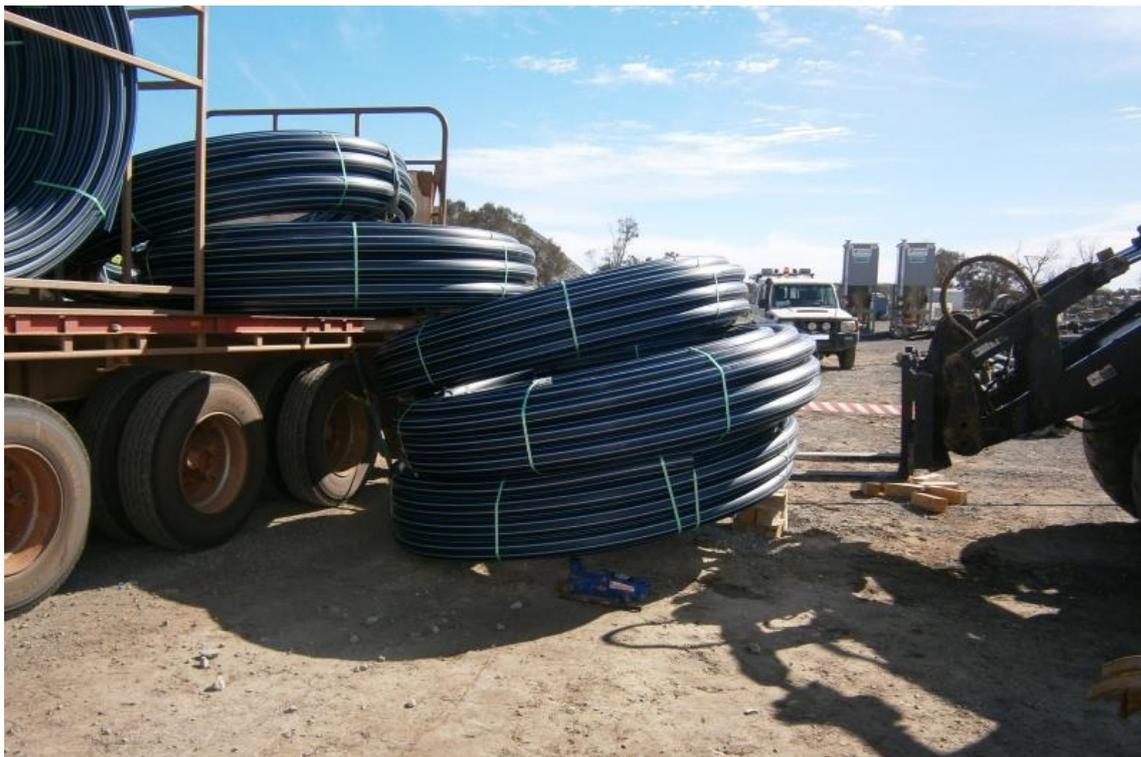
In June 2015, an underground operator became trapped beneath rolls of poly pipe that fell from a trailer during unloading. The operator was releasing tie-down straps securing the rolls, when the rolls of poly pipe toppled. He over balanced, fell from the truck tray to the ground, and was struck by the falling poly pipe receiving serious crush injuries.

Position of poly pipe after the incident. The forklift and hydraulic jacks were used to move the poly pipe to access the underground operator trapped beneath.

- Workers required to be on the truck tray and in close proximity to the load in order to release the load binders.
- There was no secondary restraint on the rolls of poly pipe after the release of the load binders.
- The loading and unloading procedure did not consider all of the hazards.
- A risk assessment, such as a job safety analysis (JSA) or similar, was not completed.
- Workers received only limited training in removing unstable loads from a trailer or flatbed truck.
- Site workers are unfamiliar with the task and associated hazards (e.g. in some instances transport company operators normally unload the poly pipe).

- Consider the use of engineered structures (e.g. frames) to contain loads.

- Review freight unloading procedures and adequacy of risk management controls.

- Conduct specific risk assessments (e.g. JSA) when job parameters change and where workers may not be familiar with the loading and unloading process.
