## Mines Safety Bulletin No. 184

**Subject:** Workers ejected from underground work platform

**Date:** 30 August 2021

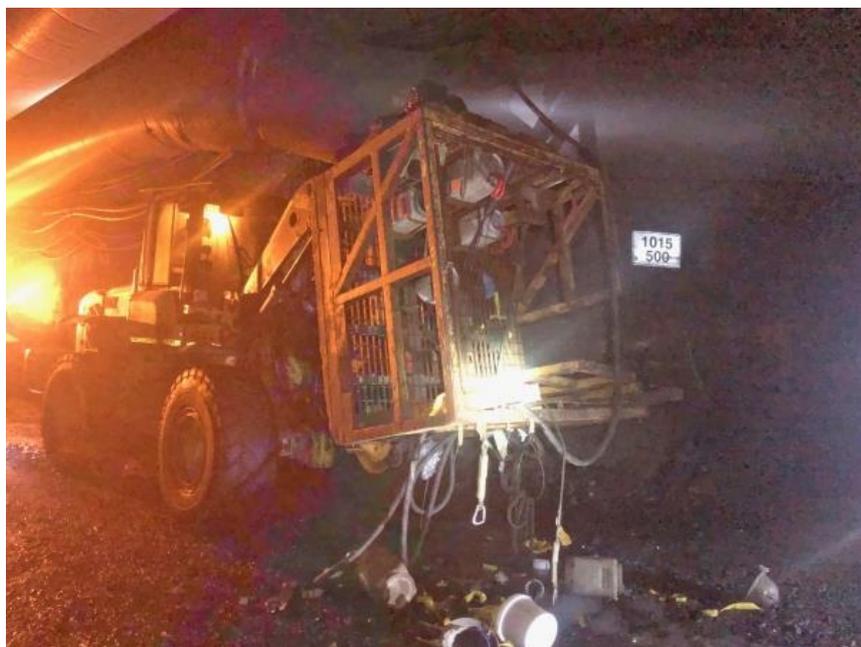
As the two workers were hanging the cable from the WP, a hydraulic failure associated with the tilt cylinder (crowd function) on the boom of the ITC caused the WP to tilt fully forward under gravity. Due to the sudden and unexpected movement, one of the workers was ejected from the WP onto the ground below while the other remained in the WP as his right boot was caught in the door.

The floor of the WP was reported to be approximately two metres off the ground immediately prior to the incident, and despite both workers wearing fall control equipment, their shock adsorbing lanyards failed to deploy. Although the two workers received minor physical injuries, the potential consequences could have been much more serious.

Work platform on integrated tool carrier at location of the July 2020 incident (scene preserved following rescue of injured persons).

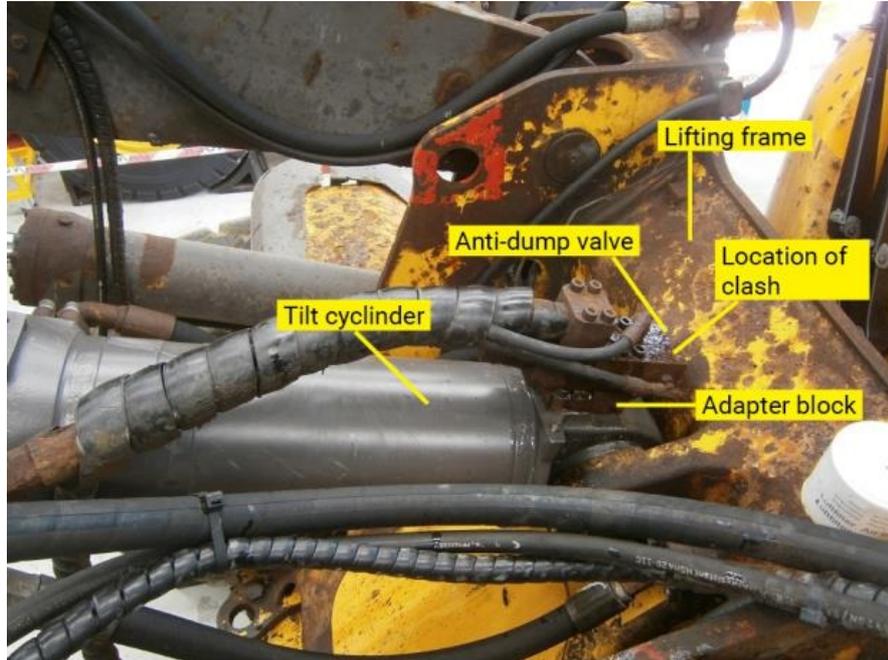
The hydraulic failure resulted from the anti-dump valve on the tilt cylinder becoming separated from the cylinder port when its mounting bolts sheared. The mounting bolts sheared when the body of the anti-dump valve clashed with the lifting frame of the ITC as the boom was being raised.

- The anti-dump valve included no guard or cover to protect it from physical impact. Other ITCs in the same fleet had robust protective covers on their anti-dump valves.

- The anti-dump valve involved in the incident required an adapter block for mounting. The adapter block made the "anti-dump valve" more vulnerable to impacts and allowed mounting in two different orientations. One of the available orientations did not allow clearance for the full range of boom elevation. These issues were not known to maintenance personnel and there were no mounting, testing or commissioning instructions available to them. A correctly sized anti-dump valve should match the hydraulic port size and mounting holes on the hydraulic cylinder so it can be directly mounted.

- After the anti-dump valve had been fitted to the tilt cylinder, the tilt capability was function tested, but the boom lift had not been function tested through the full range of movement. The anti-dump valve only clashed with the lifting frame of the ITC when the boom was raised close to full height during subsequent operational use.

Anti-dump valve on clevis end of tilt cylinder - re-enactment showing how valve body will clash with lifting frame of ITC.

The load-holding cylinders on MEWPs are required to be fitted with a safety device to prevent unintended movement caused by failure of a hydraulic line (refer to AS1418.10, Section 2.9.2). On an ITC with a WP that is used underground, this is typically achieved by fitting what is referred to as an "anti-dump valve" or "hose burst protection" to each of the boom lift and tilt cylinders. Such safety devices should:

- always be installed, tested, inspected and maintained in accordance with the ITC's original equipment manufacturer (OEM) instructions. When non-OEM supplied devices are used or other changes are made to the OEM design, appropriate change management and engineering due diligence must be applied
- be designed, selected, installed, tested, periodically inspected and maintained by competent persons to ensure they have a high level of reliability
- whenever they are fitted or replaced, have a complete functionality test of the ITC's physical movements and hydraulic functions performed, all in accordance with OEM recommendations before the ITC is returned to service.
