Significant incident report No. 132

Mine haul truck runs over a light vehicle following a driver change

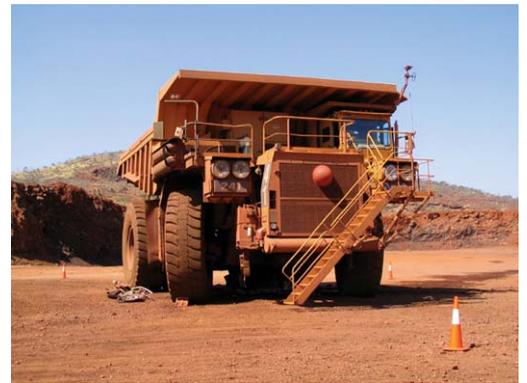
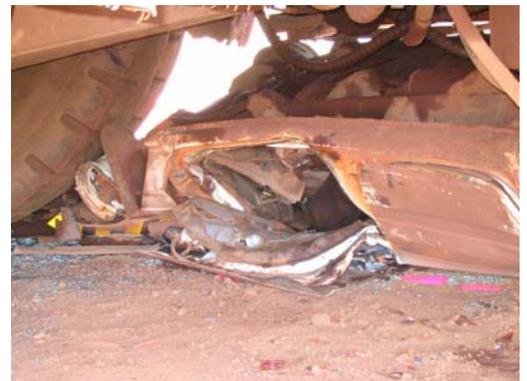
As a result of the collision the light vehicle had been turned over onto its roof, the cabin was crushed, and the vehicle ended up facing the rear wheels of the haul truck. The alarm was raised and the injured person was finally extricated several hours later. The light vehicle was extensively damaged and the injured relief driver was evacuated for treatment by RFDS, having suffered fractured ribs and severe bruising to the legs.

- Installation of lockout devices, camera or collision sensor technology on haul trucks and other large machinery to prevent or reduce the chances of a blindspot collision taking place.

- Provision of designated haul truck and light vehicle parking bays with vehicle separation bunds at suitable locations around the mine.
- Vehicles should never be parked in a blindspot, for example, directly in front or behind large equipment. It is recommended that a vehicle should be parked in a location outside the line of travel and where it can be seen from the driver's seat of any large mobile plant in the area.
