Mines Safety Significant Incident Report No. 165

Sudden depressurisation of an ANFO charge-up kettle

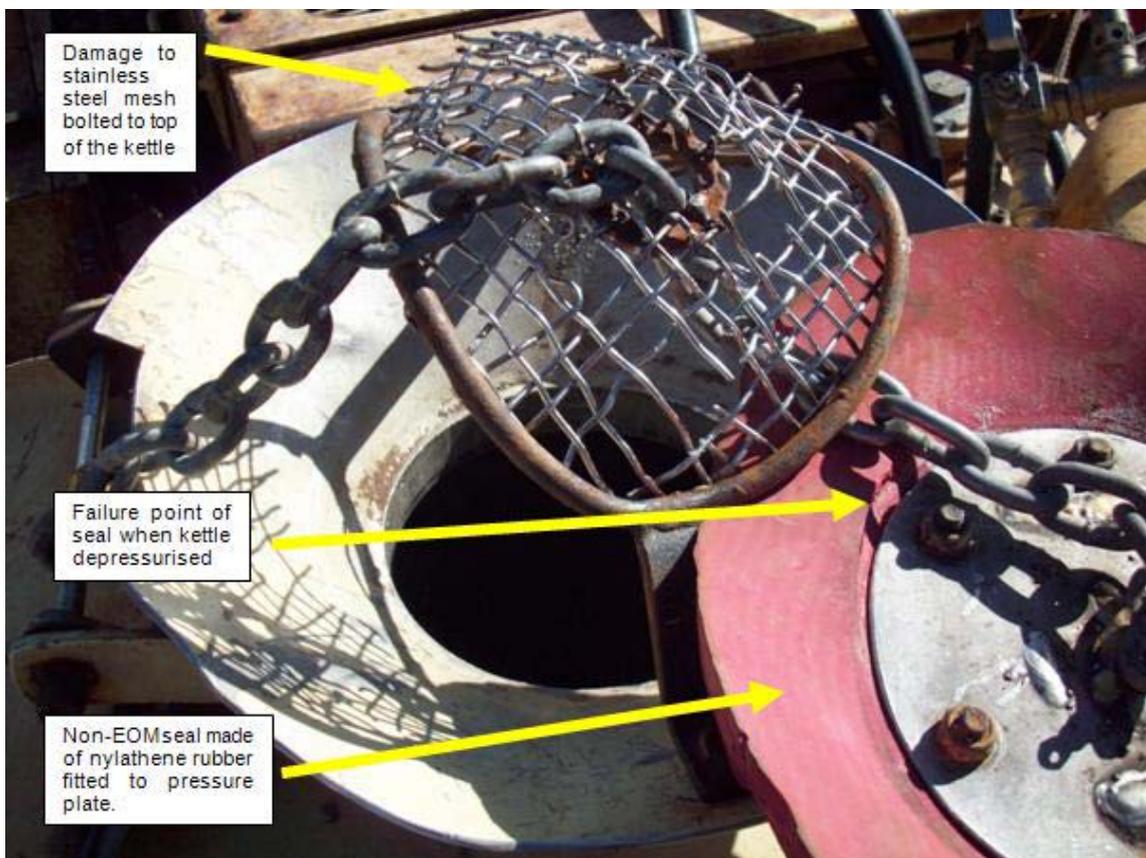
Shortly after a Normet Charmec ANFO charge-up kettle was pressurised, the pressure (sealing) plate ejected from the throat of the kettle (Figure 1). The plate was restrained by a stainless steel mesh screen bolted to the top of the kettle. However, an operator standing nearby received facial and eye injuries when ANFO sprayed into his face as a result of the sudden pressure release. The operator's hardhat and safety glasses were blown off.

Figure 1 The Normet Charmec ANFO charge-up kettle following the incident

Some time before the incident, the OEM seal on the pressure plate had been removed and replaced with a fabricated non-OEM seal made of nylathene rubber, about 10 mm thick and extending about 100 mm beyond the diameter of the pressure plate (Figure 1).

Normet provides a handle on the pressure plate and a pivoting screen that can be lifted out of the way when pressurising the kettle. However, a chain had been connected to the top of the pressure plate and pulled through an opening in the fixed mesh screen to position the pressure plate. This modification made it difficult to accurately locate the pressure plate in the throat of the kettle before pressurising it.

It appears that when the kettle was being pressurised, the pressure plate was not located in its correct position inside the throat of the kettle. The oversized pressure plate seal allowed a “false” pressure seal to develop against a section of the nylathene rubber but the kettle suddenly depressurised when the nylathene rubber seal failed.

- relevant procedures are in place to check that the pressure plate, seal and mesh screen are in a serviceable condition and meet OEM specifications; and
- charge-up operators and assisting personnel are properly trained and competent before pressurising the kettle.

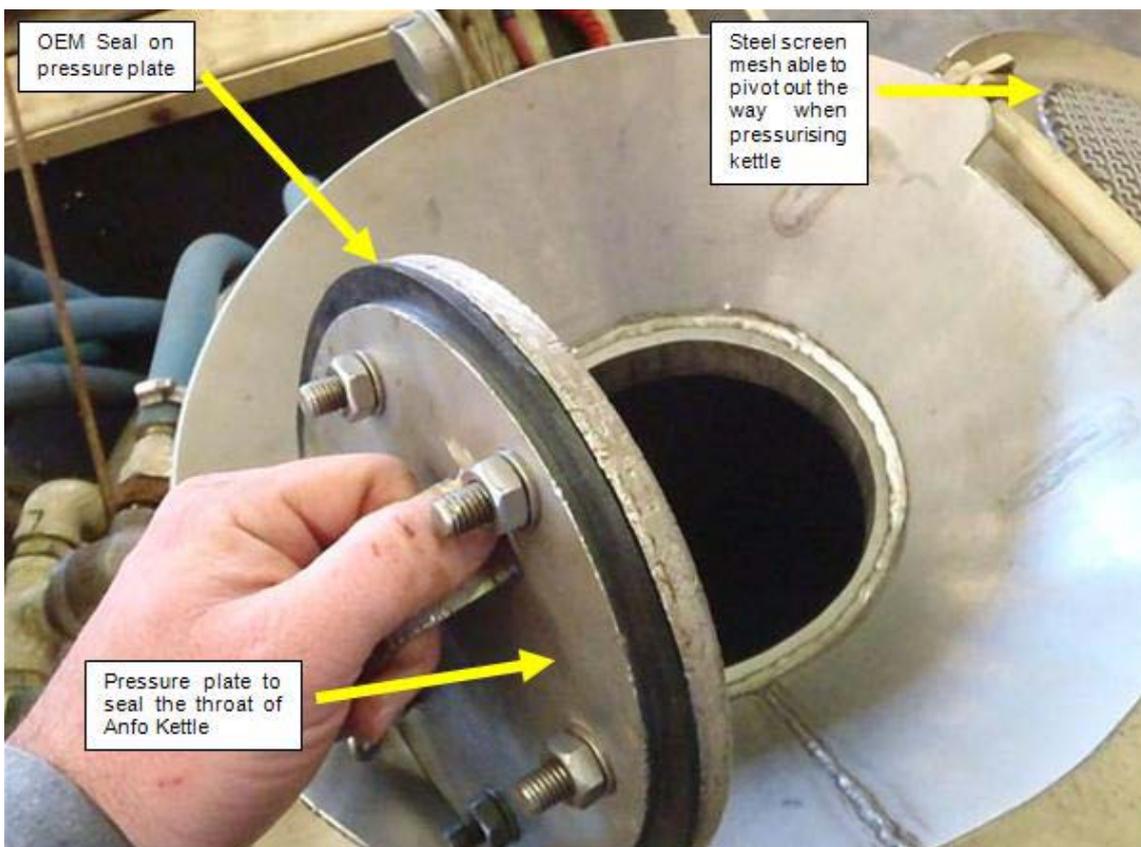
The Normet Charmec ANFO charge-up kettle involved in the incident had a slightly oval-shaped pressure plate to seal and pressurise the vessel (Figure 2). The plate was slightly wider than the throat opening but could be removed when placed vertically along the major axis of the opening. The kettle could be pressurised when the plate seated inside the throat.

The pressure plate was originally fitted by the original equipment manufacturer (OEM) with a seal about 3 mm thick and positioned about 10 mm outside the diameter of the plate. This seal allowed the kettle to be pressurised.

The investigation revealed the OEM pressure plate seal (Figure 2) required regular replacement to ensure an effective seal of the kettle. However, the service sheets for the kettle did not specify any requirement to inspect the pressure plate seal.

Figure 2 A Normet Charmec ANFO charge-up kettle complying with OEM requirements
