Mines Safety Significant Incident Report No. 167

Failure of the rope guide on a Demag overhead travelling crane

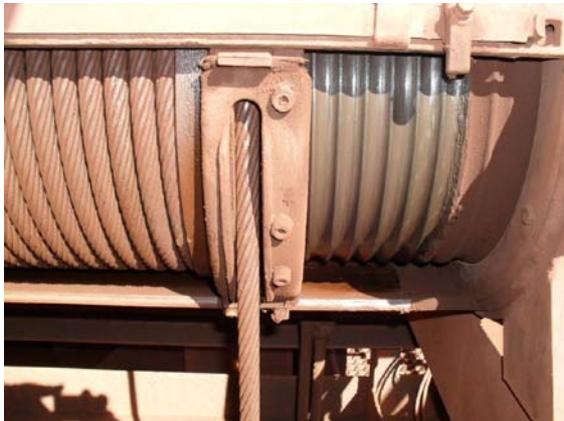
The metal rope guide on the hoist winch (Figure 1) of a three-tonne auxiliary hoist overhead travelling crane (Demag model P416H22L) broke apart while the crane was being set up for a task. A section of the guide weighing about 7 kg fell 23 metres, narrowly missing an employee who had been rigging up for the lift task (Figure 2). Another 2 kg section slid down the rope to rest on the hook sheave (Figure 3), while a third section weighing about a kilogram was found in plant adjacent to the overhead crane lifting bay.

Figure 1 Undamaged metal rope guide on the hoist winch of a Demag crane model P416H22L

- Metal rope guides are common on all Demag overhead travelling crane models that are identified by a "P" prefix, which indicates pre-1985 manufacture. For such cranes, contact the OEM for recommendations on replacement components, fitting or installation procedures, inspection and maintenance requirements, operating instructions and limitations on the crane's use.

Note: After 1985, the hoist drums should be fitted with a plastic rope guide. There is currently no retrofit available to replace metal rope guides with the plastic versions.

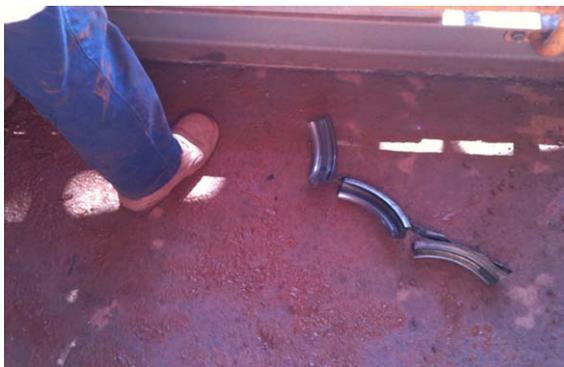
Figure 2 Final resting position of 7 kg section of rope guide and location of the employee involved in the near-miss incident

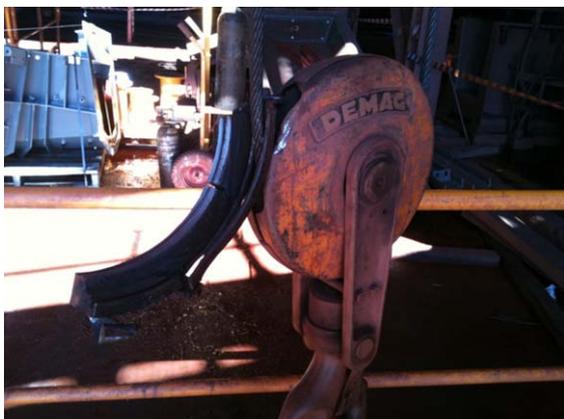
Figure 3 Section of rope guide resting on hook sheave after incident

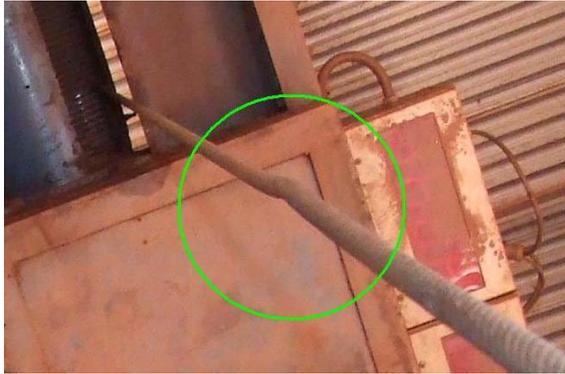
It appears that there had been a severe side loading or impact event, or both, before the incident involving the rope guide. Evidence included:

- kinking of the wire rope (Figure 4);
- shavings from the rope guide as it wore on the host drum (Figure 5); and
- wire rope impact marks on the rope guide (Figure 6).

Figure 4 Kink in wire rope

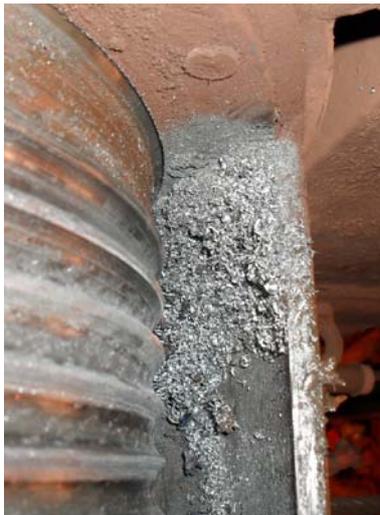
Figure 5 Rope guide shavings

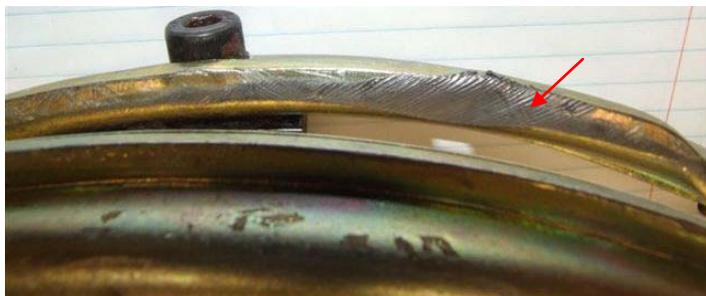
Figure 6 Wire rope imprint
