Mines Safety Significant Incident Report No. 168

Pressure release blows blanking plate off dozer tilt cylinder

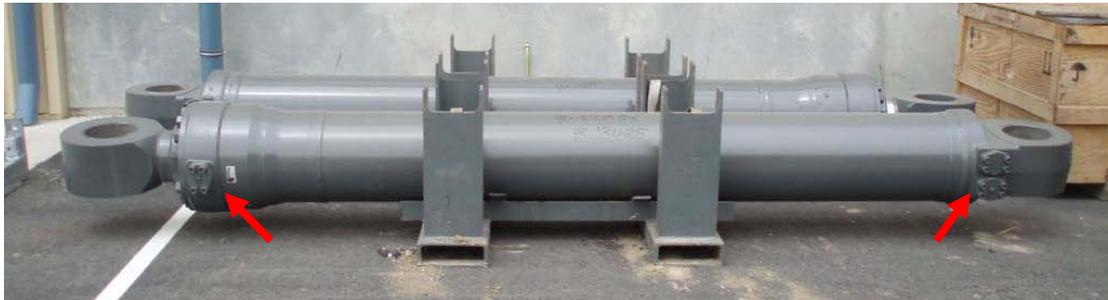
A blanking plate blew off a dozer tilt cylinder that was being replaced by a fitter. The fitter had removed the four bolts clamping the blanking plate without first releasing the cylinder's internal pressure. The blanking plate, bolts and retaining collar blew off under pressure, lacerating and abrading the fitter's hands, which required surgery.

The tilt cylinder involved in the incident has blanking plates fitted at each end to prevent the ingress of dirt before the cylinder is fitted to the dozer (Figure 1).

Figure 1 Location of blanking plates on tilt cylinder. Photograph courtesy of Liebherr

- The temperature within the supplier's factory is commonly much lower than that experienced onsite, where the cylinder may be placed in a holding yard and subject to the elements.
- Testing is undertaken at the supplier's factory and the cylinders, as supplied, contain residual fluids.
- Onsite, oil and air contained within the cylinder expand in the higher temperatures, increasing the internal pressure.
- The service manual provided by the original equipment manufacturer (OEM) warns of the possibility of a pressure increase within the cylinders and the need to loosen the blanking plate bolts before removing the blanking plate. In this incident, however, the warning was not heeded and the pressure was not vented before the blanking plate was removed.

To avoid a recurrence of this type of incident for tilt and other sealed cylinders, management must ensure:

- maintenance personnel
 - follow the OEM service requirements and release any pressure build up within the cylinder in a controlled manner

- are appropriately trained and competent to carry out the task
- are supplied with and use appropriate personal protective equipment (PPE); and
- where possible, warning labels are fitted to cylinders advising of the potential hazard.
