Mines Safety Significant Incident Report No. 187

Serious crush injuries caused by falling ball-mill liner plate

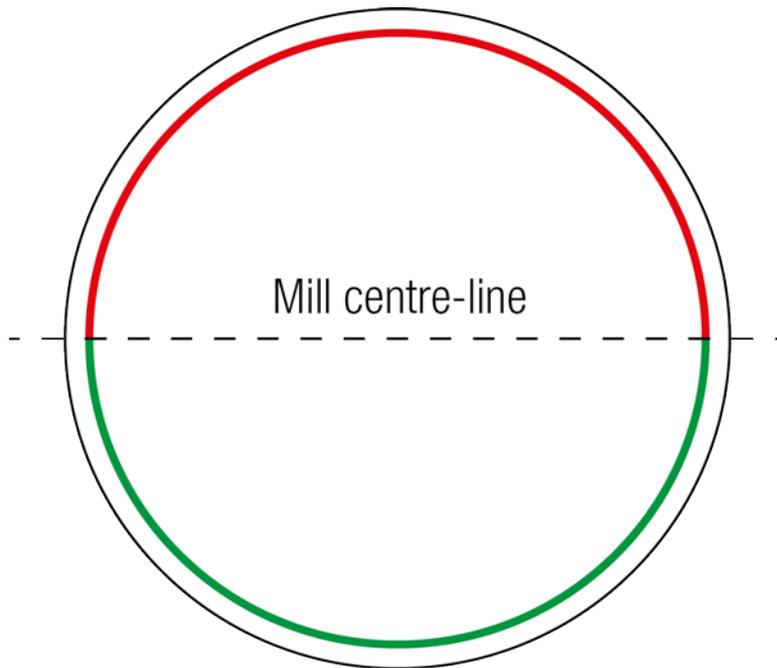
- The unsecured liner plates were identified as a hazard but there were no controls in place to prevent their uncontrolled movement or prevent worker exposure to falling object hazards.
- The resting position of the unsecured liner plate was above the horizontal centre-line of the ball mill (Fig. 1).
- The workers undertaking the mill relining were not adequately trained and had not been assessed as competent for the task.

Figure 1: Cross-section schematic of mill showing potentially hazardous section above the centre-line (red) from which unsecured objects may fall, and less dangerous section below the centre-line (green).

Ensure competency-based training has been undertaken by those involved in the mill relining operation (including contractors). This should include awareness of the increased potential for unsecured liner plates to fall if they are located above the mill centre-line (red area in Fig. 1), and the need to prevent the mill moving as the centre of gravity adjusts when liner plates are removed or added.
