Mines Safety Significant Incident Report No. 188

Light vehicle struck by underground truck in decline

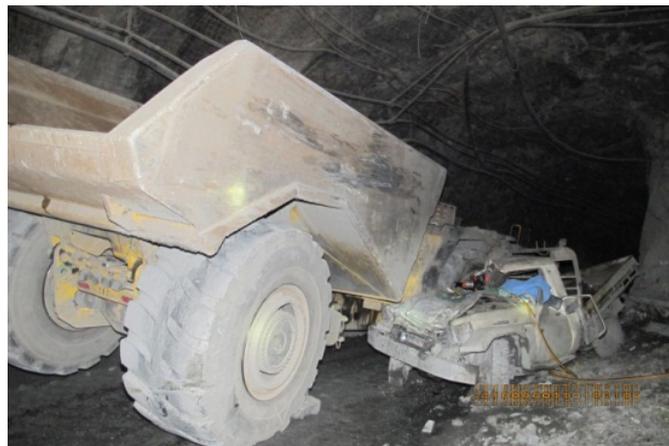
As the truck travelled past the pump cuddy, its right hand side collided with the rear right hand side of the light vehicle. The light vehicle was pulled out of the cuddy and its front wedged under the truck's rear tyre.

Figure 1 Incident scene after the light vehicle driver had been extracted and the truck reversed back

- The light vehicle driver attempted to travel further along the decline than was practicable before interacting with the truck.

- Absence of designated and standard signs at call-up locations for trucks using decline.
- The light vehicle driver attempted to enter and park in an unsuitable location.
- A blind bend on the decline and the location of the beacon on the light vehicle did not provide sufficient illumination to make the light vehicle visible to the truck driver.

Review the site's traffic management plan with respect to the potential for collisions and contacts between underground mobile equipment. The plan should:

- identify adequate call-up points
- establish appropriate signage along the decline to indicate each call-up point
- establish clear radio usage protocols
- provide an adequate number of passing and parking locations suitable for light vehicles along the decline
- restrict access to decline locations that are not suitable for parking vehicles.

Review the appropriateness of the location and type of beacon used on underground mobile equipment.

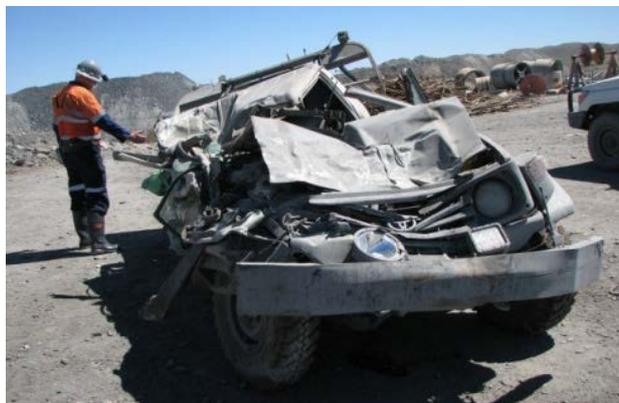
Figure 2 A mines inspector viewing the recovered damaged light vehicle
