Significant Incident Report No. 196

Subject: Front tyres of light vehicle over open edge

Date: 27 May 2014

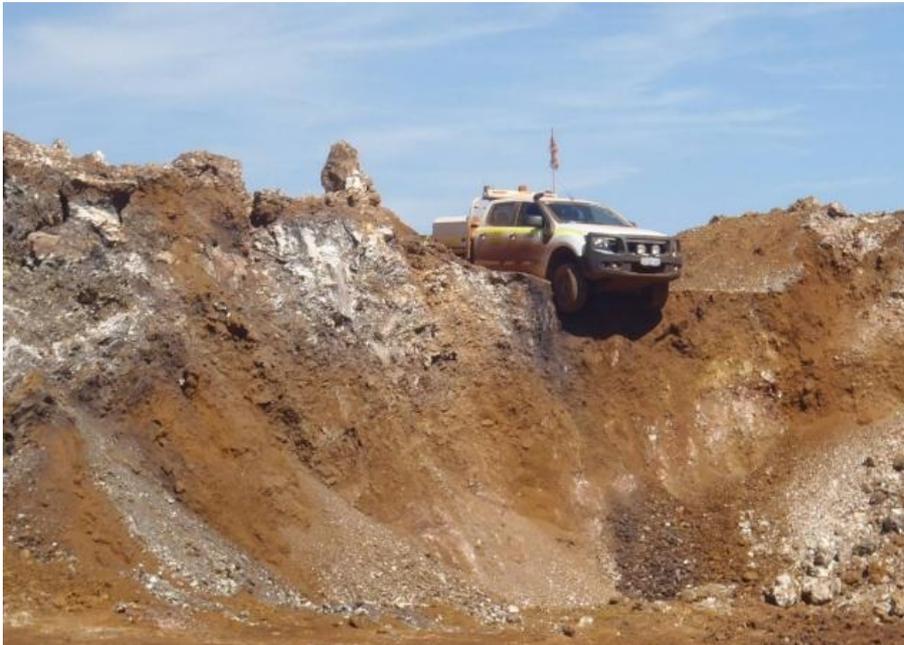
The supervisor then drove towards the open edge that had been left exposed. His vehicle was travelling slowly enough to enable him to stop it before driving completely over the edge. Almost two metres of the vehicle, including the front wheels, were left perched about five metres above the excavated floor. The supervisor was able to exit the vehicle without further incident.

Light vehicle with front wheels hanging over open edge of excavated area

- A light vehicle track was constructed over blasted ground that was subsequently excavated.
- Area inspections had not identified the light vehicle track, nor the need to construct a bund to prevent access to the mined area.

- The light vehicle track over blasted ground had not been:
 - approved by the Quarry Manager
 - surveyed
 - recorded on plans.
- The excavator operator did not know there was a site requirement to report the excavation of tracks to his supervisor. This requirement was not explicit in the training processes.
- Demarcation signs did not have specific location information that could be used during call ups.
- The inspection regime for mining areas did not match the rate of change in the work environment.

Review the site's traffic management plan with respect to:

- the use of light vehicle tracks
- the demarcation of mining areas
- how changes will be captured and transmitted to those affected.

- Eliminate the development of light vehicle access tracks or roads over blasted ground. If this is not possible, only the mine manager should be able to authorise the creation of such tracks or roads.
- Implement a system for reporting the creation of tracks and roads, including new intersections.
- Survey, demarcate and add all light vehicle tracks or roads to mine production plans.
- Implement an inspection schedule around mine areas to identify tracks and roads being used by light vehicles that may be affected by mining operations.
- Ensure tracks and roads that will be affected by mining operations are made inaccessible.
- Ensure the locations of tracks and roads are correctly identified on demarcation signs to assist with call ups when requesting access permission.
