## Significant Incident Report No. 197

**Subject:** Dozer loading leads to prime mover jack-knife and fuel tank rupture

**Date:** 27 May 2014

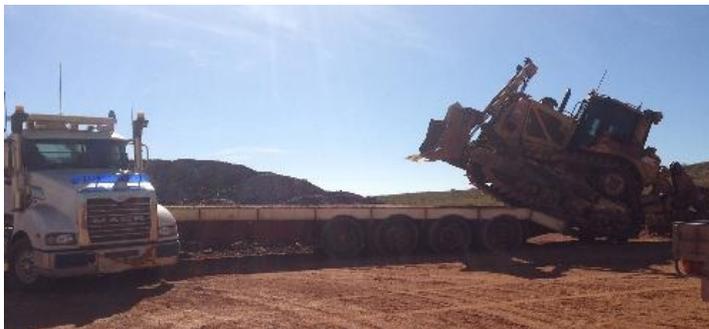
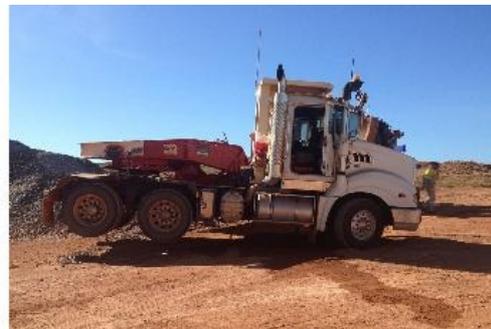
The rear of the trailer tilted down under the weight of the dozer as it was being loaded, and the drive wheels of the prime mover lifted off the ground. The prime mover, trailer and dozer moved forward 10 to 15 metres. The truck driver entered the cab of the prime mover while it was moving and attempted to steer the vehicle.

The dozer cantilevered backwards, digging its ripper tines into the ground, which stopped the forward movement of the trailer.

The prime mover, while lifted off the ground, swung into the trailer, rupturing the main fuel tank.

Photographs showing prime mover, trailer and dozer after the incident; and jack-knifed prime mover and the spill from the ruptured fuel tank

- The loading ramp was higher than the trailer, leading to most of the dozer's weight being transferred onto the rear of the trailer as it was being loaded. The change in the trailer's centre of gravity made it unstable and the rear of the trailer tilted down while the front lifted.
- The configuration for connecting brake hoses to the trailer was not compatible with that for the prime mover, and only the emergency hose was connected. This allowed the trailer brakes to be released and, consequently, there was no braking capacity on the trailer to stop it moving.
- The wheel chocks stored on the trailer and prime mover were not used.

- When the trailer tilted down, the prime mover was lifted at the trailer's gooseneck such that its rear wheels were no longer in contact with the ground. Consequently, the only brakes stopping the forward movement of the prime mover were rendered ineffective.
- There were no safe work instructions for loading the dozer, nor had a risk assessment been conducted.

Managers and supervisors are reminded of the importance of safe work instructions that identify the hazards and controls for each job step. For loading and unloading operations, the position of the centre of gravity of an object affects its stability. Those involved in such operations should be aware of this hazard and know how to respond.

- Those involved in the job receive competency-based training aligned to the tasks, including awareness of the increased potential for loads and vehicles to move.
- Transport contractors are inducted in the safe work instructions prior to commencing work on site.
- The controls to prevent the uncontrolled movement of vehicles during loading and unloading are defined and implemented, including the use of wheel chocks.
- Loading ramp designs and locations have been assessed as suitable by a competent person and are known to those responsible for loading and unloading activities.
