Significant Incident Report No. 209

Subject: Potential signal tube detonator explosion ("snap, slap and shoot") during charge-up

Date: 20 November 2014

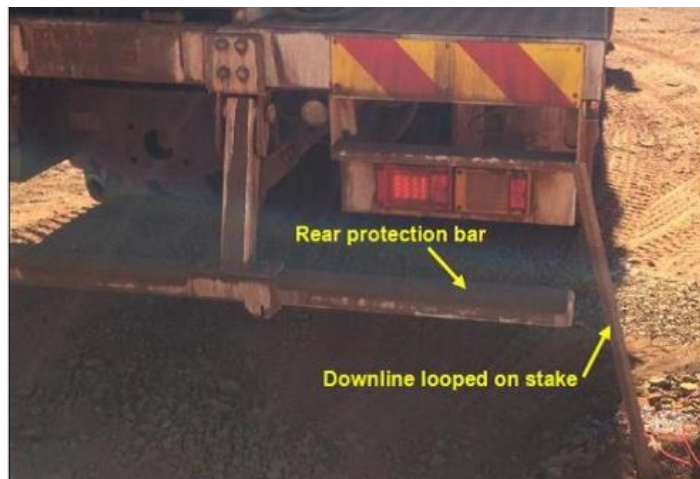
The downline lead stretched until it snapped, raising the potential for an initiation due to the "snap, slap and shoot" phenomenon. Fortunately, the detonator did not initiate.

Photograph showing proximity of downline lead and stake to MPU's rear protection bar during loading

- The spooled downline lead was looped around a stake at the same height as the rear protection bar, allowing the lead to become tangled as the MPU moved forward.
- The design of the MPU's rear protection bar allowed the downline lead to become entangled.

- The spotter was not observing the movement of the MPU as he had already moved to the next row of drill holes.

- equipment is designed or modified to eliminate the risk of entanglement
- where a task requires a spotter, this person is positioned where they can observe the safe and unhindered movement of equipment.
