Significant Incident Report No. 235

Subject: Scaffolder falls from height in a process vessel at a refinery - fatal accident

Date: 18 December 2015

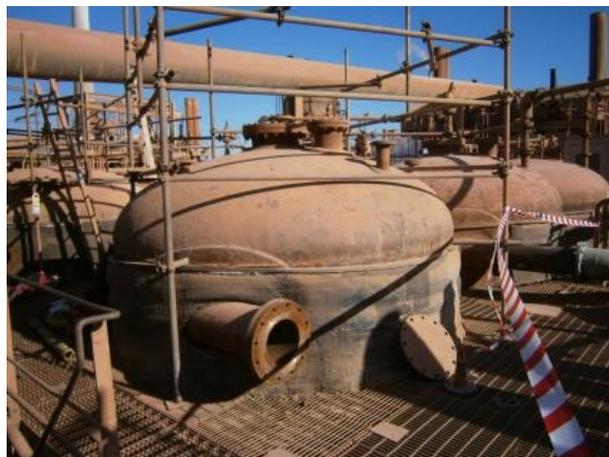
A bank of six digesters at the refinery had been off-line for maintenance and refurbishment work since July 2015. All pipework had been disconnected and scaffolding installed in August for refurbishment work inside the digesters. When the refurbishment work was almost complete, scaffolders began dismantling the scaffolding. Scaffolds had been removed from three digesters in the days before the fatal accident.

Top level of the digester bank showing disconnected pipework

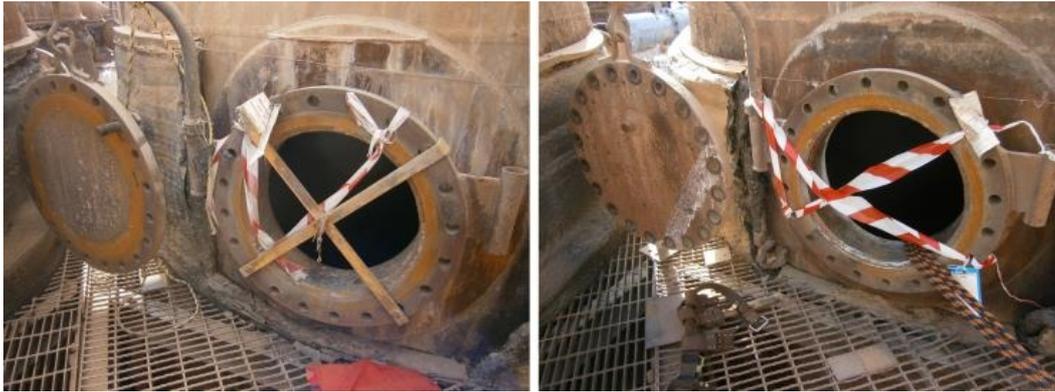
- There was no device or guard on the open manway to prevent inadvertent access to the digester from which scaffolding had been removed.

Left: Manway into a digester with mechanical guard fitted. Right: Manway entry for the digester without scaffolding (tape placed by emergency response team).

- A digester has two manways. The company procedure required a mechanical guard to be fitted on each manway when the doors were opened for maintenance to proceed, but did not address how guards were to be removed and replaced during and after the work. On the day of the incident, not all guards were in place.
- The company procedure for scaffolding did not address how scaffolds were to be constructed in process vessels and how to access them.
- There was confusing terminology in the company procedures regarding confined spaces.
- There was a lack of appropriate signage, and digester entry points were not identified or differentiated with a number or name.

It is critical that mine operators conduct detailed risk assessments of areas or tasks where workers might be exposed to fall hazards and take preventative measures. Mine operators, employers and workers should ensure that safe work procedures are available, followed and enforced.
