Significant Incident Report No. 256

Subject: Process tank roof bursts due to uncontrolled reaction

Date: 21 November 2017

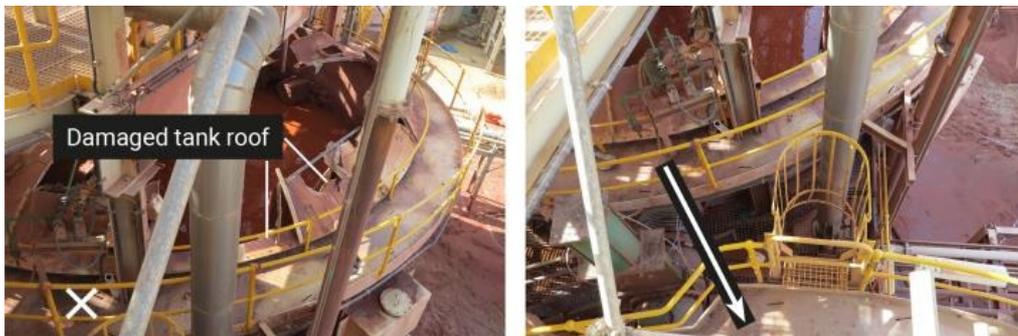
When the tank was returned to service, it was drained of limestone slurry and filled to launder level with acidic slurry. However, although the tank had been emptied, limestone residue had accumulated at the bottom. When the tank was filled with acidic slurry and the agitator turned on, there was a rapid acid-base reaction between the free sulphuric acid and limestone, liberating carbon dioxide gas which could not readily escape. The tank's fibreglass roof burst and about 10,000 litres of hot slurry (87°C) escaped from the tank.

Failed tank. Left. Damage to tank roof; cross indicates where the process technician was standing prior to tank failure. Right. Arrow indicates the escape path taken by the process technician over the handrails using the actuator. Note the slurry (at ground level) in foreground of pictures.

- The reaction between the free sulphuric acid and limestone in solution resulted in the uncontrolled liberation of carbon dioxide gas.

Note: The rate of reaction was increased by the high temperature of the slurry (87°C) and agitation of the solution, which made the residual limestone more readily available for reaction with the free acid.

- The risk assessment was not adequate and failed to identify the hazard associated with mixing of the acid slurry with limestone that might accumulate on the bottom of the tank.
- Control measures, such as cleaning the tank to remove residual limestone before refilling it with acidic slurry, were not implemented.
- There was only one means of access or egress from the tank platform.

- Develop and implement change management procedures to identify the potential impact of the proposed changes on the working environment.
- A risk assessment should identify hazards, and assess and control all risks that may arise from the change, including those to workers. As part of the risk assessment process:
 - consult with those who may be affected by the change
 - provide them, in so far as is practicable, with adequate information, instruction, training and supervision about the change.

- Employers must ensure that plant at the mine is used only for the purpose for which it was designed, unless the employer has determined, and a competent person has assessed, that a proposed change in use does not present an increased risk of exposure to any hazard [r. 6.21(a)].
- So far as is practicable, an emergency exit is provided from each treatment plant and building on the surface of the mine [r. 4.31(a)]. In addition to the usual means of access.
