Significant Incident Report No. 288

Subject: Off-highway haul truck tyre blowout in workshop injures workers

Date: 01 September 2021

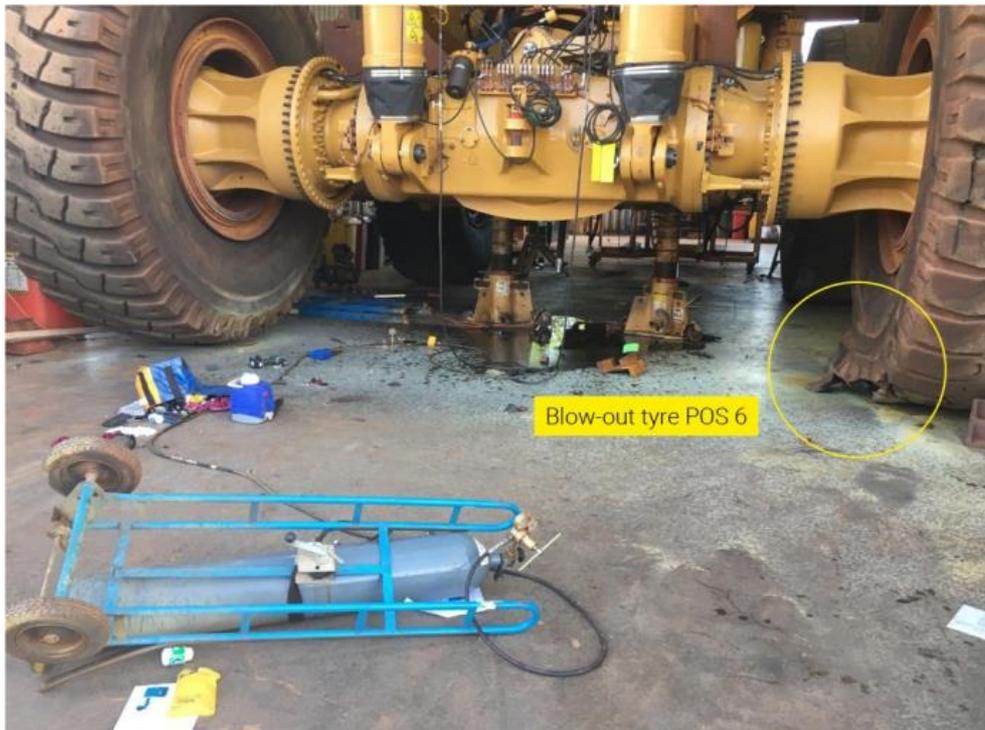
Photo of the haul truck showing the blown out tyre fitted in position 6. Tools and equipment are in their original positions.

The direct (physical) cause was cut damage on the outside edge of a tread lug of the tyre. This exposed the steel reinforcing layers to air and moisture resulting in progressive corrosion and separation damage that reduced the integrity of the tyre casing to resist internal pressure.

- The tyre was not disposed of when it was removed from service in October 2018. It had a large cut caused by a rock during operation which, over time, allowed moisture to enter the steel cord area causing corrosion.
- The tyre was stored in the elements for 16 months before being fitted to transport the truck to the workshop.
- The decision to return the discarded defective tyre to service was not based on an inspection and assessment by a suitably competent person.
- The site did not have a safe system of work for the inspection of tyres used for transportation purposes.
- The damage to the tyre was not obvious due to the steel cord corrosion being internal.
- Persons in the workshop were working in close proximity to fully inflated tyres.

- Tyres that are known or suspected of being defective are not fit-for-purpose and must not be returned to service unless they have been inspected and assessed as fit-for-purpose by a competent person [r. 6.22 Mines Safety and Inspection Regulations 1995 (MSIR)].

- Persons who inspect and assess tyres must be competent, having an appropriate combination of knowledge, experience and qualifications [r. 4.13 MSIR].

- As part of a comprehensive tyre management plan, mining operations should have established safe working procedures for the inspection and assessment of tyres that are known or suspected of being damaged.

- To reduce the hazardous energy, tyres in workshops may be deflated to a lower pressure if persons are working in close proximity. A risk assessment should be conducted to determine if the tyre pressure should be lowered. Because the tyres are not carrying as much load (just the empty weight of the truck), the pressure may be reduced to a lower value as advised by a competent person.
