Significant Incident Report No. 289

Subject: Damaged excavator recoil spring fragment became a projectile

Date: 11 January 2022

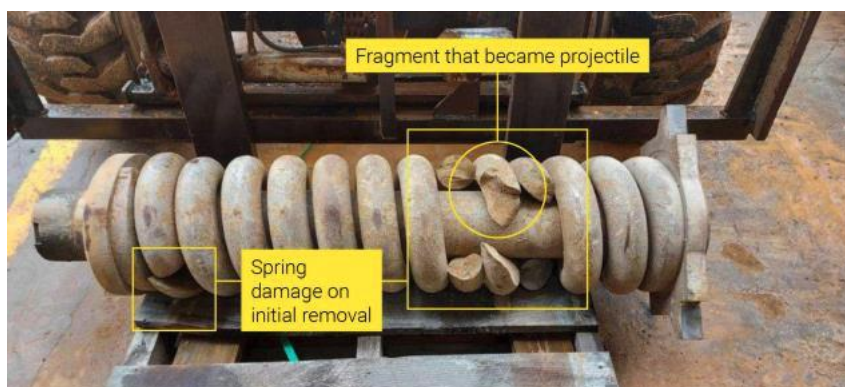
Recoil spring after removal from excavator prior to incident.

- The recoil spring assembly is designed to be installed and removed as a pre-assembled unit with the spring compressed/pre-loaded by approximately 58,000 kilograms of force.
- No information was provided by the original equipment manufacturer (OEM) on the potential hazards associated with performing work on the track recoil assembly with a damaged spring.
- Prior to removal, the recoil spring was inspected via the inspection window on the side track frame, which identified sections of the spring were cracked and missing.
- Although the spring had cracks and segments missing, the assembly remained under compression/load after it had been removed from the excavator, despite the integrity being compromised and susceptible to failure while under load.

- Ensure suitable safe systems of work are in place and followed when installing or removing pre-loaded spring assemblies.
- If spring damage is observed, where practicable, release all stored energy from the spring in a controlled manner prior to removal from the equipment.
- Develop and implement suitable controls to manage the potential stored energy hazard associated with the removal or dismantling of a damaged spring assembly.
- Ensure recoil spring assemblies are inspected and maintained as per OEM recommendations.
- Confirm workers performing maintenance and repair work are adequately instructed, trained and assessed as competent prior to conducting work.

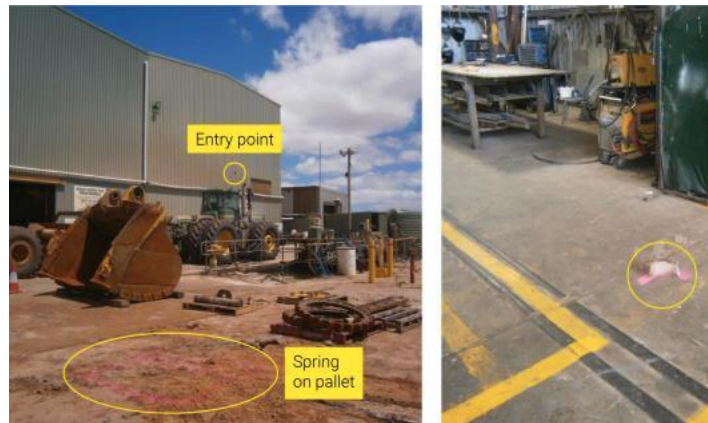
In February 2021, a damaged recoil spring assembly for an excavator had been removed from the track arrangement and stored outside a heavy mobile plant workshop. The following morning, a fragment of the spring separated while under compression and travelled approximately 28 metres across the yard and through a workshop wall, coming to rest in a walkway beside a workbench.

The fragment, weighing 9 kilograms, penetrated the shed wall at approximately 6.5 metres above floor level. While employees located at the opposite end of the workshop heard a loud bang when the spring fragment impacted the wall, no persons were present in the areas where the fragment came to rest or outside where the spring was being stored.

L: Position of spring in storage yard when event occurred, with wall entry point.
R: Spring fragment final position on workshop walkway.
