## Significant Incident Report No. 224

**Subject:** Underground workers injured by arc flash and blast from a motor control centre (MCC) cubicle

**Date:** 24 July 2015

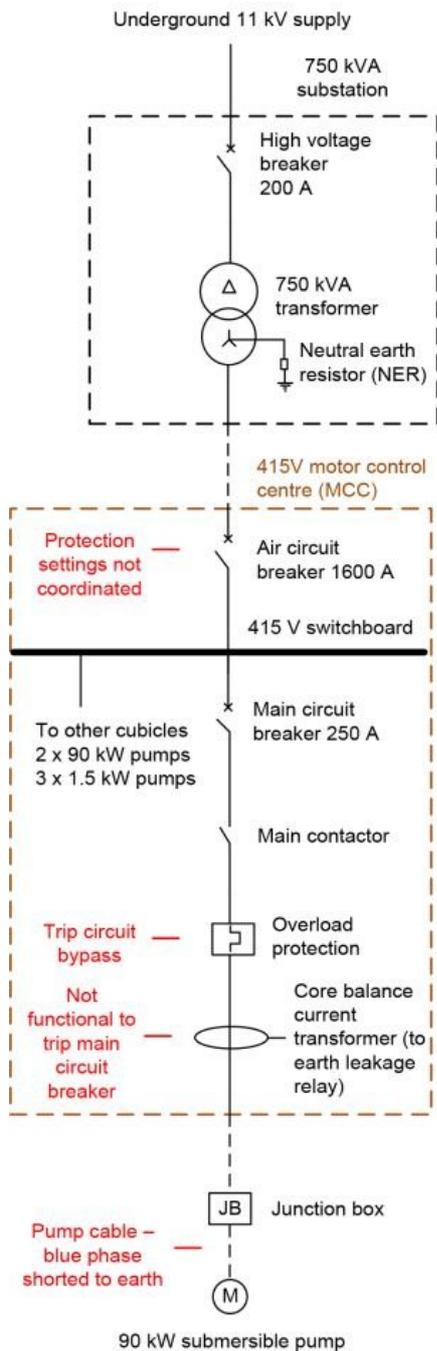
- The pump supply cable blue phase was shorted to earth (as confirmed by an insulation resistance test after the incident).
- The electrical circuit was not designed to automatically disconnect the main circuit breaker under an earth leakage or earth fault.
- The protection settings were not coordinated correctly, therefore the upstream air circuit breaker connected to the 415 V MCC busbars failed to operate. The high voltage circuit breaker connected on the primary side of the 750 kVA transformer cleared the arc fault current of about 9.5 kA in more than 1 second.

- The pump cable was not tested for insulation resistance prior to energising at the cubicle.
- The drawings did not match the electrical installation. Specifically, the trip circuit of the motor overload protection had been bypassed, allowing the pump to operate under overload conditions.

Conditions that contributed to the incident are indicated in red on the overall single line diagram for the electrical installation. The photographs show the MCC cubicle and damage.

- Ensure that electrical installations are designed, inspected, installed and tested according to Australian Standard AS/NZS 3000 Electrical installations (known as the Australian/New Zealand Wiring Rules) and are adequately protected against thermal overload and short circuit protection (earth and phase faults).
- Conduct protection coordination studies to provide the best possible fault clearance times to limit arc flash energy levels arising from a fault.
- Consider manufacturer's recommendations when designing electrical installations to eliminate known hazards.

- Ensure electrical drawings are updated and correctly reflect the installation.
- Consult electrical installation drawings as part of the risk assessment process to identify hazards and implement adequate control measures before undertaking maintenance tasks.

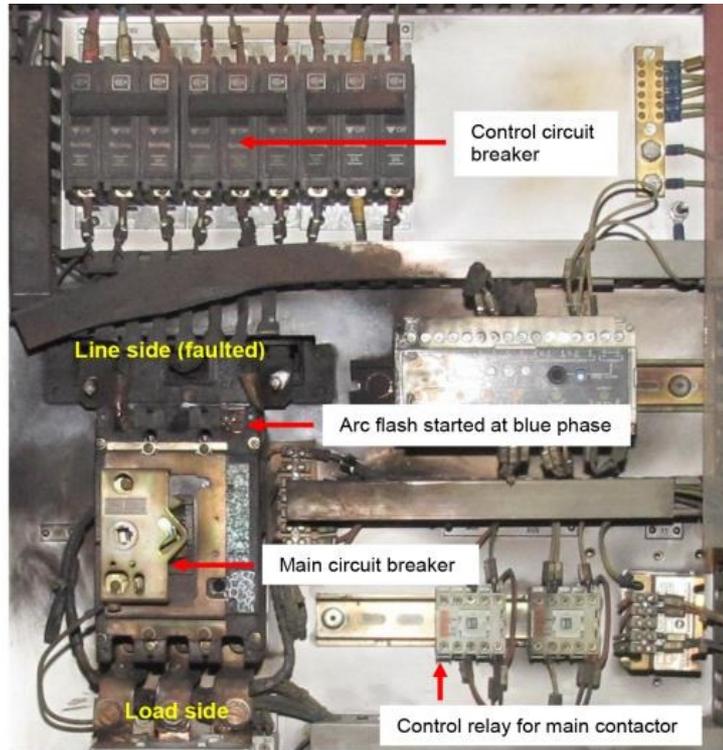
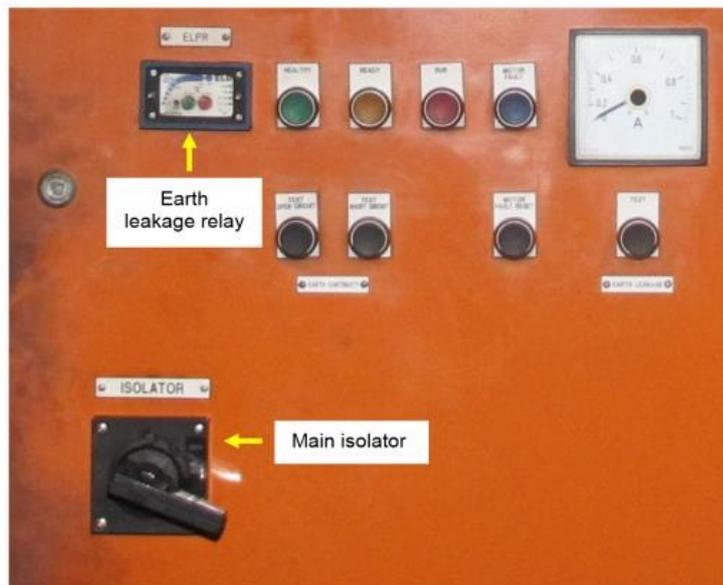
The electrician closed the cubicle door but without properly securing it. He then switched the main circuit breaker to the "ON" position. At that instant, there was an arc flash and blast, which blew open the door of the cubicle. The electrician received first degree burns to his neck, face and ears, while the fitter received a minor facial injury.

The subsequent investigation revealed that the main circuit breaker had suffered a phase-to-phase arcing fault. The arcing fault started within the main circuit breaker terminal on the line side of the blue phase, and then transferred to a three-phase fault.

- Ensure adequate PPE (i.e. rated for arc flash) is worn when working on switchboards or distribution boards where there is the potential for arc flash.
