Mines Safety Bulletin No. 78

Date: 2 March 2007

Subject: Use of explosive mortar devices for bringing down rockpass or drawpoint hang-ups

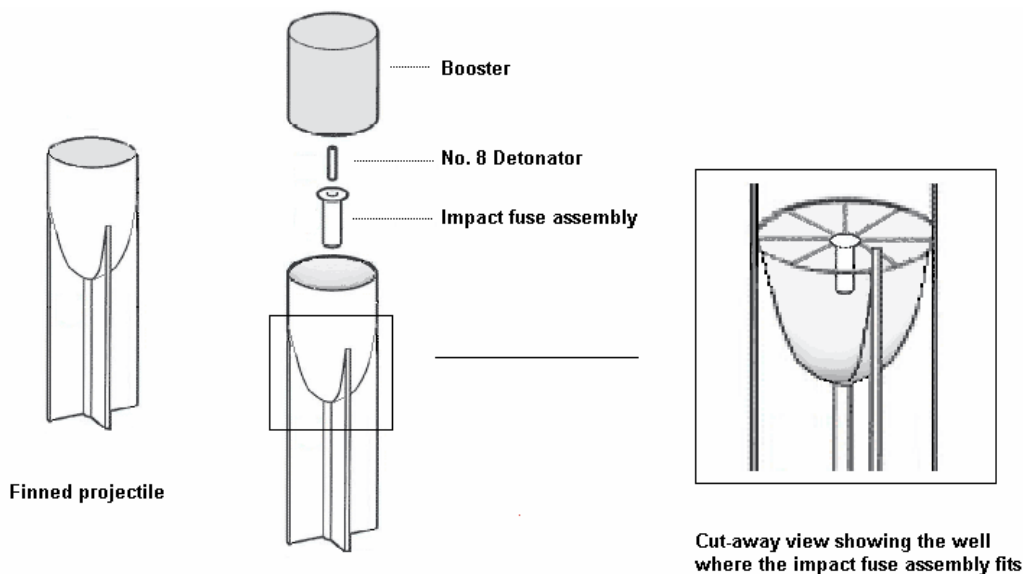
The likely cause of this particular incident was found to be a misaligned well in the centre of the plastic tailfin used to mount the impact fuse assembly and hold the booster charge. Misaligned wells appear more oval-shaped, rather than circular in cross-section, as they should be. The problem apparently results from a manufacturing error, not picked up by quality control processes.

It would appear that this manufacturing error has occurred in a certain percentage of finned tubes (around 5-6% of those checked). The well in the centre of the finned tube is not formed properly in the manufacturing process and when the impact fuse assembly is inserted into the well, it sits at an angle, rather than in the correct position in-line with the long axis of the projectile. This may be compounded by another fault, where the well designed to receive the impact fuse assembly is tapered, rather than cylindrical, resulting in the impact fuse standing slightly proud of its seat, rather than fitting in the correct position within it. It is thus impossible for the operator to assemble the finned projectile properly. This results in the impact fuse assembly sitting too high in the well and when the finned projectile is assembled, the detonator is forced against the booster instead of fitting comfortably inside it as it is designed to do. Forcing the detonator against the booster in this manner is potentially extremely hazardous because the detonator may be prematurely initiated by crushing either during set-up or at launch.

Mine managers are strongly advised to consider discontinuing the use of such explosive mortar devices for bringing down rockpass or drawpoint hang-ups on each site where they are employed until the supplier has confirmed by inspection of the products supplied to the site that the manufacturing problems noted above are not likely to constitute a hazard at that site.
