DEPARTMENT OF MINES INDUSTRY
REGULATIONS AND SAFETY

**Bulong Tailings Storage Facility
Conceptual Closure Report**

121085.01 R02 Rev0
February 2021

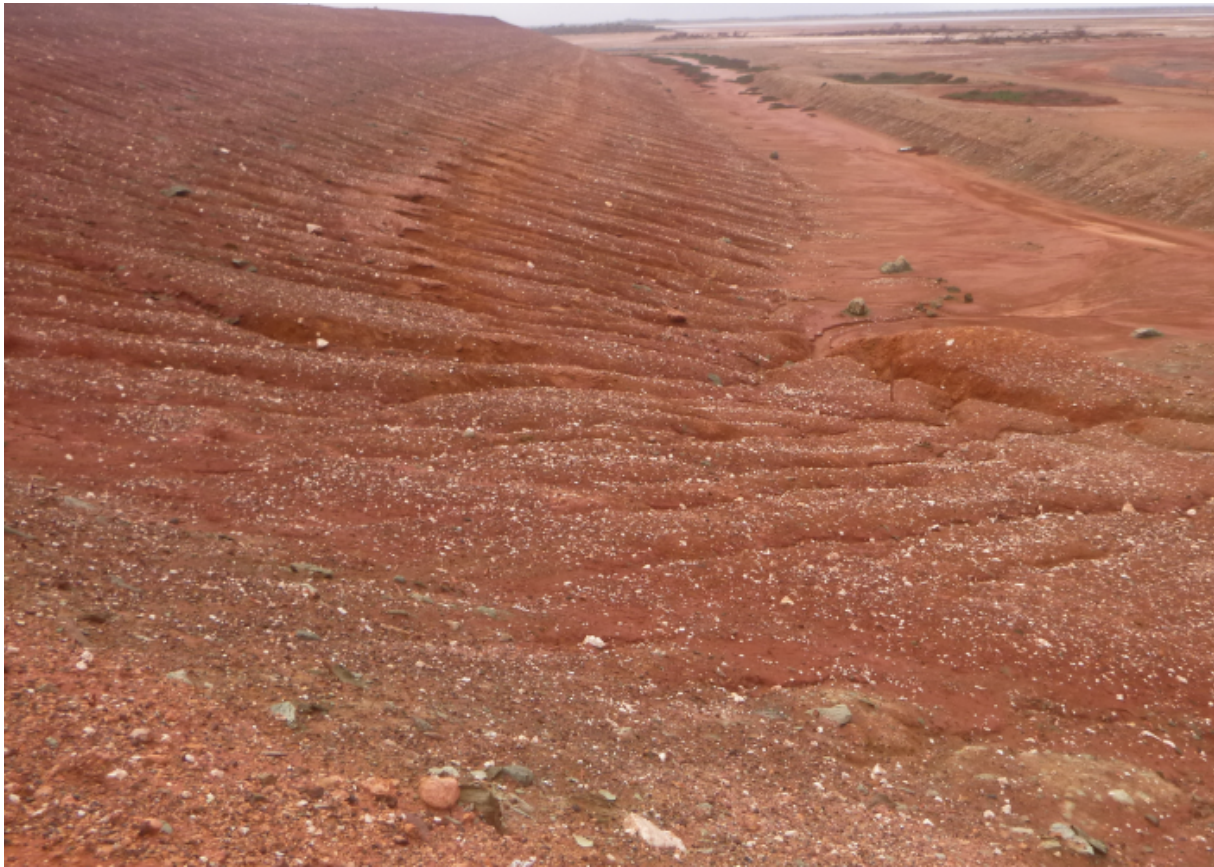
PHOTO 1: EROSION OF TSF EMBANKMENT

The outer embankment shell is constructed with mine waste rock (refer **Section 2.1**). During the site inspection undertaken by a representative from ATCW, erosion of the embankment walls was observed as shown in **Photo 1**. Recognising that long term erosion of the TSF batters has the potential to impact embankment stability aspects through loss of material, two rehabilitation options were developed, summarised as follows:

- Batter Option 1: Do not reshape batters, with scheduled inspections to be undertaken to monitor erosion and scouring. Maintenance to be undertaken as required to replace material lost through erosion.
- Batter Option 2: Reshape batters with rock armouring to provide an erosion resistant surface as depicted in **Diagram 2**.

Based on discussions with DMIRS, limited rock is available and as such the preferred approach is currently Option 1. It is noted that this may be subject to change based on the next phase of design, including a materials investigation. If suitable quantities of rock material are found to be available, Option 2 may progress as the preferred design.

On this basis, ongoing inspections would be required to ensure the embankment stability is not compromised. A recommended monitoring schedule is discussed in **Section 5**.
