Our Ref: 121085.01 L02

20 September 2021

**BULONG TAILINGS STORAGE FACILITY CONDITION ASSESSMENT
SITE INVESTIGATION**

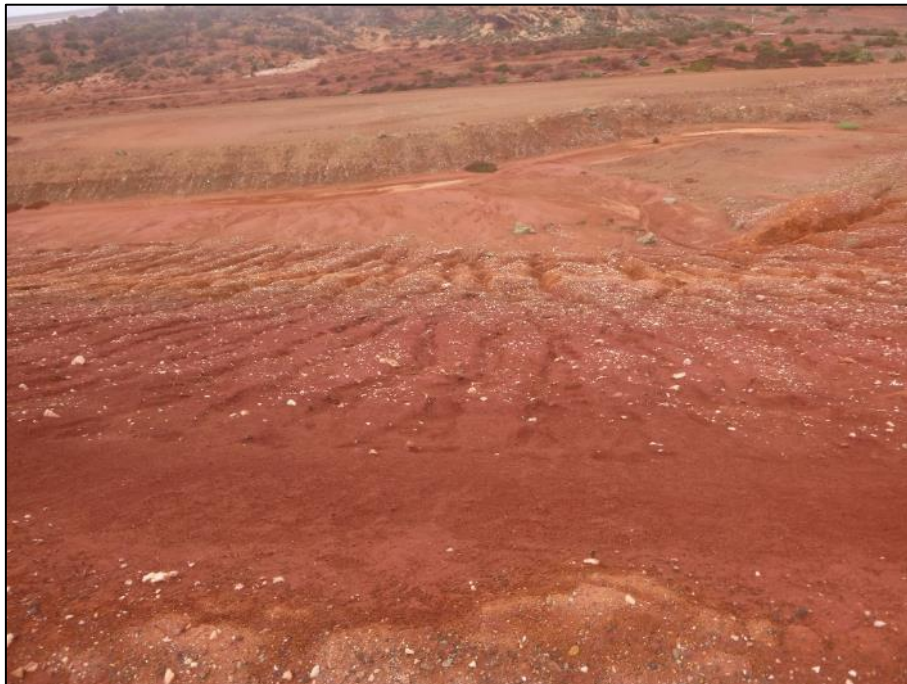
Item	Observations
Downstream Slope	<p>The embankments appeared to generally be in good condition with some surface erosion. The northern and eastern walls were covered with windblown tailings possibly covering erosion. Approx. 0.5 m height of the northern wall toe had eroded possibly due to surface water movement (Photo 4).</p> <p>The embankments have a clayey surface with some surface erosion on the downstream face of the south (Photo 1), southeast and southwest walls. Most of the northern downstream faces were covered with windblown tailings, the covering was thicker in the northeast (Photo 3).</p>
Crest	<p>The crest appeared to be flat, partially covered with gravel and large sections covered with windblown tailings (Photo 5). The entire crest was able to be driven across in a light vehicle (LV). In general, the surface provided good support for trafficking with no rutting observed. Some minor erosion was observed close to the downstream edge. Windrows were either small or total absent.</p>

PHOTO 1 : SOUTHERN EMBANKMENT SURFACE EROSION

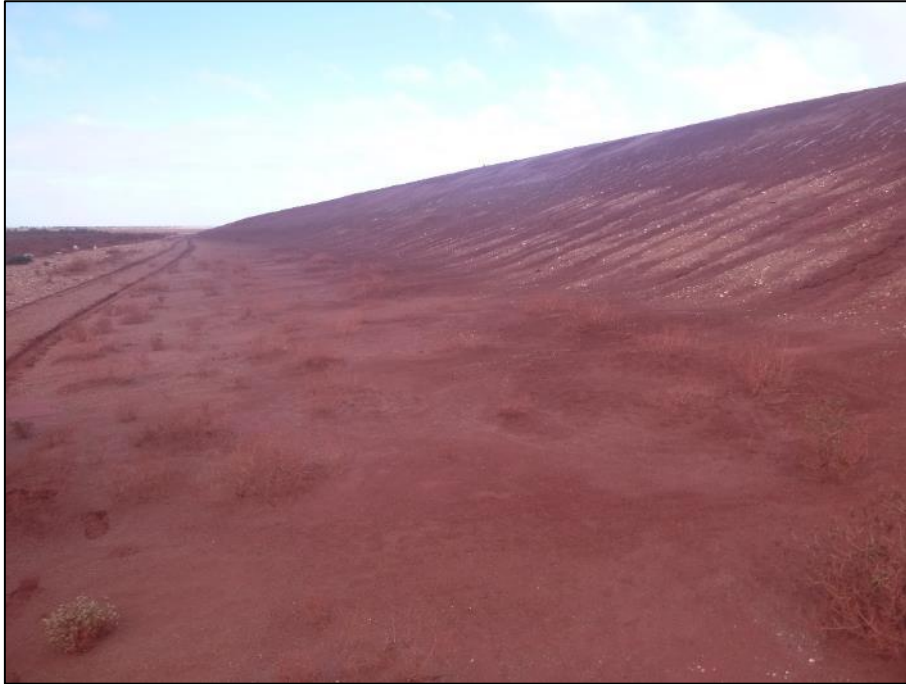
PHOTO 2 : SOUTHERN EMBANKMENT DOWNSTREAM TOE

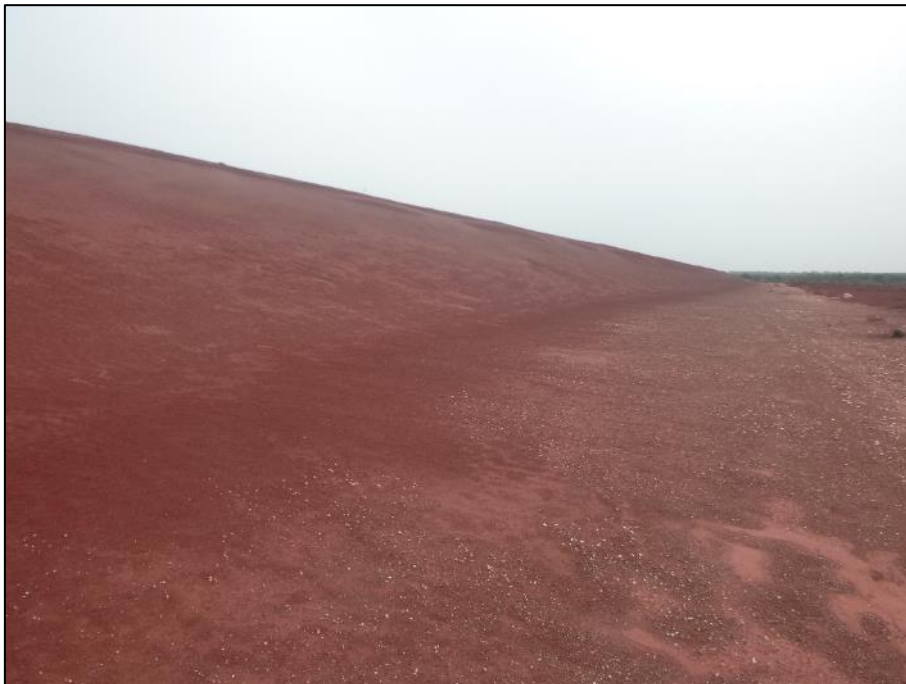
PHOTO 3 : NORTHERN EMBANKMENT

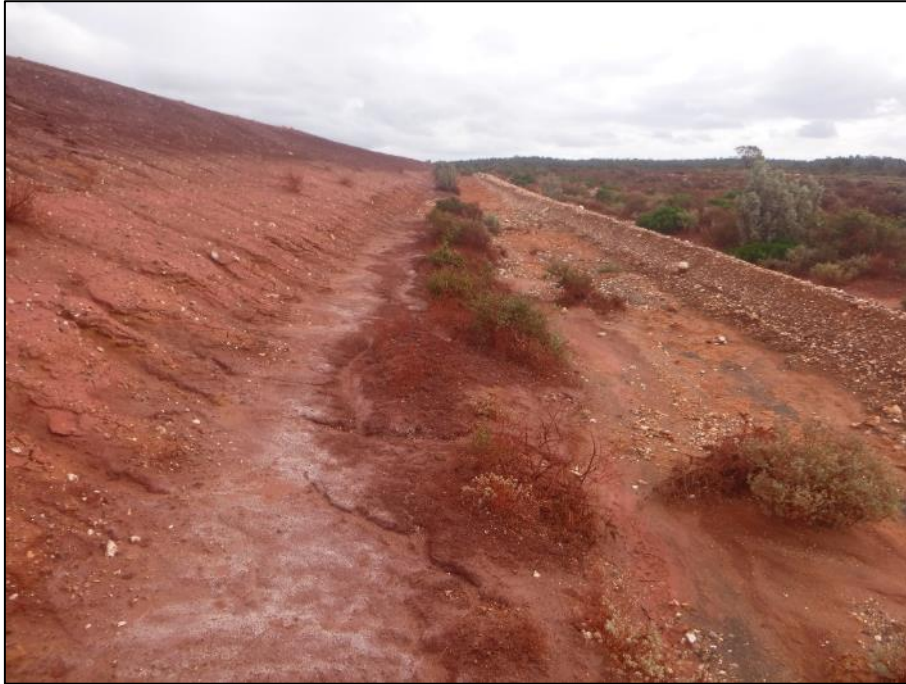
PHOTO 4 : NORTHERN EMBANKMENT TOE EROSION

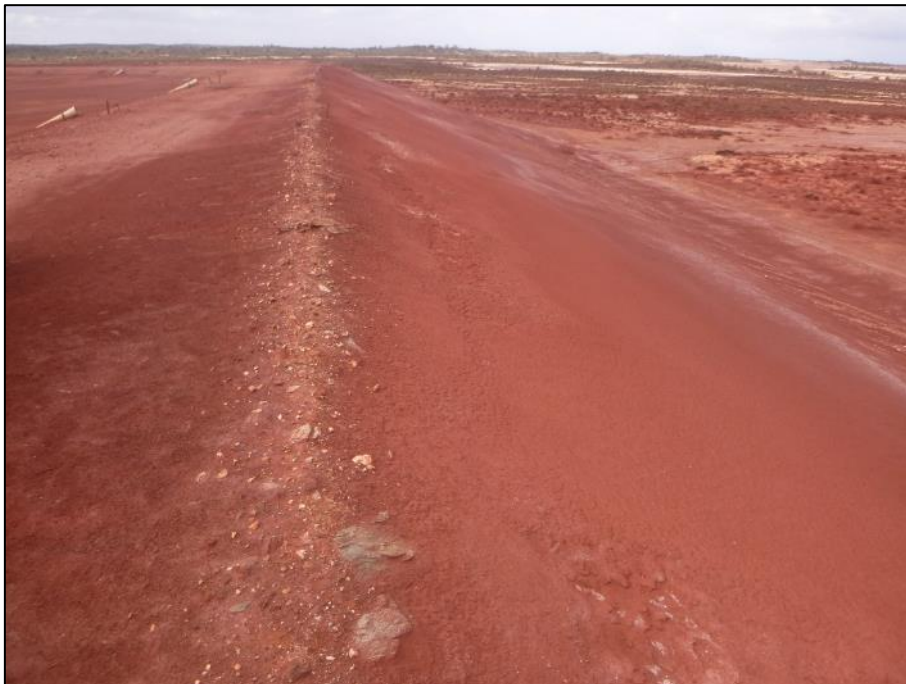
PHOTO 5 : SOUTHEAST EMBANKMENT CREST

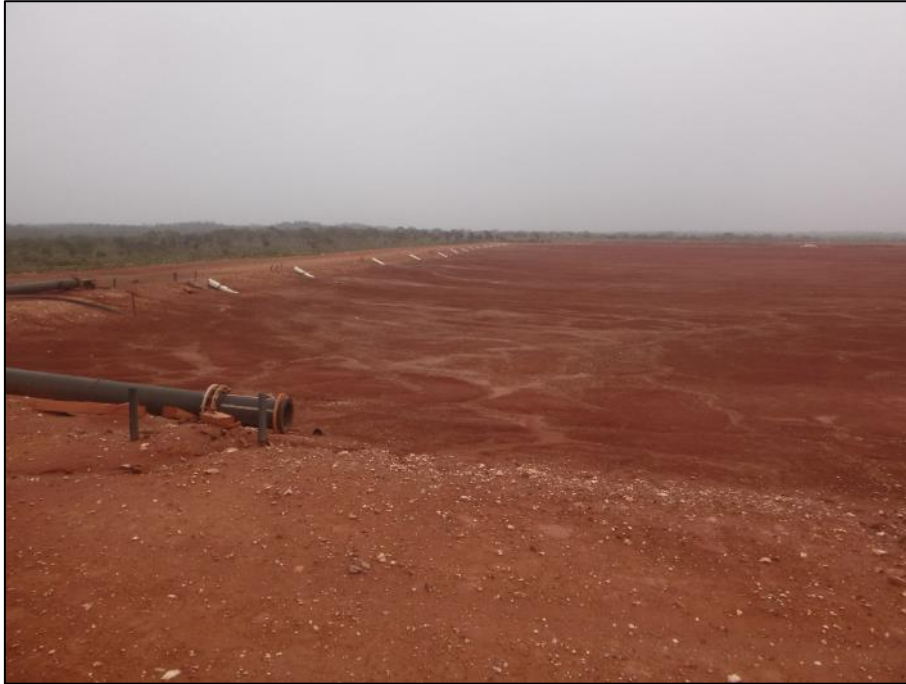
PHOTO 6 : TAILINGS SURFACE SOUTHWEST CORNER

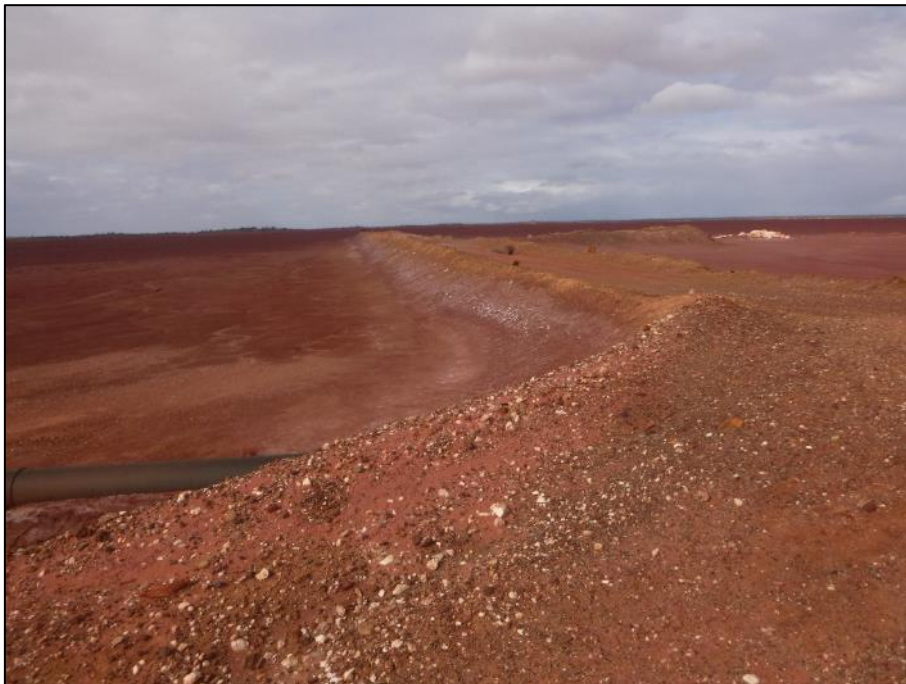
PHOTO 7 : CAUSEWAY LOOKING EAST

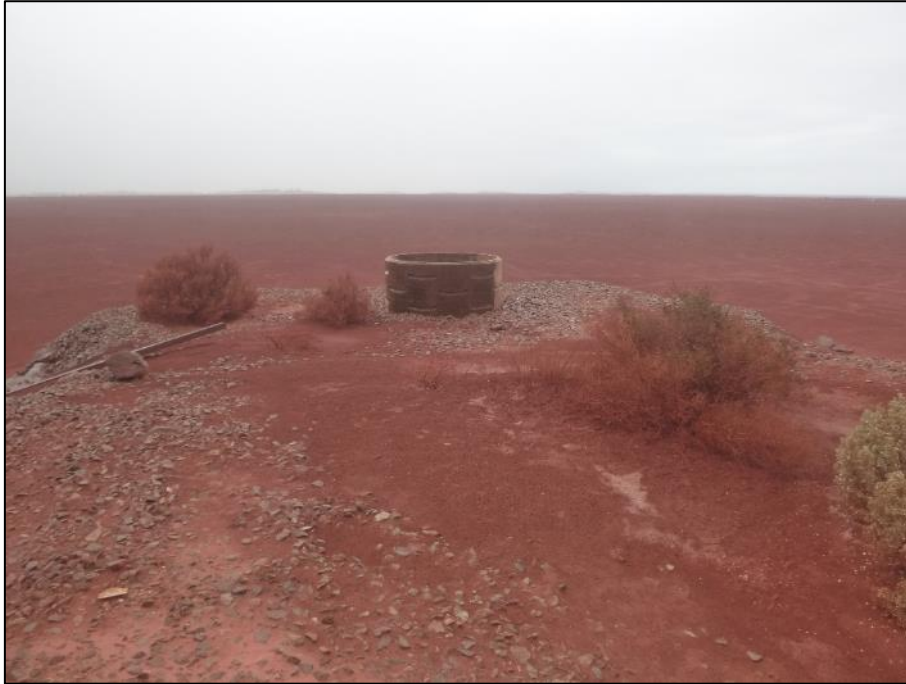
Decant System	<p>Generally, the decant surrounds are surfaced with 50 mm gravel and windblown tailings and appeared stable (Photo 8). The decant tower was open and dry. No obvious signs of movement were observed in the tower (Photo 9).</p>
Tailings Delivery System	<p>In general, the pipework on and surrounding the TSF has been removed. Only a small section of partially buried pipe remains, in addition to the spigot pipes (Photo 10). Observations indicate the main tailings pipework originally travelled up the ramp in the southwest corner and then along the crest.</p>
Underground Drainage Pond	<p>The underground drainage pond is located to the south of the TSF. Access is restricted by wire fence surrounding the pond. The pond is below the surrounding ground surface level, lined and was partially filled with water at the time of inspection. Some pipework remains open (judged to be the underground pipes). All pumps have been removed. No warning signs or lifebuoy were observed.</p>

PHOTO 8 : CAUSEWAY AND DECANT TOWER

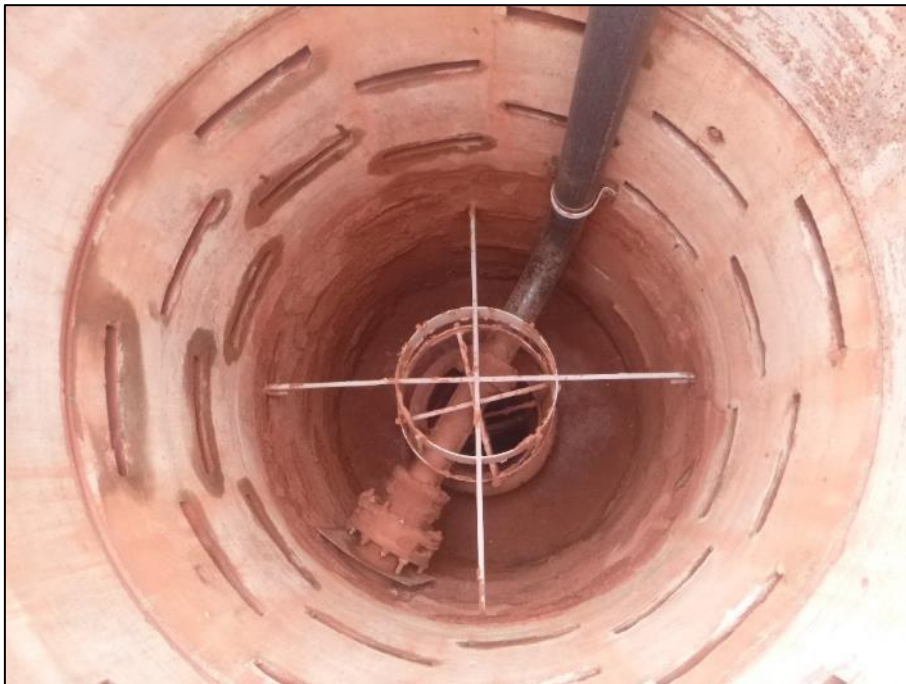
PHOTO 9 : DECANT TOWER

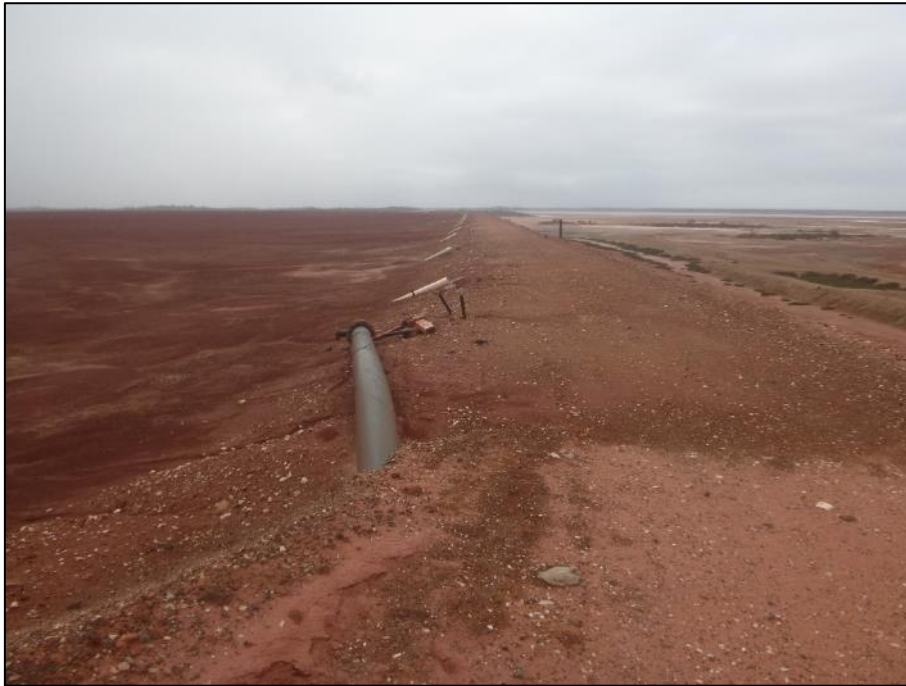
PHOTO 10 : PIPEWORK SOUTHWEST CORNER

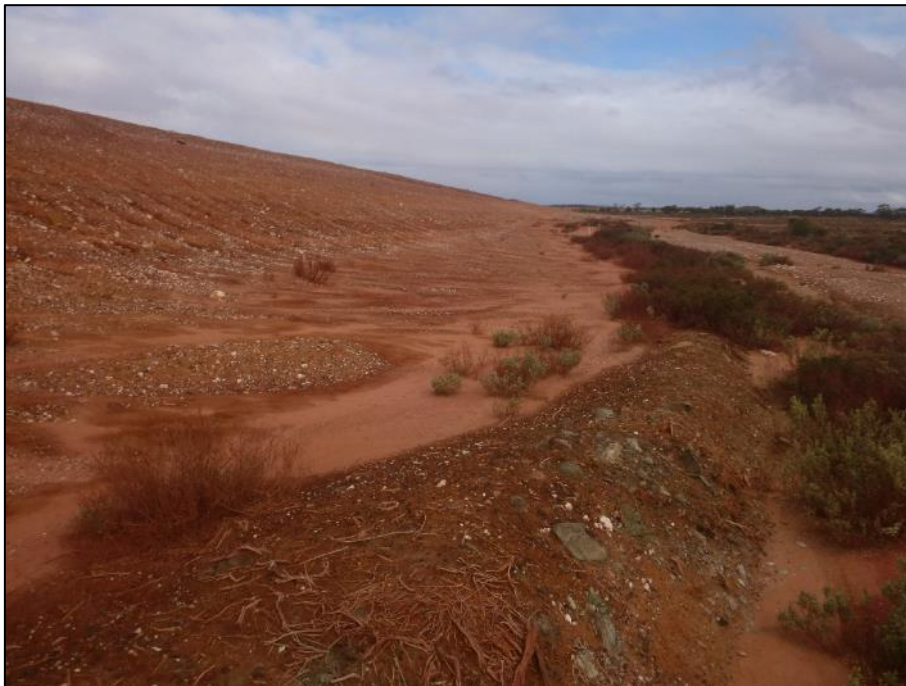
Toe Drain	<p>An apparent toe drain runs around the TSF leading to an outflow adjacent to the pond south of the TSF (Photo 11). In general, the toe drain is full of soft erosion sediment and windblown tailings. A road blocks the drainage pathway near the pond with signs of localised wet ground.</p>
Causeway	<p>The causeway was flat and generally covered with gravel and windblown tailings. The surface driven across with an LV. In general, the surface provided good support with no rutting observed. Remnant windrows remain.</p>
Tailings Surface	<p>At the time of the visit, the tailings surface appeared to be relatively flat. Approximately 0.75 m tailings freeboard was observed to the embankment crest (Photo 6, 7 & 10). No standing water was observed anywhere on the tailings surface. Apparent cracks were infilled with windblown tailings.</p> <p>The tailings surface was accessed on foot to the Panda DCP test locations (refer Section 5) and was generally stable under foot with occasional loose spots which were considered to be infilled cracks.</p>

PHOTO 11 : TOE DRAIN SOUTH SIDE

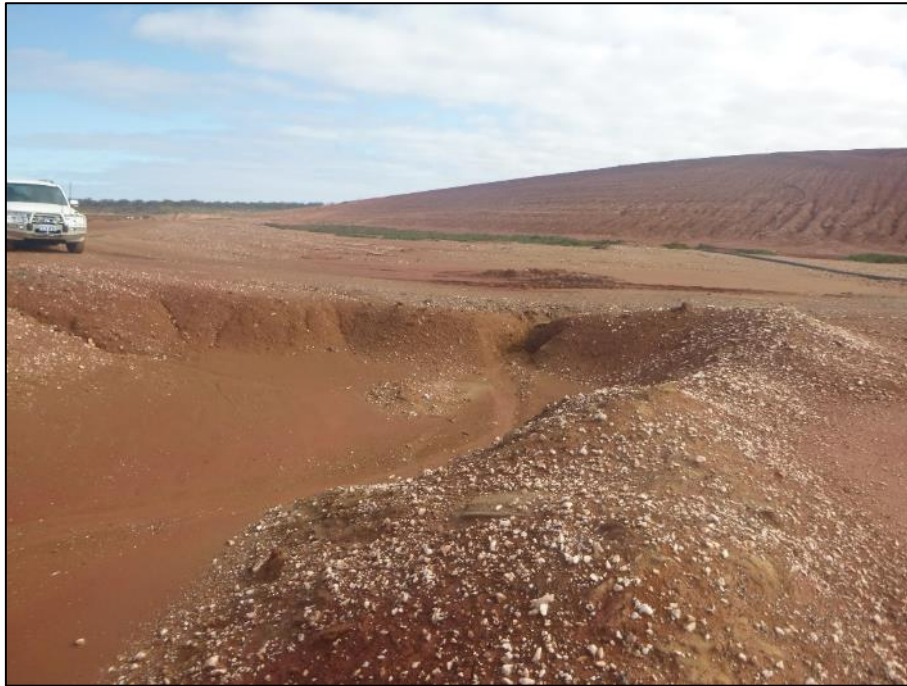
PHOTO 12 : BLOCKED DRAIN ADJACENT TO POND

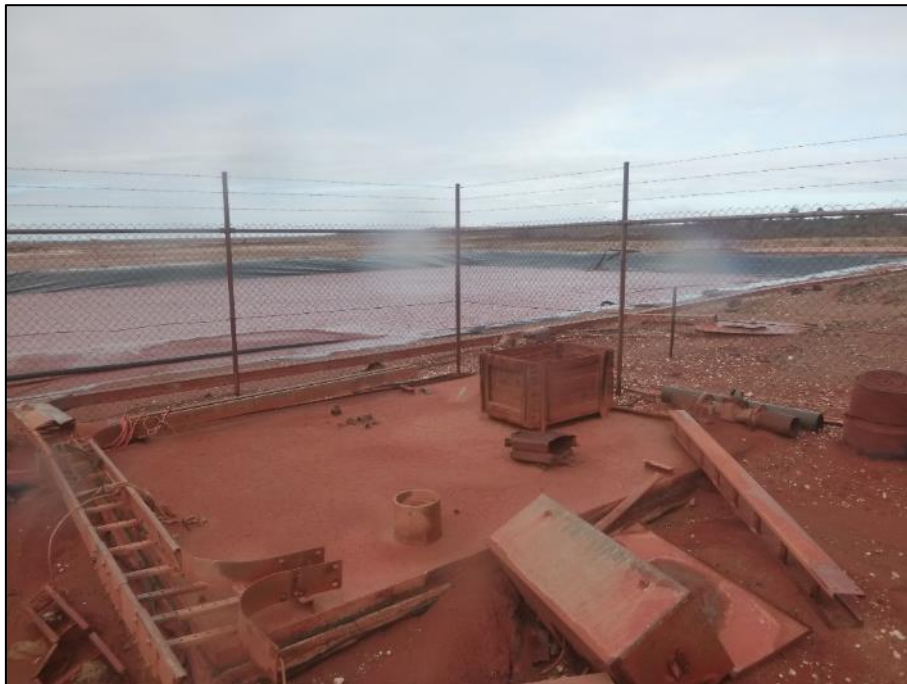
PHOTO 13 : UNDERGROUND DRAINAGE POND

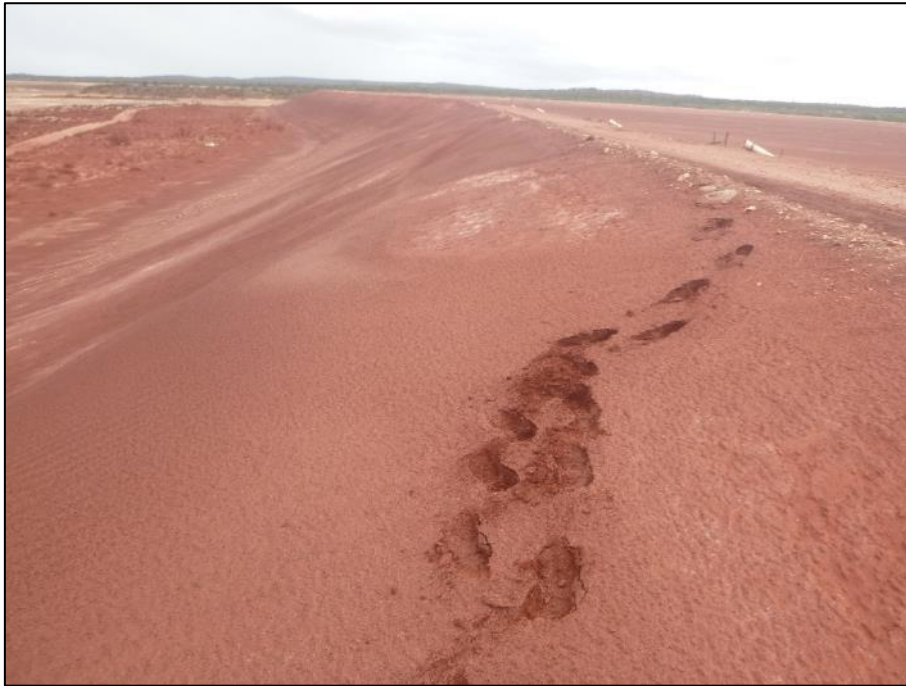
Item	Observations
Surrounding Area	The general topography surrounding the TSF falls to the east. Windblown tailings have covered vegetation in a local area predominantly in a north easterly direction turning the natural the vegetation red-brown as seen on Photo 14 .
Topsoil Stockpile	A topsoil stockpile was observed at the base of the access ramp on the western side, see Photo 145 . Measurements on google earth suggests the stockpile is approx. 145 m x 120 m. Observation on site indicated an average height of 1.5 m. Thus, approx. 26,000 m ³ .

PHOTO 14 : WINDBLOWN TAILINGS COVERING VEGETATION

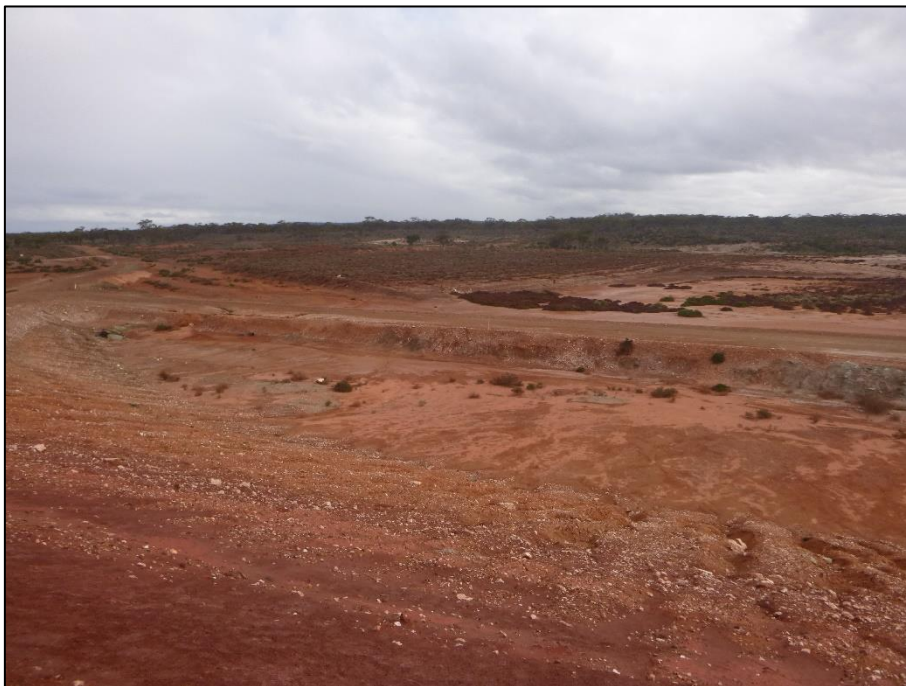
PHOTO 15 : TOPSOIL STOCKPILE

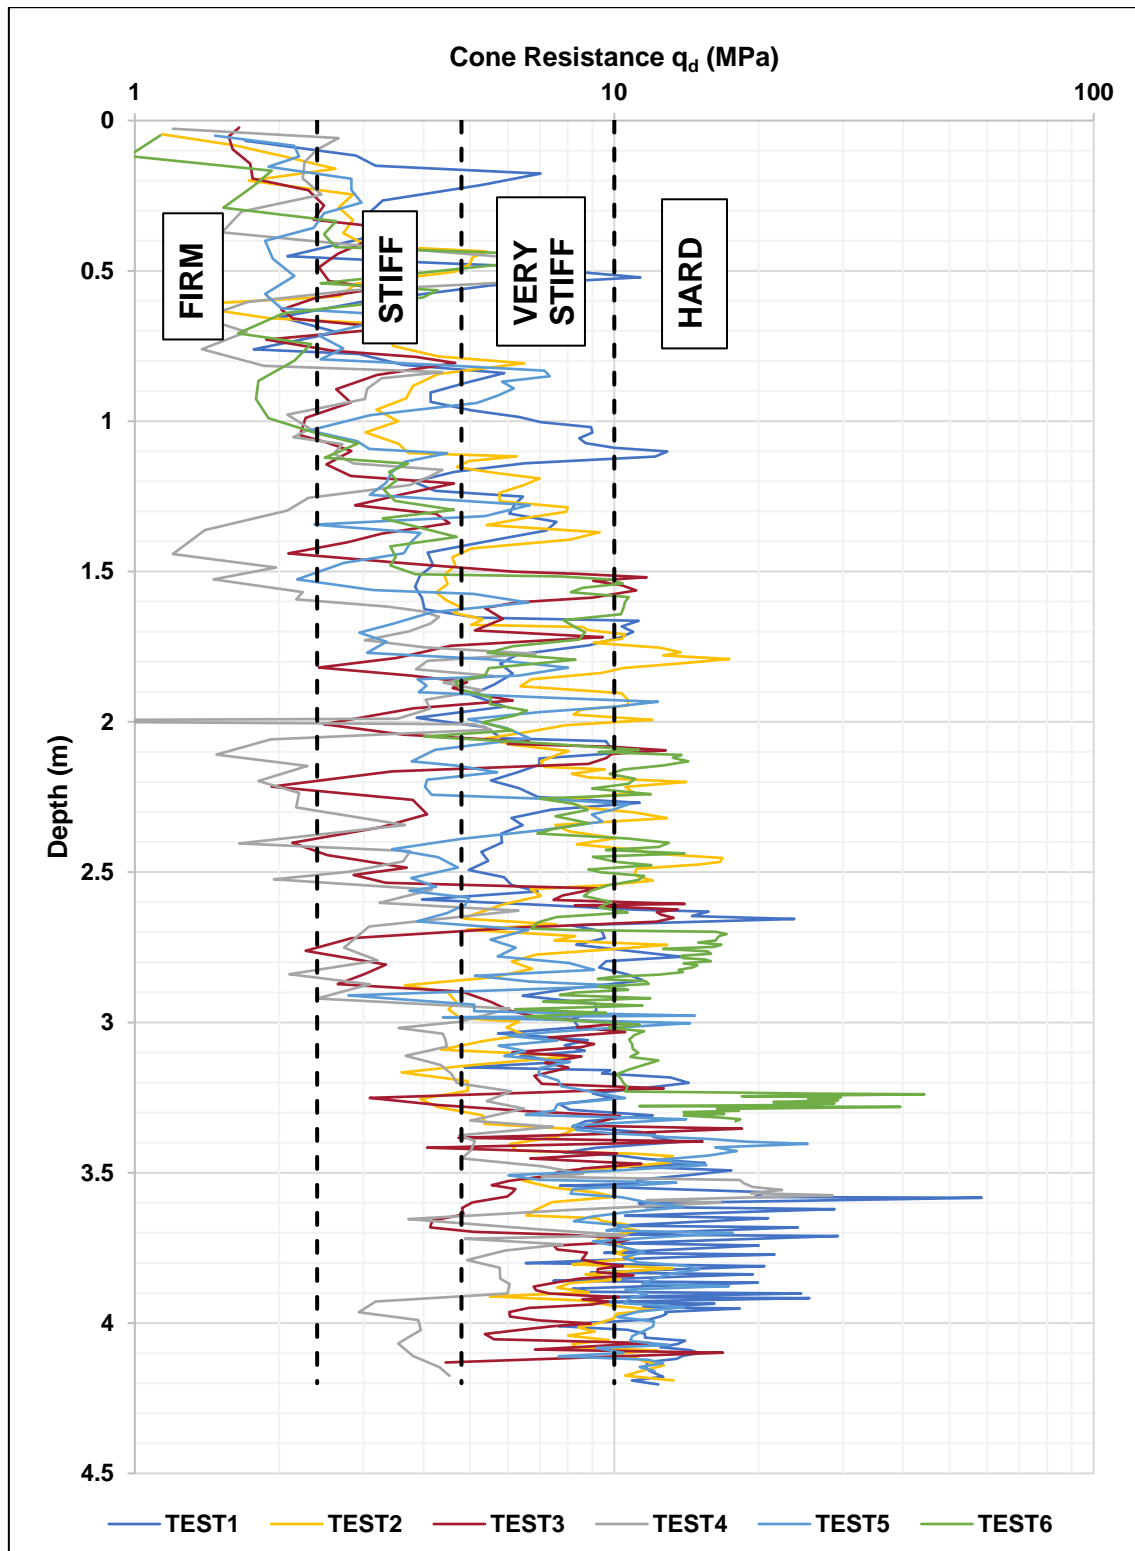
DIAGRAM 2 : TAILINGS CONE RESISTANCE PROFILES

As shown in **Diagram 2**, the tailings profiles can generally be classified as having a 'Stiff' to 'Very Stiff' consistency up to the investigated depth of 4.2 m.

Shear vane tests were undertaken adjacent to all PANDA DCP tests. Due to the hard tailings crust layer, all in-situ shear vane tests reached refusal.
