Mines Safety Bulletin No. 164

Subject: Wheels detaching from graders

Date: 17 April 2019

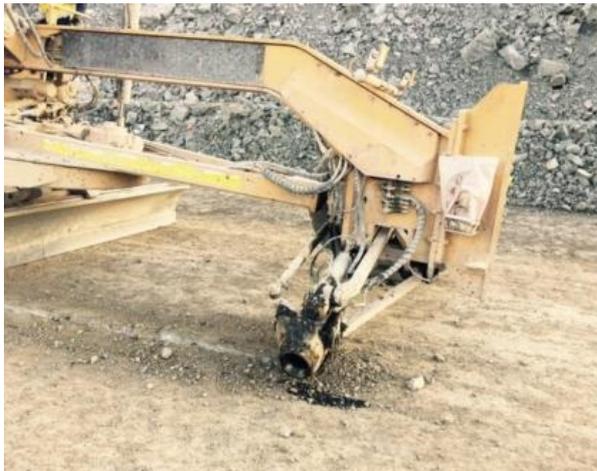
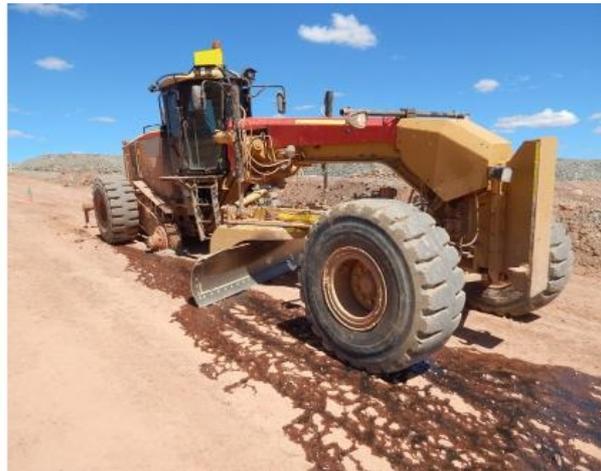
The Department has received reports of potentially serious incidents involving graders when either a front steering wheel or a driving wheel experienced catastrophic failure of its stub axle, resulting in the wheel suddenly detaching during operation. Recent incidents include:

These incidents were injury free. In all cases there was temporary loss of control of the machine and the detached wheel rolled away in an uncontrolled manner. The modes of failure, the physical root causes and contributory factors in all these incidents were found to be similar.

Example of a steering wheel failure and a driving wheel failure.

- Ensure stub axles are periodically inspected for surface cracks and other defects using OEM approved Non Destructive Testing (NDT) methods, at the OEM recommended intervals and by competent inspection personnel. When defects are observed, apply OEM recommended discard criteria.

- Use only genuine (OEM approved) or other fit-for-purpose replacement parts for shaft group assemblies.
- Ensure maintenance management systems adequately track and manage fatigue limited components such as stub axles.

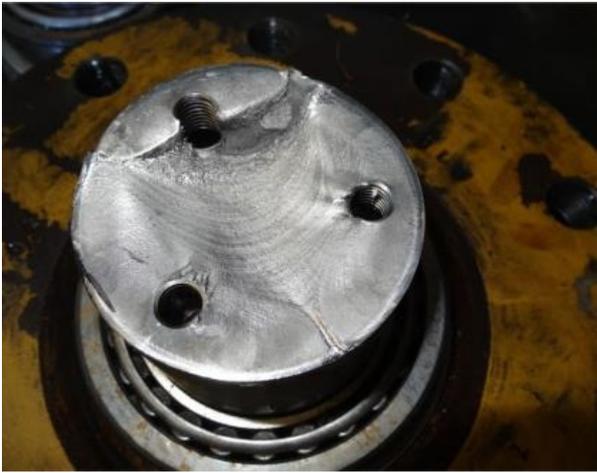
- Failure of programmed maintenance practices to adequately inspect stub axles at appropriate periodic intervals as defined in original equipment manufacturer (OEM) manuals.

Progressive fatigue failure on a steering stub axle and a steering stub axle failure due to suspected shock load.

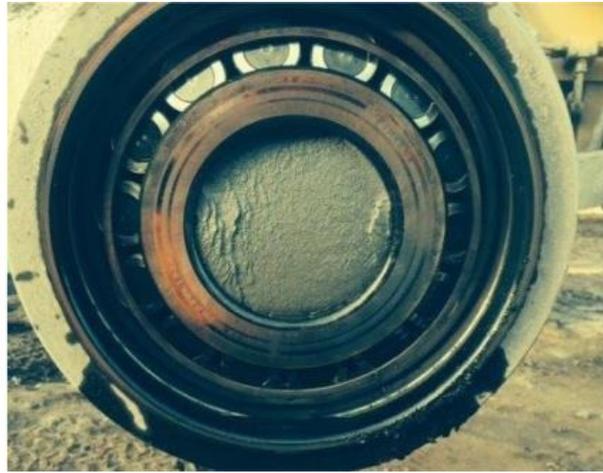
- operating on sharp turns and tight switch-backs
 - exceeding the oscillation stop limits of axles in rough terrain (total range of 32 degrees)
 - imposing excessive speed and shock loads to the grader front end (e.g. from excessive or sudden braking, or impacts with rocks and depressions in the road).

- Ensure maintenance personnel have access to OEM dealership support whenever additional technical information, guidance or advice is required.
- Ensure grader operators are adequately trained/assessed and fully aware of the performance limitations of their equipment and the types of operating practices that may contribute to premature failures.
