## Mines Safety Bulletin No. 176

**Subject:** Inspection and maintenance of accessway and platform gratings

**Date:** 10 August 2020

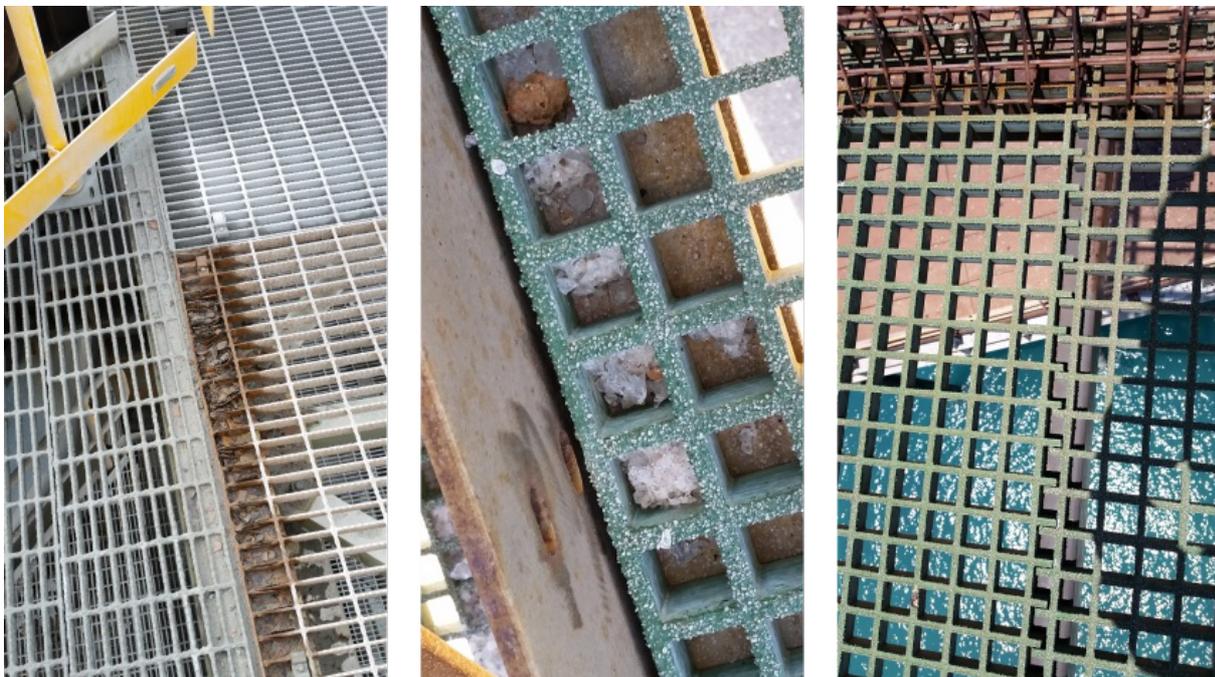
Since 2018, mines inspectors have raised many defects and notices related to the poor condition of accessway grating in plants at more than 60 mines. This is notable around sumps and drains, above leach tanks and in saline environments. Gratings are often corroded, deformed, inadequately secured and/or incorrectly installed. Grating supports are frequently cracked, corroded or missing.

1. Corroded load bars at support 2. Grating trapping corrosive material against the steel support 3. Grating trimmed with insufficient end bearing on support

- All gratings and grid mesh panels should be inspected regularly by a competent person. The inspection should include sumps, drains, platforms, walkways and stairways.
- Competent persons inspecting accessways must be trained to identify:
  - the load capacity of the gratings and recognise when they are overloaded
  - the correct installation, the end bearing and fixing requirements, and the maximum span and minimum width of all grating types used on site.
  - when grating, or its support, should be referred to an engineer for further assessment.
- Ensure both the designer's and the original equipment manufacturer's (OEM's) specifications and manuals are available for the competent person inspecting the accessways.
