## Fall from heights

Issued December 2019

Department of Mines, Industry Regulation and Safety

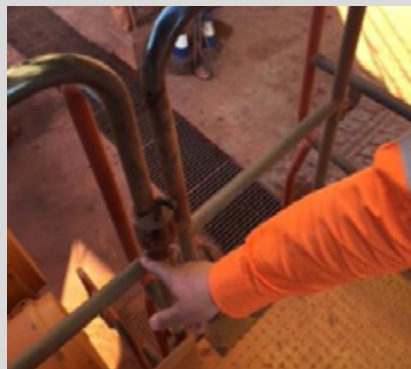
### Near miss when latch fails and gate swings open on a haul truck

23 November 2018

- The site's routine maintenance program and prestart inspection regime for the plant didn't prompt workers to inspect the latch.
- The original equipment manufacturer (OEM) released a service bulletin in April 2017 relating to the latch; however, the recommended works were not actioned on this vehicle.
- The OEM's service bulletin didn't identify the hazard relating to a failure of the latch. Nor did it communicate this as a mandatory improvement or a priority for the recommended works.

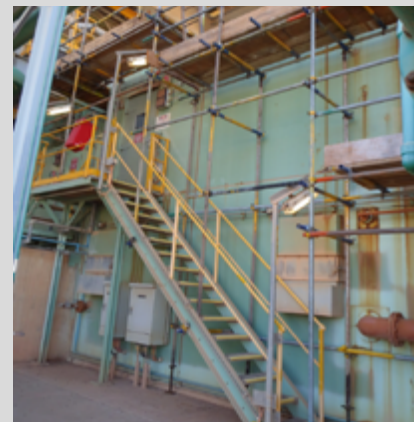
### Fall from height after failure of retractable type lanyard

28 May 2019

- Higher level risk mitigation measures (e.g. a stairway) were not in use.
- The fall arrest equipment was not used in a way to reduce, so far as is practicable, the possibility of injury to the user.
- The anchor point selection was incorrect for the application and outside the maximum of 30° offset recommended in AS/NZS 1891.4:2009, Part 5.1.2.
- The lanyard integrity was compromised at the connection between the inertia reel and the shock absorber with the webbing material worn and/or damaged.
- The scaffolder's lateral swing (the pendulum effect) extended the fall distance, likely exceeding free fall limits, before the lanyard took up the load.

Assess work area and take proper precautions. Conduct risk assessments (e.g. JSA) prior to work when necessary.

Ensure workers undergo working at heights training.

Maintain equipment in good working order. Always inspect anchorages and equipment before use.
