Significant Incident Report No. 211

Subject: Freight truck driver injured in fall from trailer

Date: 16 December 2014

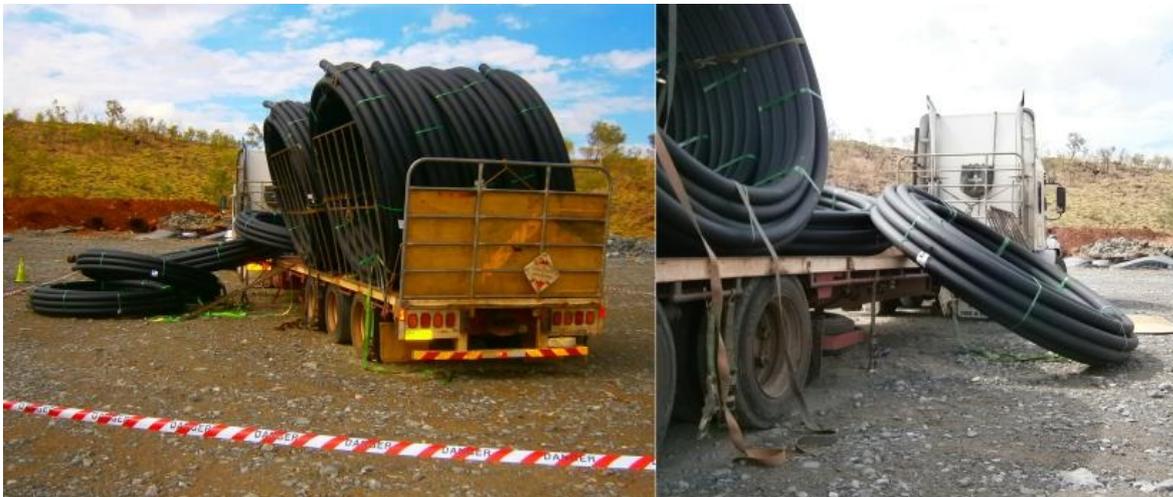
The pack separated and the rolls fell. Two rolls fell off the trailer. The middle roll landed half on the trailer. The remaining two rolls landed partly on the middle roll and partly on the trailer deck. The uppermost roll slid off the trailer on the other side, dragging the driver with it.

Rolls of poly pipe that fell after the pack's binding strap was cut. The driver fell to the right side of the trailer after being caught in a sliding roll. Note the intact packs of poly pipe rolls at back of trailer showing the arrangement of restraints

- There was uncontrolled movement of the rolls of poly pipe when the pack's strap was cut.
- The truck driver was positioned inside the pack when the poly pipe rolls moved.
- The truck driver was working at height without fall protection.

- Although a site procedure was available for loading and unloading, the hazard of stored energy and the need to undertake a job-specific risk assessment were not recognised.
- The store person and truck drivers had not unloaded packs of poly pipe rolls of this size at the site before.
- The method and equipment required to safely unload the pipe packs from the trailer had not been communicated to the truck drivers or store person.
- The binding strap ratchet could only be operated by a person standing inside the pack.
- The style of binding strap ratchet was unfamiliar to the truck drivers.

- ensuring personnel loading and unloading freight understand the hazard of stored energy and have the information, equipment and training necessary to handle freight safely
- reviewing site freight unloading procedures and adequacy of risk management controls, including the need for specific risk assessments where job parameters have changed.
