## Significant Incident Report No. 217

**Subject:** Underground worker crushed between charge-up basket and roof - fatal accident

**Date:** 21 May 2015

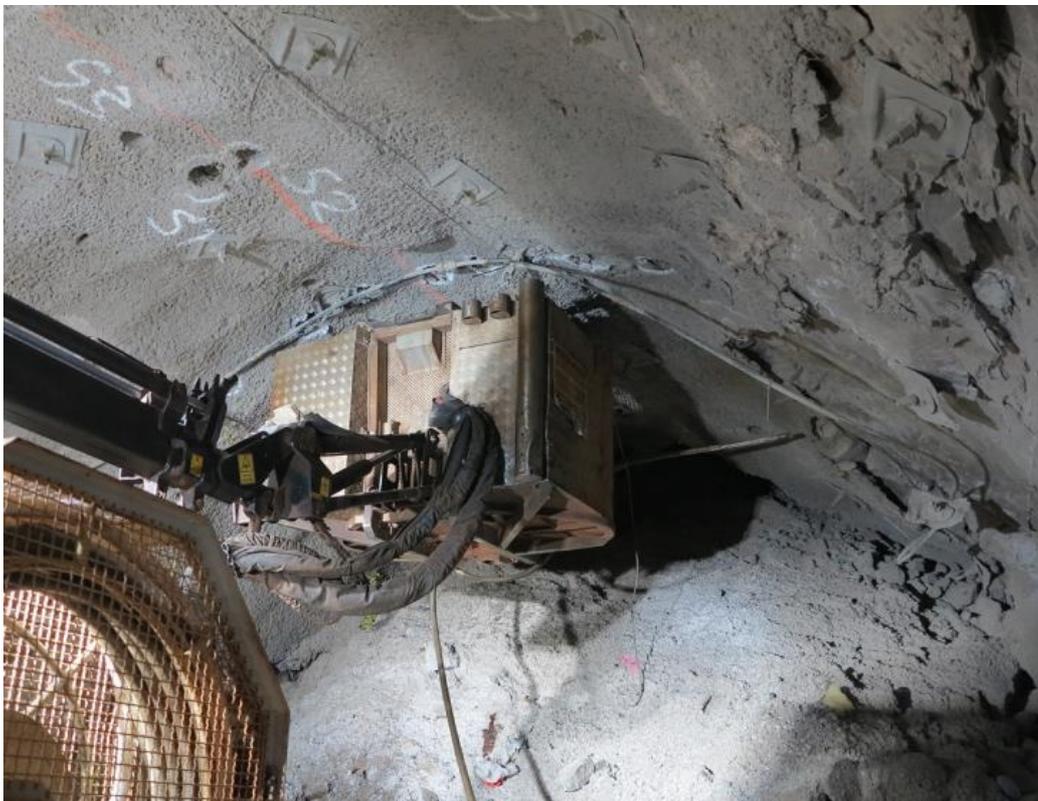
An underground worker using an elevated work platform (EWP) was fatally injured when the charge-up basket he was in moved upwards, crushing him against the roof of the cross-cut. It appears he was leaning over the front of the basket when he accidentally activated the control stick for raising and lowering the basket.

After the accident, the control stick was found to be bent forward (i.e. in "raise basket" position).

Charge-up basket near the roof of the cross-cut

- The worker was leaning over the front of the charge-up basket, in a restricted working space, when the basket moved upwards.

- Work from a charge-up basket is often undertaken at the front of the basket, so the worker can reach the charge-up hose.
- Rill slopes can restrict forward movement of the charge-up basket and result in the basket being close to the roof.

- The control panel is located at the front of the basket.
- Pushing the control stick forward raises the charge-up basket.
- The fail safe switch for the controls is located on top of the control stick, so that a downward force on the top of the control stick can activate the fail safe switch and allow the control stick to move forward.

- The operating procedure did not identify the potential crush hazard.
- At this mine, charging-up was typically carried out by a single person.
- The offsider assisting at the time of the accident had not been tasked with spotting, and was not trained to use the EWP.

- When undertaking work involving EWPs, ensure the potential for workers to be crushed between the basket and adjacent structures is identified and addressed.
- Inspect all EWPs used on the mining operation to assess the potential for accidental activation of controls.
- Ensure those involved in work using EWPs are familiar with their operation and the use of emergency controls.

Ensure the design and construction of EWPs for use on mine sites do not expose workers to hazards. Consider:

- how and where they will be used
- where the controls are located
- prevention of accidental activation of controls
- suitable protection structure for the operator.
