Significant Incident Report No. 238

Subject: Mobile plant interaction results in crush injuries

Date: 12 February 2016

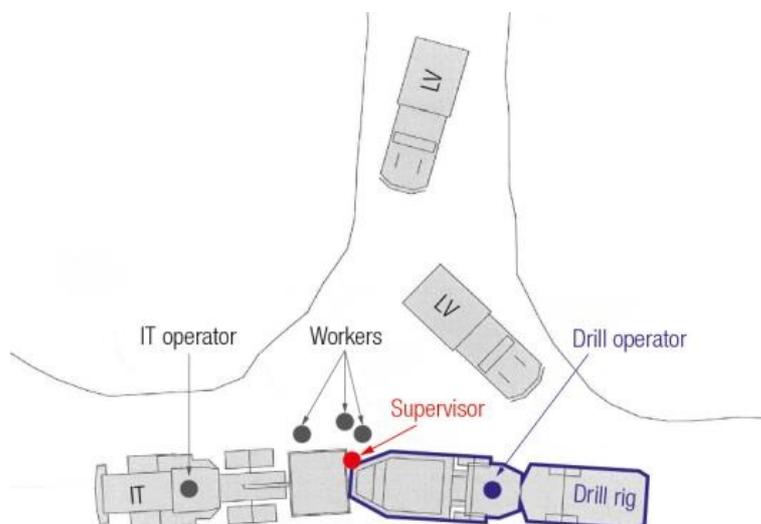
Plan view of incident scene. Supervisor was caught between the IT's basket and the horseshoe of the long-hole drill rig.

- The IT was stopped in a high traffic area of the main level access.
- The workers and supervisor were standing next to the IT.

- Lack of effective communication between personnel.
- Failure to recognise and manage the risks associated with working around mobile equipment.
- The drill operator's field of view was reduced by tramming the long-hole drill rig horseshoe first.
- The stockpile was obstructed by the parked LVs, preventing the long-hole drill rig from turning around.
- Failure to manage the risks associated with congestion and mobile plant egressing underground levels.

- implementing and promoting positive communication protocols to maintain situational awareness
- developing, implementing and reviewing appropriate traffic management systems within all work places
- ensuring mobile plant operators are aware of workers and other mobile plant in their vicinity and potential line-of-fire risks
- promoting continuous awareness of the hazards associated with working in proximity to mobile plant.

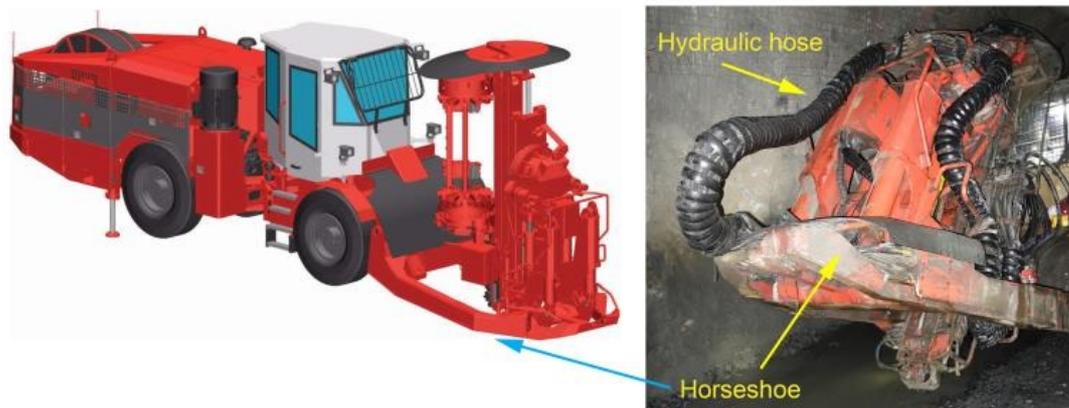
Long-hole drill rig showing the position of the horseshoe and hydraulic hoses.
