Significant Incident Report No. 239

Subject: Low-voltage arc flash during switching operation

Date: 11 March 2016

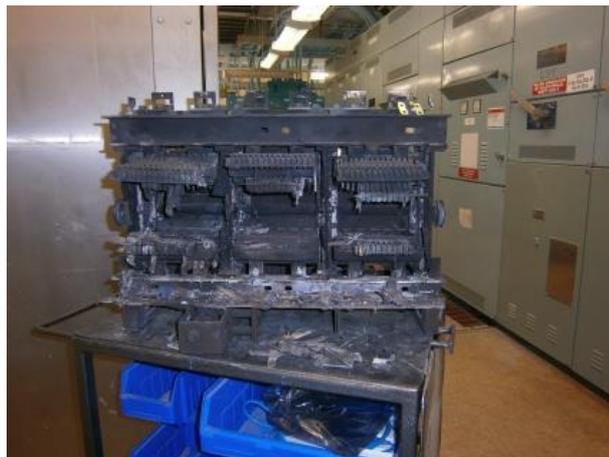
The switch was severely damaged and much of the evidence destroyed. However, the arc flash seems to have propagated from the cluster contacts (where the switch plugs into the switchboard). It appears that the lubricant ignited, initiating the arc flash.

Damage to 4,000 A switch following incident

- The cluster contacts had a history of losing their spring tension and creating a hot joint.
- The aerosol lubricant was flammable when atomized and subject to a heat source.

- Work was performed outside of the safe work instruction and without performing a risk assessment for the change in the isolation process.

- The switch had not been subject to a maintenance, test and repair program.
- The aerosol lubricant, labelled by the manufacturer as non-flammable and suitable for electrical equipment:
 - did not meet classification criteria for non-flammable aerosol
 - had an incorrect material safety data sheet (MSDS).
- The arc flash was not fully contained due to the open panel door on the switch enclosure.
- The electrical worker removed the glove (arc-flash rated) on his right hand.
- The arc-fault clearing time of the upstream over-current protection device was outside that prescribed in Clause 2.5.5.3 of AS/NZS 3000 *Electrical installations*.

- Routinely inspect, test and maintain electrical switchgear in a safe condition, having regard for the original equipment manufacturer's specifications.
- Report all defects identified with electrical equipment to the electrical supervisor.
- Set protective devices to limit, as far as is practicable, the harmful effects of a switchboard internal arcing fault (by automatic disconnection).

- Provide safe work instructions that cover the specific work undertaken.
- Assess workers as competent in electrical isolation before undertaking electrical work.
- Monitor the effectiveness of, and compliance with, safe systems of work.
- Confirm that workers are wearing appropriate personal protective equipment (PPE).
- Consider remote switching of all protection circuit breakers, which removes the operator from the arc flash danger zone. Conduct a protection coordination study of electrical power systems.
