Significant Incident Report No. 241

Subject: Underground worker crushed between integrated tool carrier (IT) work basket and roof of excavation (backs)

Date: 07 June 2016

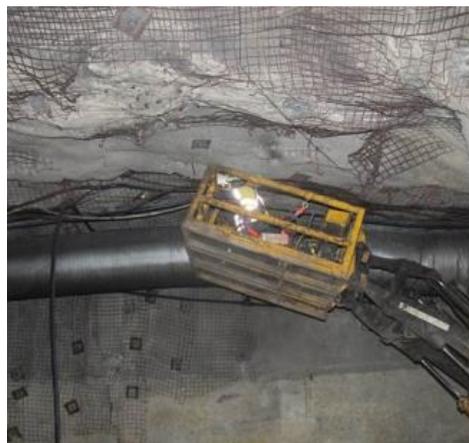
IT work basket in position beneath the backs

The worker was leaning over the front of the basket when the basket was tilted upwards.

- Lack of effective communication between personnel.
- The injured person was new to the task and was undergoing training.
- Tilting of the work basket was not included in the training documentation.
- The operator directing the work basket was not aware of the position of the offsider when the direction was given to tilt the work basket.

- The operating procedure did not identify the potential for a crush hazard while conducting work from the basket.

- When undertaking work at height using IT or EWP work baskets, identify and address the potential for workers to be crushed between the basket and adjacent structures. Work should be done without leaning over the edge of the work basket.
- Confirm that the equipment is fit-for-purpose — tilting the work basket for extra reach height introduces additional hazards from sloping floor surfaces.
- Consider installing height-limiting sensors or physical barriers to prevent crush nip points for personnel working in work baskets.
- Consider installing audible movement warning buzzers to work baskets.

- Implement and promote positive communication protocols between all personnel involved in the work to maintain situational awareness. This may include verbal and visible means of communications.
- Develop and implement standard signals for the control of IT and EWP work baskets.

- Provide employees with adequate instruction, training, assessment and supervision to conduct work safely from IT and EWP work baskets.
- Include guidance on the signals for controlling work baskets in training packages.
