## Significant Incident Report No. 277

**Subject:** Haul truck over open pit wall edge - fatal accident

**Date:** 22 August 2019

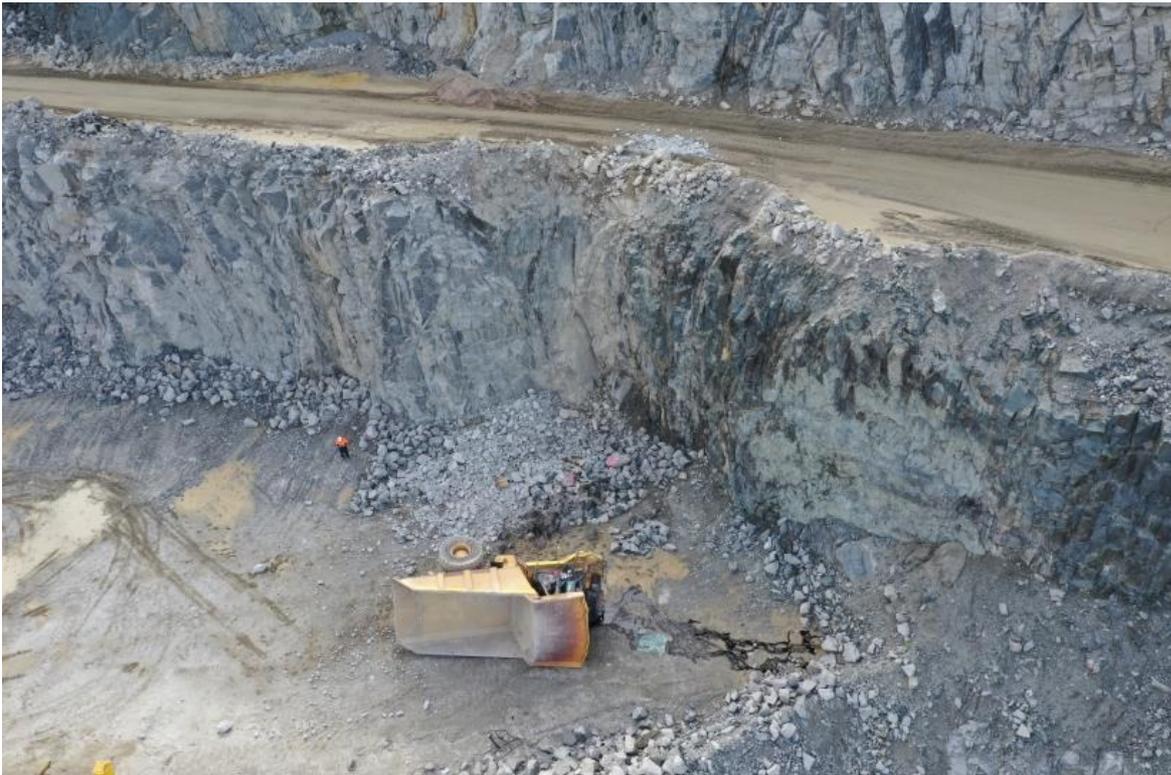
A fatality occurred on 20 June 2019 when a 110 tonne haul truck crossed a windrow and fell down a pit wall. At this stage of the investigation, the following is evident: the loaded truck entered a single lane section of roadway with two narrow points. When it reached the second narrow point, the truck's right side wheels rode up and over the windrow. As it straddled the windrow, its forward movement was initially arrested with the right side wheels over the crest edge, but the truck then slid over the edge falling 15 metres to the lower bench.

The truck fell 15m over a pit wall.

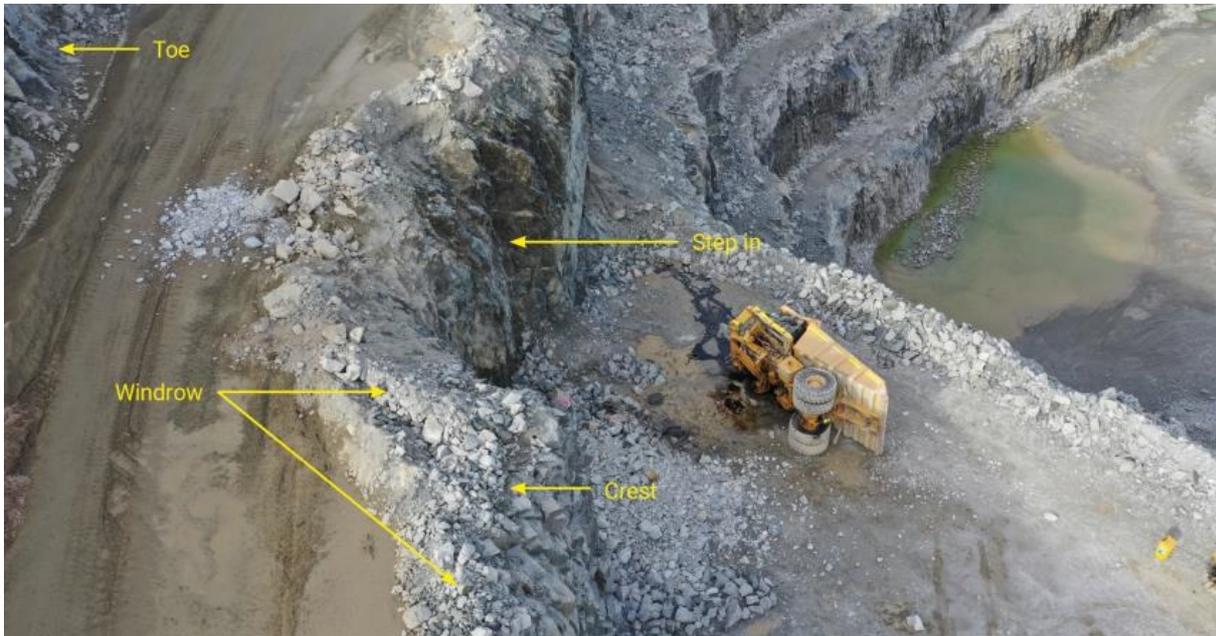
The truck was exiting the pit when it failed to negotiate a narrowing section of roadway on the ramp. The right wheels rode up over the crest edge windrow leading to the truck straddling the windrow before it teetered and fell over the edge.

Narrowing section of roadway. Note the deviation in the pit wall profile resulting in a 'step in' on the wall reducing the running width of the ramp.

- A 'step in' on the crest side reduced the bench width by over 20% along a 25 metre section.
- The 'step in' was on the driver's offside which has restricted visibility.
- The crest (drop-off) edge windrows were located along the immediate edge of the bench.
- The size and shape of the windrow, as well as adjacent material buildup, assisted the truck's wheels to ride up over the windrow.
- There was no demarcation or signage in the near area.
- The truck did not change the angle of approach to avoid the 'step in'.
- The incident occurred between dawn and sunrise when the light is changing, affecting visibility.

Haul roads should be designed to make it easier for truck to navigate safely. Blasting and excavating should be planned so as to avoid introducing hazards.

- Analyse the haul route to identify if there are any areas or features, not limited to narrow sections and curves, that may pose a higher risk and adjust windrows and other controls in those areas accordingly. For example, the curve along a haul road should have the largest possible radius and the curvature should be smooth and consistent.

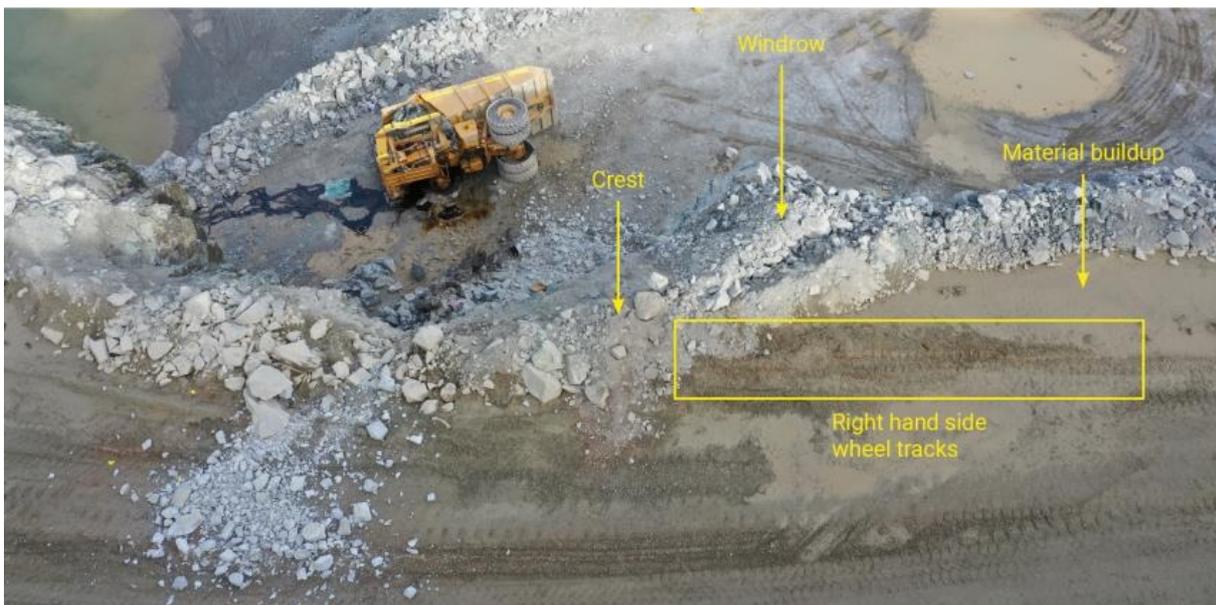
The right hand side wheel tracks can be seen leading to where the truck contacted the windrow.

- Design and construct adequate windrows to control operational hazards considering dimensions (shape, batter angle, height), location and construction material. High risk areas require larger barriers to prevent a vehicle from going over the edge.

- The windrow should delineate where the truck should be on the haul road and be an adequate distance from the edge.
- Design of windrows and traffic management of vehicles operating around windrows should take into account the angle at which equipment operates and any vehicle blind spots in relation to the windrow.

- Regularly inspect and maintain windrows and remove any build up of material that would reduce effective windrow height or provide an intermediate ramp up onto the windrow.
