## Significant Incident Report No. 226

**Subject:** Collision between an autonomous haul truck and manned water cart

**Date:** 11 August 2015

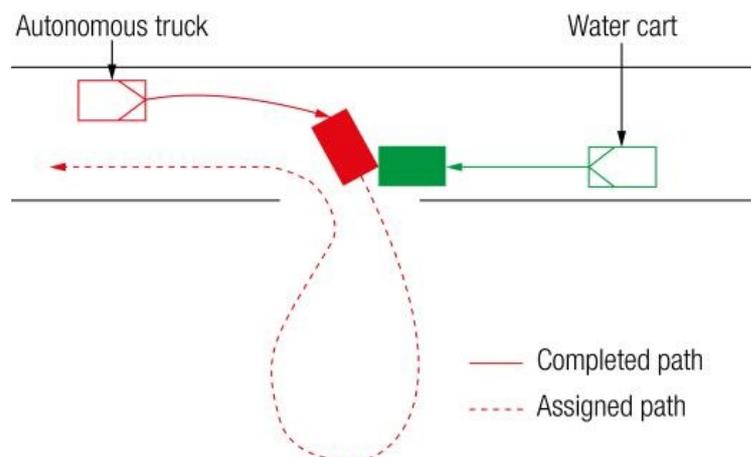
A manned water cart was travelling in the opposite direction when the autonomous truck was about to turn to right. The water cart driver was not aware of the autonomous truck's assigned path and, on recognising it, tried to take evasive action. The two vehicles collided, resulting in significant damage to the autonomous truck. The water cart driver received minor injuries.

- The travel paths of the autonomous truck and water cart intersected.
- The turnaround loop for the autonomous truck was released for use in the control system but the corresponding intersection was not delineated on the ground, nor its intended use communicated.
- On detecting the water cart in its assigned path of travel, the autonomous truck's speed (about 40 km/hr) and response time meant it could not prevent the collision.

- The change management processes for planning and assigning roads in the control system were inadequate.

- An awareness system was set up in the water cart to allow the driver to monitor the autonomous truck's path. However, at the time of the collision, the water cart driver was not fully aware of the intended path of the autonomous truck.

- The collision awareness system used by autonomous mobile equipment should detect and react to mobile equipment outside its assigned path of travel in a sufficient time to prevent a collision.
- Ensure awareness systems within manned mobile equipment effectively monitor and alert drivers of potential collisions with autonomous mobile equipment.
- When calculating appropriate speed limits for the autonomous mobile equipment, consider the time required for object detection and response.

- Implement robust traffic management procedures to manage the risks associated with manned and autonomous interactions.
- Implement comprehensive change management processes to ensure traffic management controls are appropriate and verified on the ground before changes are made in the control system.
- Ensure control room operators and pit supervisors are competent in the operating processes and change management procedures for the control system.
- Ensure personnel working in the autonomous haulage area receive suitable training in traffic management standards and are deemed competent to operate within the autonomous haulage area.
