Petroleum Safety Significant Incident Report No. 01/2014

Worker injured in fall from height during transfer from offshore platform to support vessel

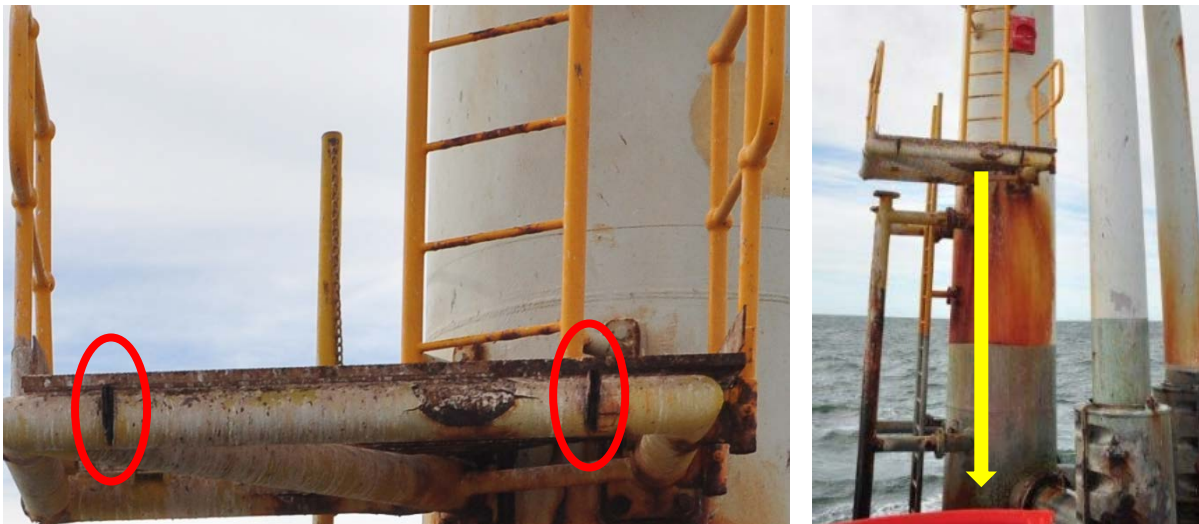
A worker fell about 4 metres after a handrail broke away from its support brackets. He had been standing on the lower access landing of the normally unmanned offshore platform, awaiting transfer from the platform to the support vessel.

A general visual inspection (GVI) to assess the structural integrity of the platform top side had been completed about 12 months before the incident and had identified moderate corrosion of the handrails.

Photographs showing location of handrail attachments that failed (left) and fall path from landing (right)

- The handrail could not support the load imposed on it by an individual person. It failed at the point of attachment (weld) to the platform base, exposing the person to the hazard of falling from height.

- Testing of the handrail had not been conducted in accordance with Australian Standard AS 1657:2013 *Fixed platforms, walkways, stairways and ladders – Design, construction and installation* therefore its true structural integrity was unknown.
- The PFD did not activate because a gas cylinder had not been screwed tightly into place following the last inspection of the device. The incorrect installation had not been detected.

Although steelwork may be fit for purpose when it is newly installed, the corrosive conditions in the offshore operating environment mean that a more rigorous approach should be adopted when assessing structural integrity. This includes:

- the identification of potential risks associated with failure
- an appropriate inspection, testing and maintenance regime.

Using GVIs alone is not a suitable method for assessing the integrity of steelwork and attachments because it does not allow the structural material thickness to be determined.

Monitoring strategies for structural integrity should include thickness measurements using:

- non-destructive examination (NDE) technologies
- fit-for-purpose testing (e.g. load testing).

The testing apparatus and a suitable process are not defined in AS 1657 and therefore a suitable process and procedure should be developed, verified and implemented.
