## Significant Incident Report No. 245

**Subject:** Worker injured by low-voltage switchboard arc flash

**Date:** 17 August 2016

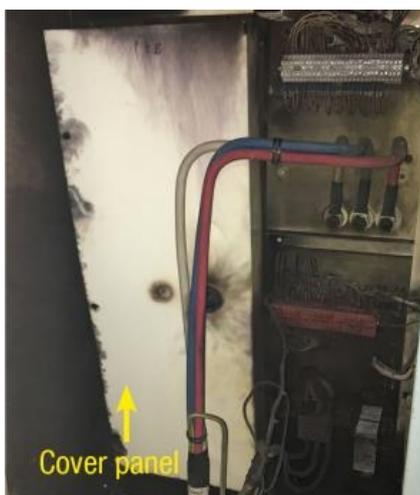
As the electrician touched the cover panel to check if it was secure, it moved and there was an arc flash and blast. He received minor flash burns to his right forearm and left hand. The worker was not wearing personal protective equipment (PPE) that was adequate for the energy released in the arc flash.

Left. Arc flash damage to the rear compartment of switchboard. Right. Protruding fuse-holder bolts in busbars.

- Design, install and maintain electrical installations and equipment in accordance with Australian Standard AS/NZS 3000 and other relevant standards, and complete to a trade finish.
- Maintain required clearances in a switchboard by rigidly fixing exposed energised and/or conductive parts.
- Conduct an arc flash energy assessment of all switchboards and MCCs, and attach arc flash hazard labels so workers are aware of the hazards and can use appropriate arc flash PPE.

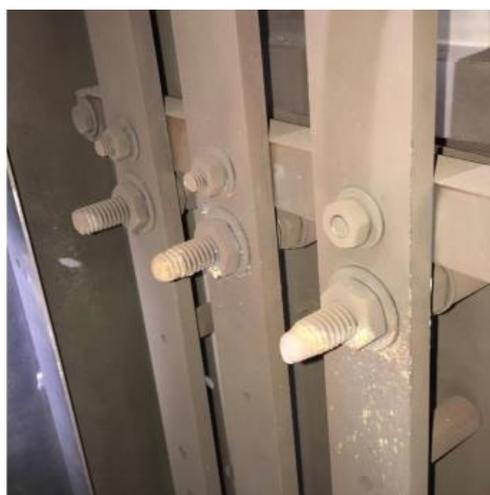
The subsequent investigation found that the cover panel had come in contact with fuse-holder bolts protruding from the energised busbars behind the cover panel.

- The loose busbar cover panel was moved, making contact with the fuse-holder bolts protruding from the energised busbars.

- The busbar cover panel was not secured.
- Moving the cover panel was not in the original scope of work.
- The busbars in the rear compartment were not isolated prior to moving the cover panel.
- The electrician was not wearing PPE that was adequate for the energy released in the arc flash.
