MINESAFE

MINING OPERATIONS DIVISION

Mining thro' old workings

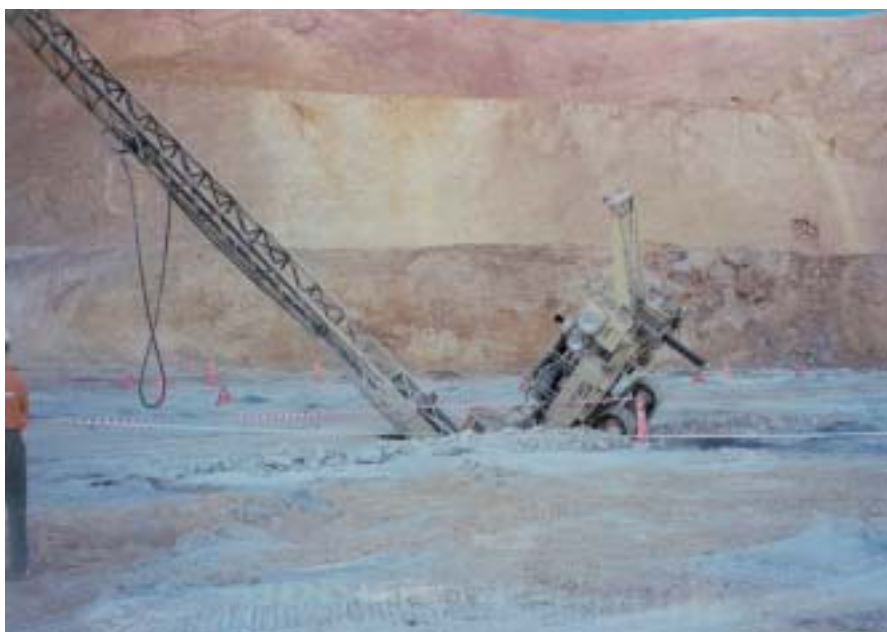
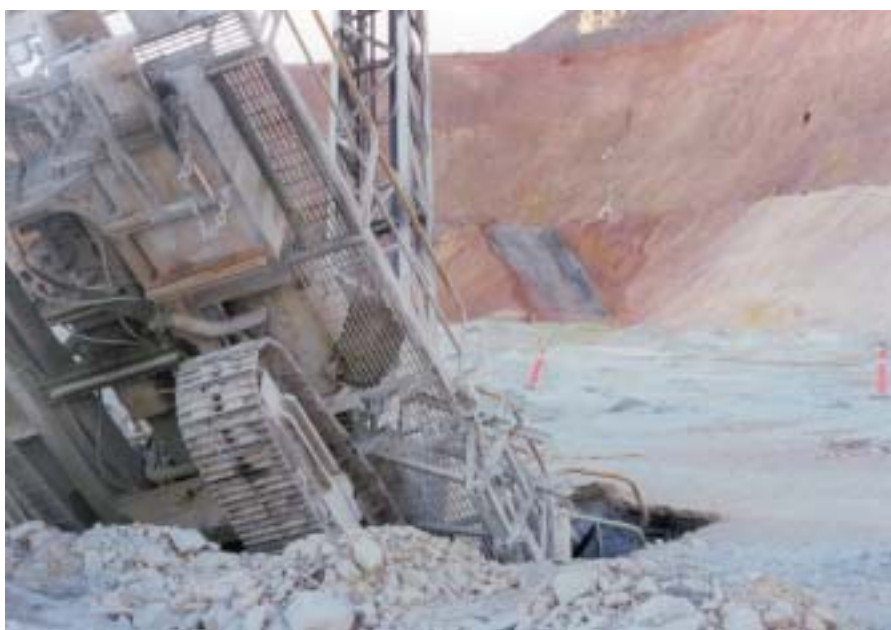
**Dropping in on
old workings . . .**

**. . . not if you
can 'a-void' it !**

The incident involved a blast-hole rig which was being used to drill a combination of blast and probe holes in the open pit floor. Drilling was taking place in an area that was known to contain an old rock-filled stope. Shortly after commencing drilling, through what appeared to be mostly broken rock, a large section of ground suddenly gave way, taking the rig with it. Fortunately the machine's cabin and mast became wedged against the side of the hole, preventing it from sliding deeper into the void, and the operator was able to clamber from the rig safely without significant injuries.

Following an investigation, it appears that two ore passes also coincided with the known stope and the overall span of the combined excavations was unusually wide. Both ore passes were apparently empty and the stope was not completely filled with rock fill. It is unclear whether the void in the stope was caused by some of the stope fill material rilling out via the passes, or whether the void developed during or after the fill cycle. The action of drilling a probe hole through loose rock (either broken wall rock and/or rock fill) was sufficient to cause the rock fill above the void to unravel into the void, taking the drill rig with it.

To determine the location, dimensions and status of underground voids, it is necessary to delineate an appropriate stand-off distance and establish a safe working procedure such that employees and equipment can work safely.

The use of standard procedures relies on an assumption that all factors contributing to a potential outcome are fairly predictable. Unfortunately, ground conditions can change suddenly. What is required is a flexible but rigorous systematic approach to hazard identification (HazID) and risk management that takes into account the full range of potential causal factors at work in an area.

Further, it is recommended that employees participate in the development of work practices, thereby ensuring all aspects are considered and securing a commitment to adhere to them.

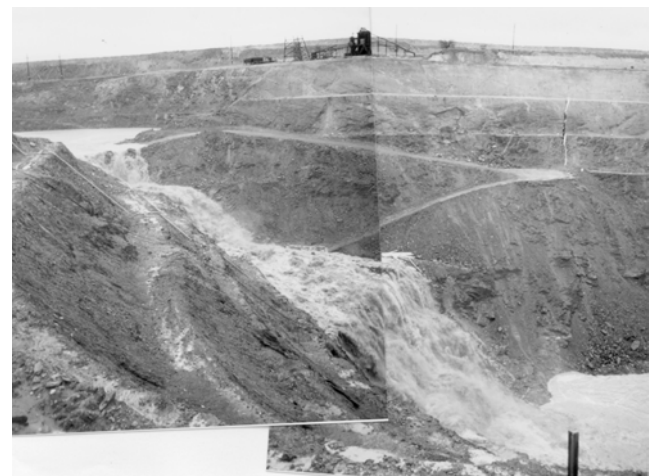
From the early hours of Tuesday 13 June 1989, extremely heavy rainfall in the area caused heavy flows in the creek system to the south and east of the mine. This eventually caused the 450 South Pit to fill to a point where "overtopping" occurred in the area of the separating 'pillar', rapidly eroding the material of which it was composed. The observation was made, subsequent to the incident, that this material may not, in fact, have been 'native' but may have been 'fill' placed in an old underground stope. This caused water to enter the Main AG Pit. As the pillar eroded the amount of water flowing into the Southern Extension increased rapidly, in ways similar to the failure of a dam. Flow from the 'creek system' was such that it continually replenished, the 450 South "dam".

Quoting from the official report: *"A wave of water rushed across the AG Southern Extension, a small portion flowing down the old EMU Shaft while the remainder cascaded over the southern wall of the Main AG Pit. Its flow towards the decline was retarded slightly by a bund of road base material which had been built during the day to prevent nuisance water flowing down the decline"*. This barrier held the water back for a very short time only. A witness estimated that the decline filled in ten minutes.

A deluge of water cascades into the open pit.

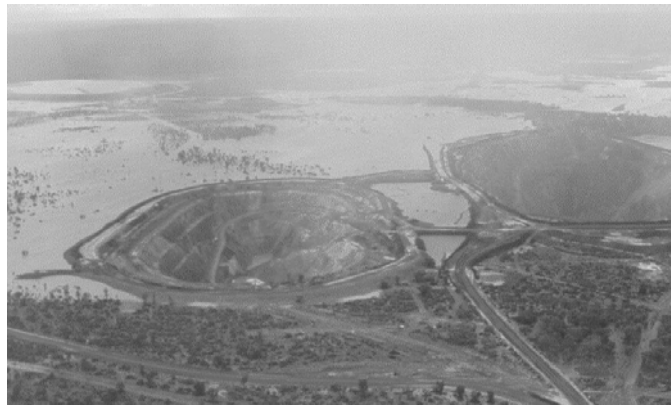
Aerial view of the flood path around the two open pits

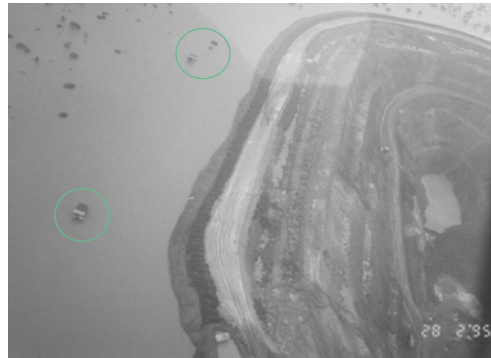
Closer view of the well-constructed water control bunds - note the swimming haul trucks.

illustrates, the additional precautions were vindicated. In fact it is understood that, even with the additional earthworks, the water level peaked only 30cm from the top of the diversion bund.

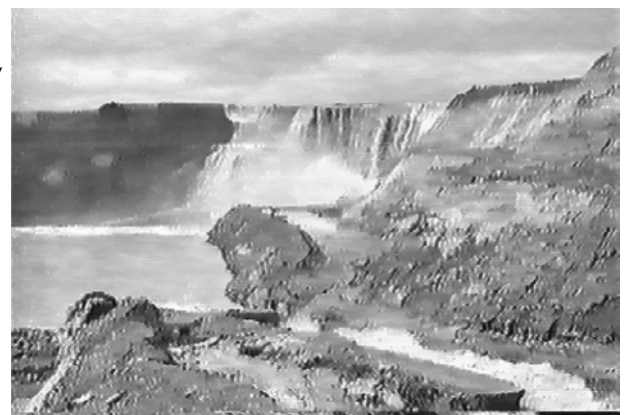
The raging torrent pours into the Bannockburn open pit on 27 February 1995. (MINESAFE thanks Scott Donaldson for the video from which this picture frame was obtained.)

Although we are heading towards what is generally known as the "dry" season in WA, many floods have occurred in this period - particularly between January and March. We must take heed of this and make sure our water control strategies are up to scratch now.

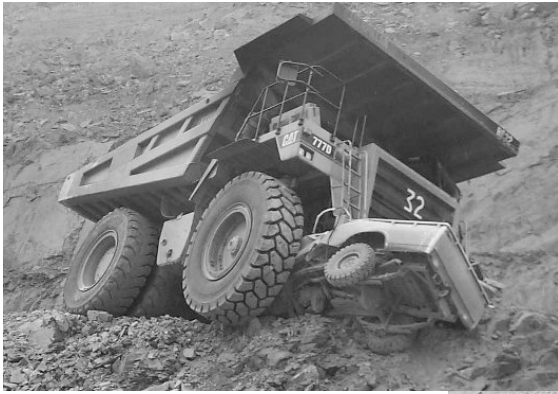
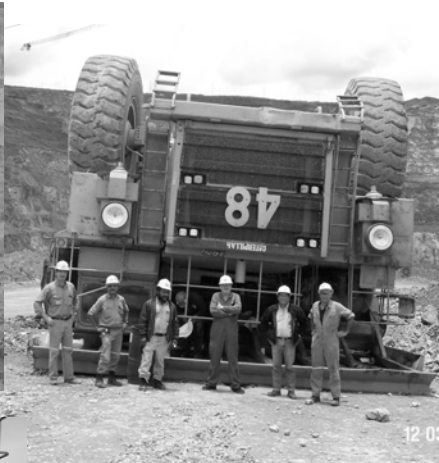
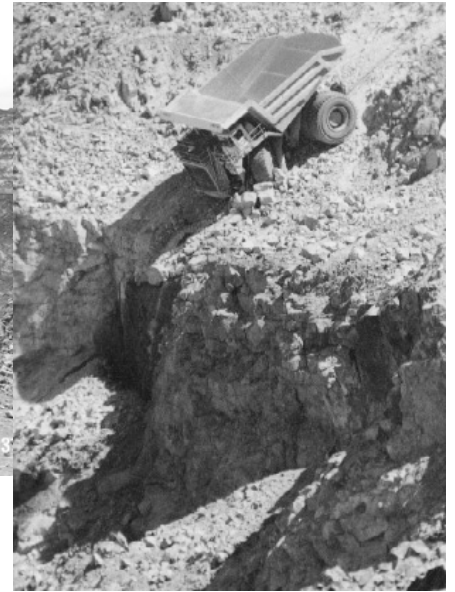
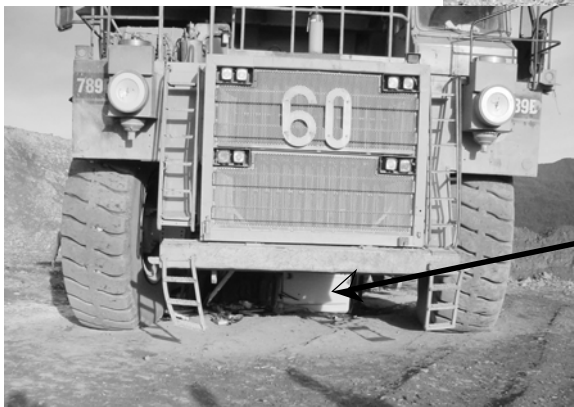
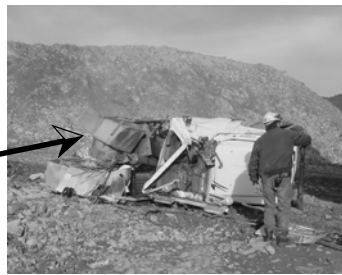
Big does not necessarily mean safe - as demonstrated by these photographs from mining regions outside WA.

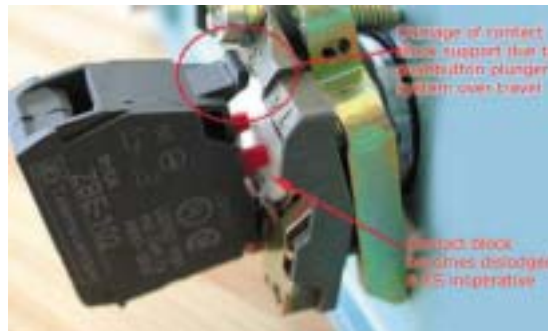
Malfunctioning may occur in cases where the operating head of the stop button is subjected to extreme operating force, the result of which may cause the associated contact block to become detached. Should this occur, the stop

button will not perform its cut-out function when subsequently operated.

Rear contact block dislodged by over-travel of operating head.

The company is replacing current operating heads with modified heads bearing distinctive marking (raised ring), as shown in the photograph, allowing for easy "front of panel" identification of old & new devices.

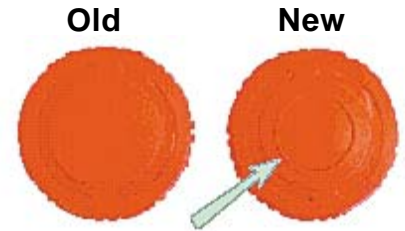
Identification ring, diameter 18mm (diameter 21mm on products with a lock)

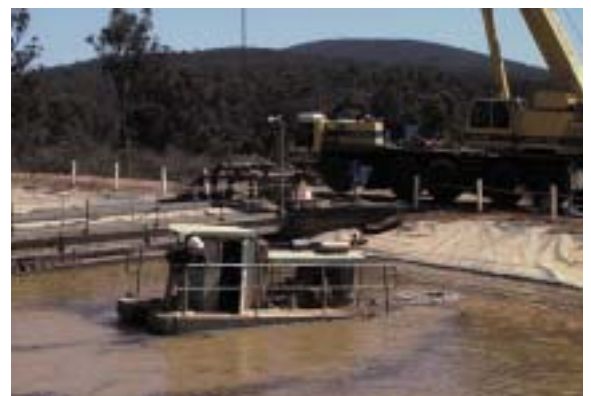
In September 2001, a small dredge (approximately 5.5 metres long) capsized while operating on a tailings pond at a gold mine. The operator made a lucky escape by swimming through a missing cabin window while the vessel was upturned. The incident had an extremely high potential to result in a fatality.

An investigation revealed several deficiencies with the design and operation of the dredge. With sludge build-up on the cutterhead or with the cutter driven into the bottom of the pond, one end of the dredge deck would become submerged. The deck was not watertight due to cracks around handrail stanchions and unsealed deck covers, allowing water to enter the port

Hardly the Titanic - but you could still drown

For further information, refer to Safety Bulletin No.65 or contact Mark Butson on 9222 3607.

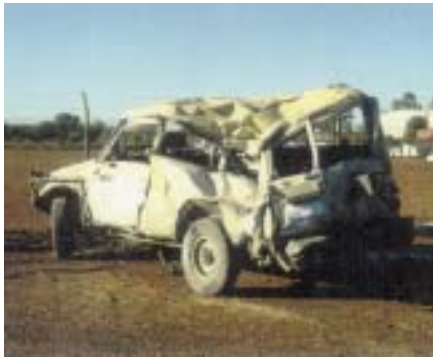
A high potential near-miss occurred underground when a personnel carrier was reversed into an ore drive and fell over the bench edge of an open stope. Most fortunately, the vehicle teetered on the edge long enough for the driver to clamber out and escape serious injury (or worse). A desperate attempt was made to secure the vehicle with chain before it slipped and fell 15 m.

Vehicle after it was recovered from the open stope

- Foreseeable risks had not been fully assessed.
- The driver was unaware that the bench edge had retreated 14 m during his R & R break.
- Restricted rear vision when reversing.
- Inadequate communications.

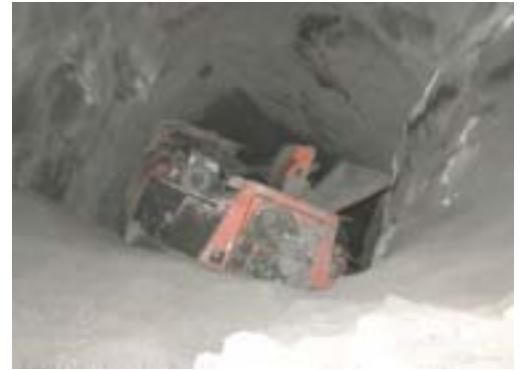
Similar incidents have occurred elsewhere. Earlier this year, at the Tara mine in Ireland, a LHD (bogger) fell 17m down an ore pass that had been filled with mullock. Unknown to the bogger operator, ore in the pass was being mucked from a level below and the machine was working on a hung-up bridge. The bogger fell when the bridge gave way. Fortunately, the driver was uninjured and somehow managed to scramble out of the near-vertical ore pass. Once again, one of the main causes of this problem was poor communication. Neither the LHD operator or his shift boss are still working at that mine.

LHD 17m down an ore pass in Tara lead/zinc mine
