DEPARTMENT OF
MINERALS AND ENERGY
WESTERN AUSTRALIA

MINESAFE

MINING OPERATIONS DIVISION

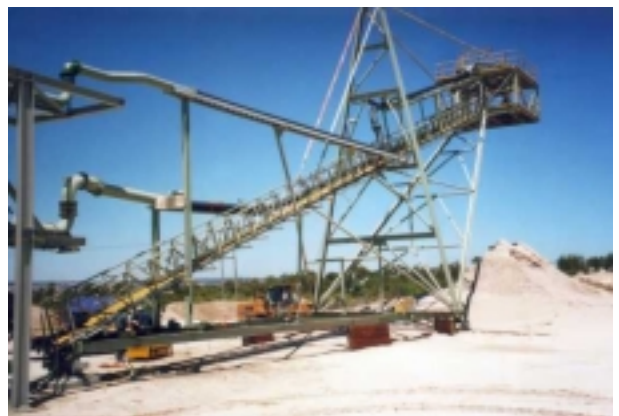
The stacker is a radial type, around 40 metres long with a central pivot bearing and bogies running on a steel rail and concrete perimeter beam. During a routine inspection in November 1999 an engineer discovered distorted steel plates and bolts in a critical structural connection at the pivot-bearing end of the stacker.

The stacker's operational procedures were immediately reviewed and temporary measures taken to ensure safety. Consultants were engaged and their investigation confirmed three structural problems that could have separately or in combination led to major failure and possible collapse of the stacker. Some of the problems had accumulated over several years of operation and were exacerbated by a lack of 'redundancy' in the stacker design. Further operation of the stacker was suspended until all of the faults had been rectified. Extensive repairs involving the replacement of two major structural

members and strengthening of a connection were carried out under strict engineering supervision. The risk assessment process and structural analysis is ongoing and will ensure long-term safe operation.

Persons operating similar machines should take heed and be aware that an accumulation of operational damage and uninformed maintenance practices may lead to dangerous conditions, and should arrange for periodic inspections to be carried out by a competent structural engineer.

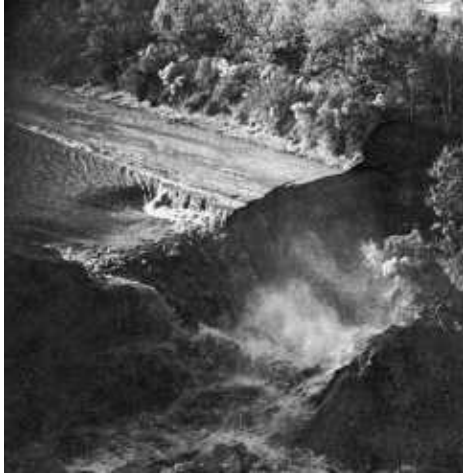
Texaco's drill penetrated the roof of the room and pillar mine; the lake waters then flowed into the workings and began to dissolve the mine pillars. The resulting collapse of ground above the mine worked its way though to the surface (or, at least, to the bottom of the lake) which

A raging torrent cascades down into the mine

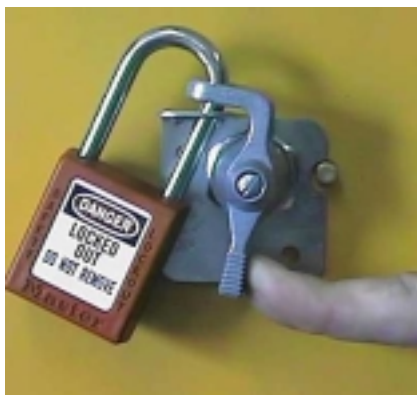
This isolator is now switched on

The potential hazard originates from the minimal degree of actuator

rotation that will cause some battery isolators to 'switch on' and the tolerance in certain pad-locking arrangements that allow this to occur. As illustrated, with minimal effort and actuator movement, the isolator illustrated could be operated to the 'on' state even though a substantial padlock had been attached.

When satisfied that an isolation is effective, a personal DANGER tag or OUT OF SERVICE tag (as appropriate) is required to be attached in addition to any padlock.

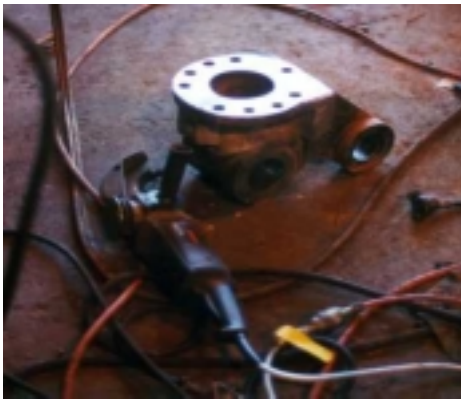
The angle grinder was being used to level the flange of a jumbo drill swing-clevis that had deformed during welding and the wheel failed when raised from the work-piece after 15 minutes usage.

Swing-clevis workpiece and angle grinder

To facilitate 'flat face' grinding of the clevis, guarding had been removed from the 180mm angle grinder and an oversized 230mm abrasive wheel installed using incorrect fixings. The machine operated at 8500rpm and the maximum rating of the wheel was 6800rpm. Failure of the wheel resulted from unsustainable centrifugal forces exerted by the increased speed and bending stress imposed on the wheel by the incorrect fixings.

Accidents involving angle grinders are not uncommon and persons must be mindful of the extreme hazards presented by machines that are incorrectly used or assembled. The peripheral speed of a 230mm wheel rotating at 8500rpm is 368Kph and has an obvious potential to inflict serious injury. Abrasive wheels are marked with a MAXIMUM SAFE SPEED and it is vital to check the nameplate speed of the machine to ensure this rating is not exceeded.

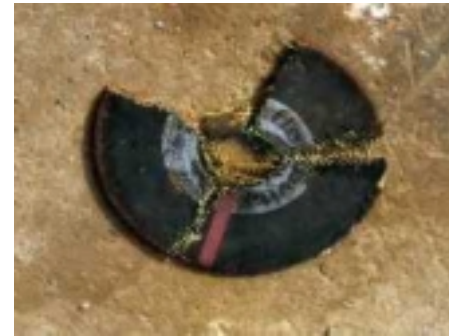
Remains of fractured grinding wheel

Removal of guarding purposely designed to deflect fragments exploding from a disintegrating wheel is pure folly. Guarding must remain in place and be properly aligned. Other persons in the workplace must be considered. The profile of grinding wheels and the means for securing them vary; follow manufacturers' instructions when installing them and do not interchange unlike components or improvise. Considering the every day industrial usage of angle grinders and a series of other safety-related issues, MINESAFE urges all users to undertake a review of current equipment and work-practices. Further information may be referenced in Australian Standard AS1788.
