## Traffic management

Issued September 2017

This snapshot covers traffic management incidents for the period from 1 June 2016 to 31 May 2017.

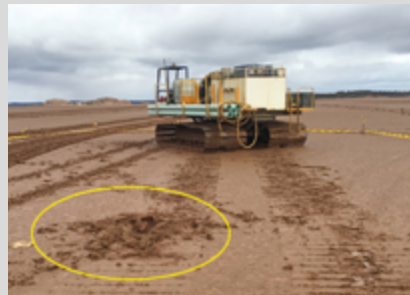
### Drill offsider run over by tracked vehicle

11 October 2016

Unauthorised changes to mobile plant safety features may result in injuries or fatalities. Any changes should be addressed by the supplier or manufacturer. Always follow safe operating procedures.
