Safety and Health Snapshot

Amputations, fractures and crushing (AFC) injuries

ssued November 2019

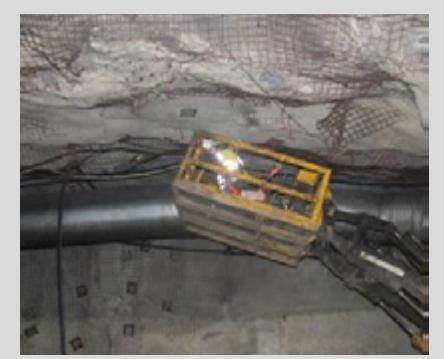
Spotlight on Mines Safety Significant Incident Report No. 241

Underground worker crushed between integrated tool carrier (IT) work basket and roof of excavation (backs)

Contributory causes

- Lack of effective communication between personnel.
- The injured person was new to the task and was undergoing training.
- Tilting of the work basket was not included in the training documentation.
- The operator directing the work basket was not aware of the position of the offsider when the direction was given to tilt the work basket.
- The operating procedure did not identify the potential for a crush hazard while conducting work from the basket.

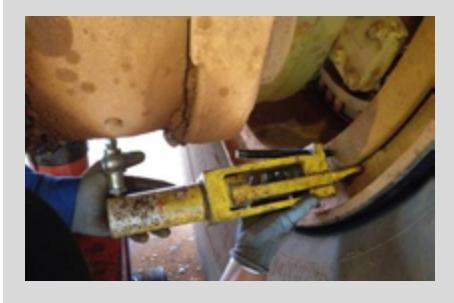
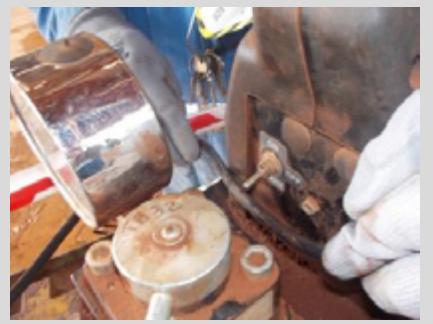
Spotlight on Mines Safety Significant Incident Report No. 242

Tyre fitter's fingers crushed while operating hydraulic bead breaker 14 June 2016

Contributory causes

- The equipment design does not encourage the correct positioning of hands nor restrict access to moving parts.
- There is no guarding to prevent inadvertent contact with moving parts nor labelling on the equipment to warn of the nip or crush point.
- Work instructions did not outline the controls for all hazards associated with the task.
