Mining Rehabilitation Fund

Yearly report 2020–21

This report outlines the functions, activities and achievements of the Mining Rehabilitation Fund and Abandoned Mines Program from 1 July 2020 to 30 June 2021, as well as providing an indication of future plans.

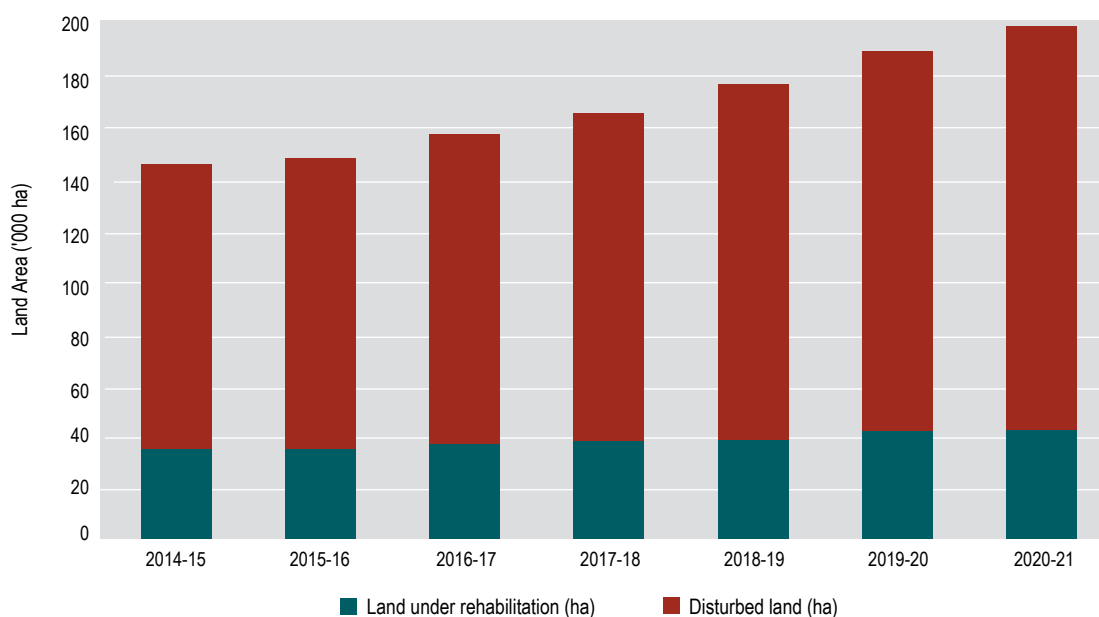
Figure 5 - MRF data reported for land under rehabilitation

For the 2020-21 FY, the area of land reported as ‘under rehabilitation’ (that is, where rehabilitation was in progress) was, at 41,883ha, essentially unchanged from the previous year. For the same period, the area of ‘active’ disturbance increased by approximately 9,000ha (6.1%) to 156,563ha. Land under rehabilitation therefore represented 21% of all disturbed land (that is, including land in the process of being rehabilitated) and 27% of the area of active disturbance.

These results suggests that, while the area under rehabilitation continues to increase, it is no longer keeping pace with the increase in overall mining activity, year-on-year.

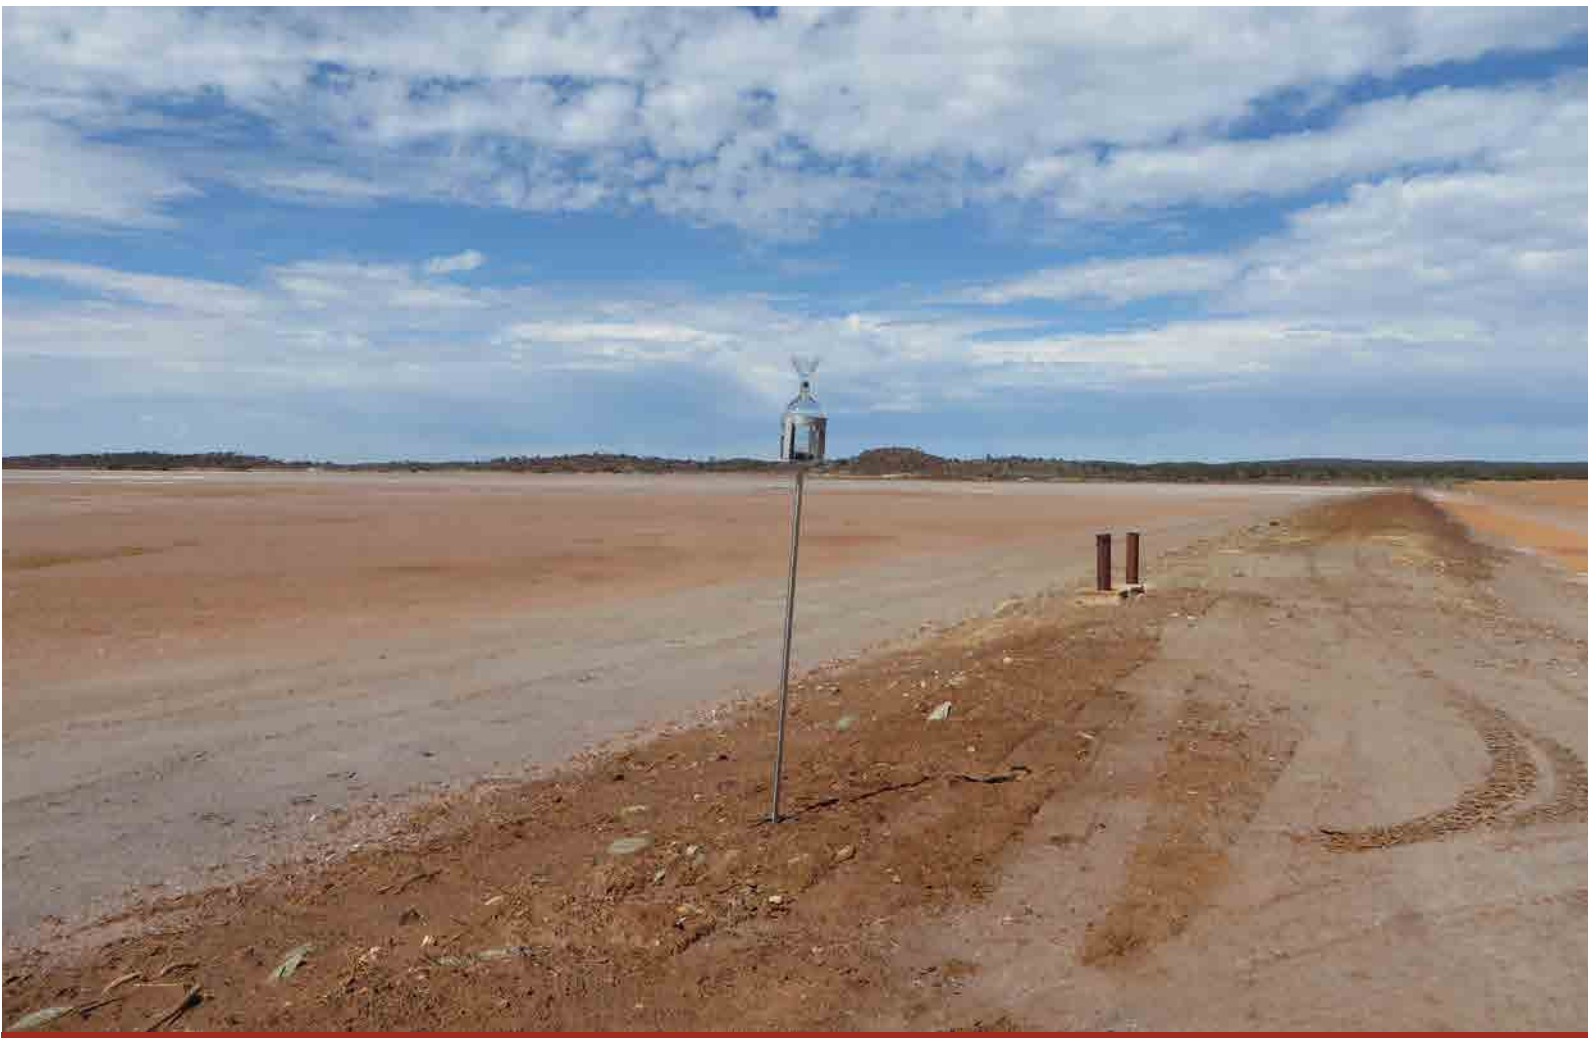
Image 1 - Dust monitoring gauge south of the evaporation pond

Concerns were raised regarding issues associated with seepage and dust from the TSF potentially escaping into the surrounding environment. The contaminated sites detailed site investigation (DSI) was followed by an ecological risk assessment (ERA) in 2020-21 FY. All reports were submitted to the Department of Water and Environmental Regulation (DWER) for their reassessment of a site classification. The ERA determined that no risks to human health from contamination have been identified and risks to the lake ecology have been assessed as low.

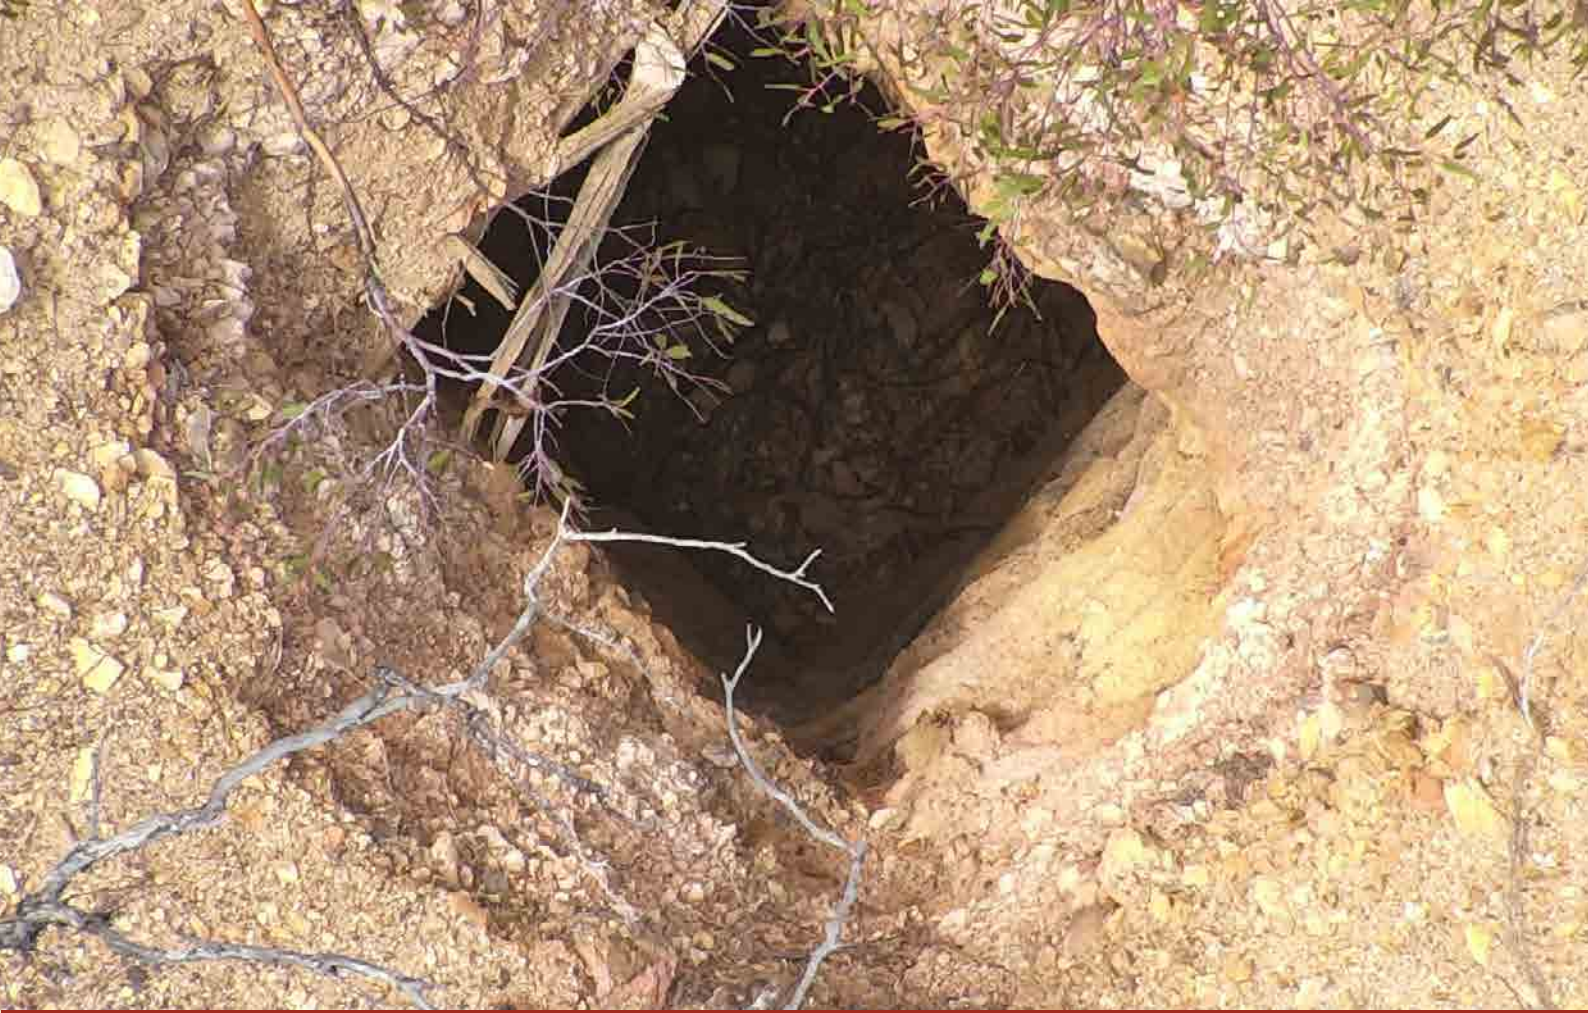
Image 2 – Drone captured image of an abandoned shaft identified in the Bulong area

During the Bulong TSF detailed site investigation field work a number of abandoned mine features were observed that are not in the abandoned mine inventory. This was seen as an opportunity to undertake a pilot project working with an Aboriginal business to design and implement a project to safely identify shafts and other abandoned mine features, to provide employment opportunities through engagement with local Aboriginal communities while being able to deliver the required information to inform future remediation options.

To undertake the work mapping these features an Aboriginal business was engaged to locate and document features within an 80 ha area in the Bulong area. The project mapped 54 previously unidentified abandoned mine features with zero safety incidents, employed one Perth based and two Kalgoorlie based Aboriginal employees and generated significant supporting data and data applications.

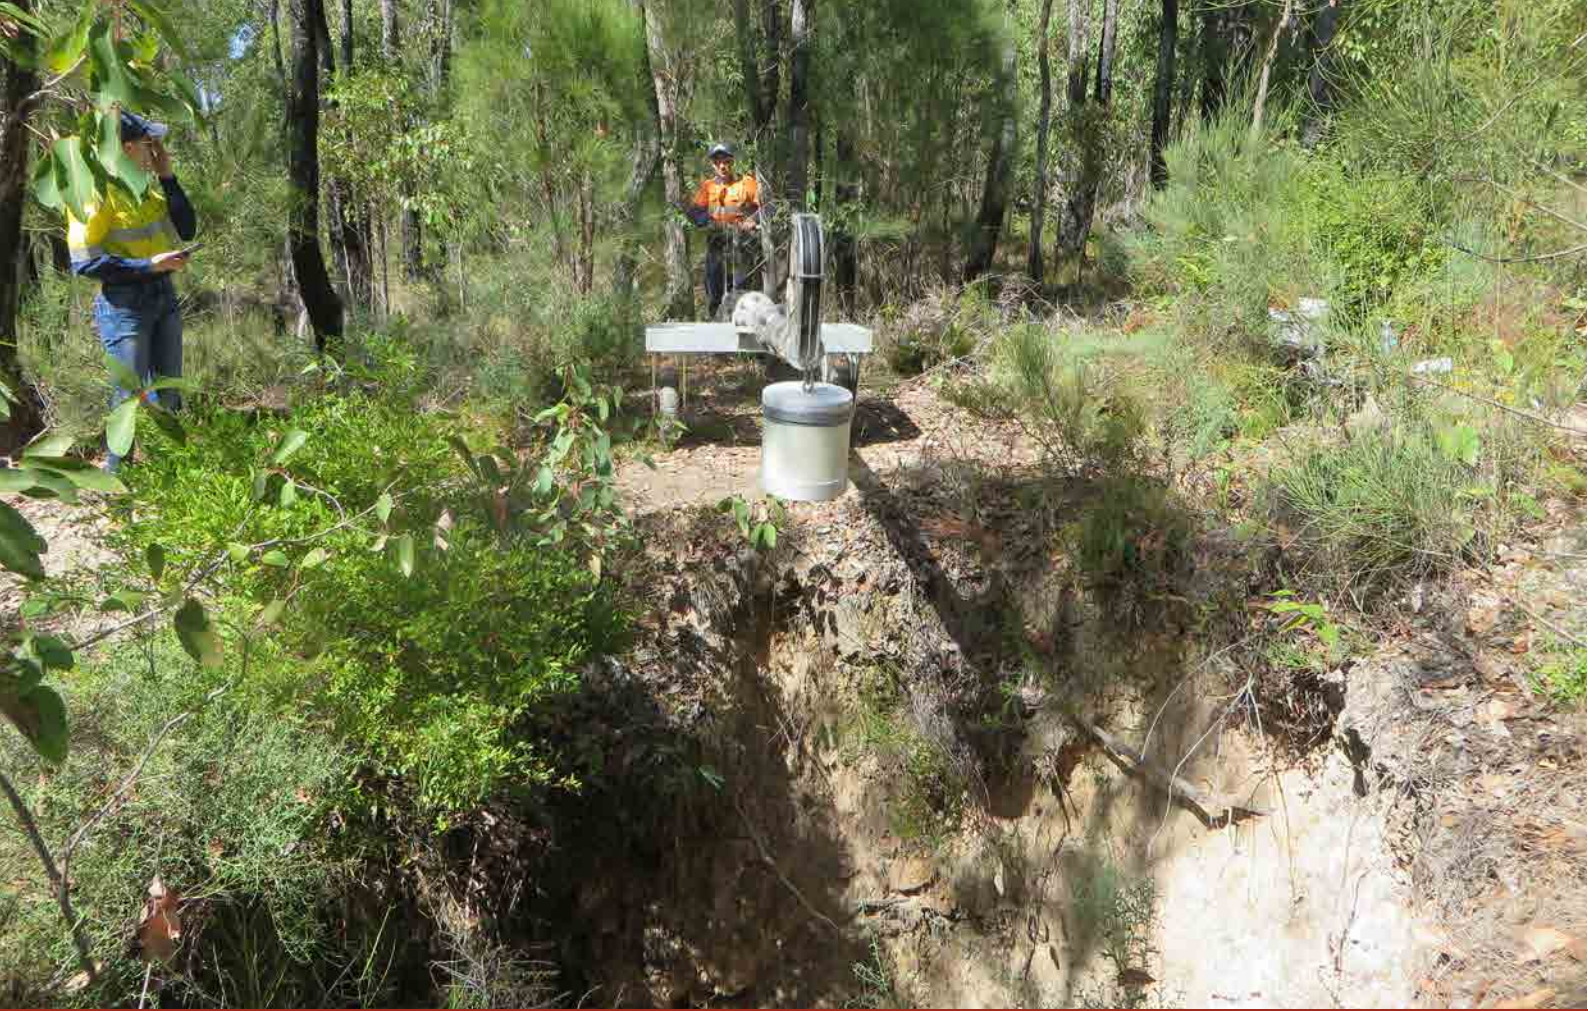
Image 3 – Geotechnical assessment down shaft camera and LiDAR survey

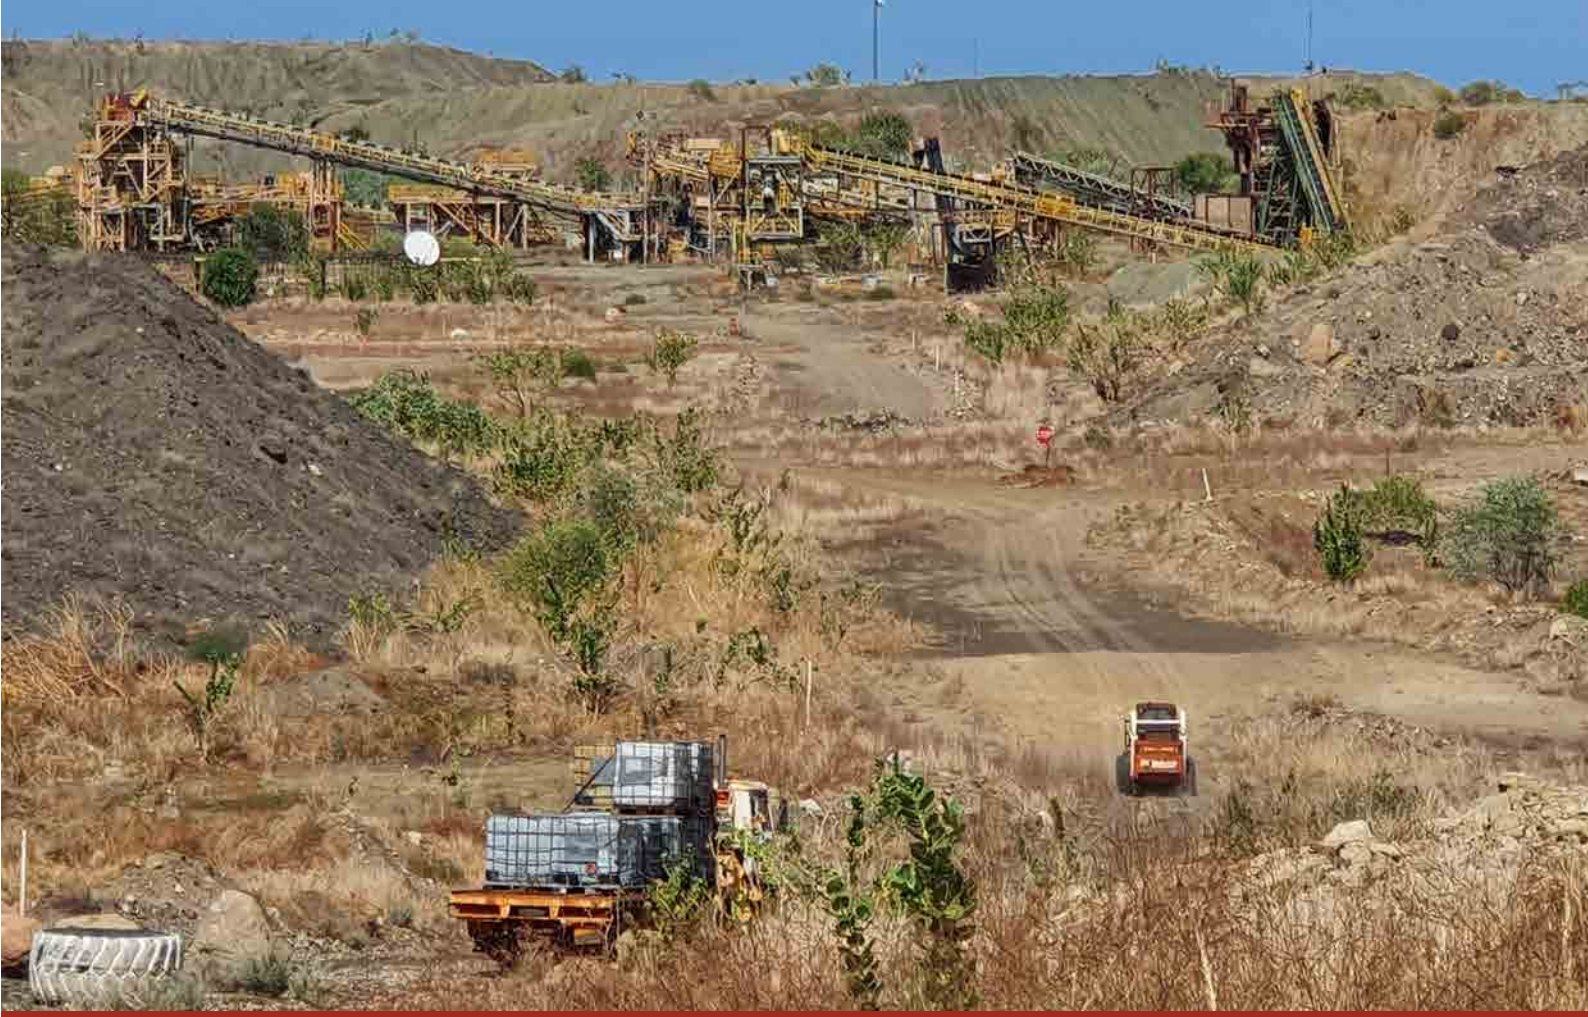
Image 4 – Removal of hydrocarbons and waste containers from the E9 area

During 2020-21 FY a structural engineer was engaged to undertake a detailed inspection of the redundant plant and equipment across the sites as part of developing the technical scope of works to support the deconstruction and removal of these items. The engineering inspection re-confirmed the obsolete and redundant plant and equipment pose significant safety risks and also contributed towards identifying significant amounts of remnant hydrocarbons remaining on site. All potential hydrocarbon waste materials and containers were removed from site immediately before the 2020-21 wet season and taken to licensed waste disposal facilities in Derby.

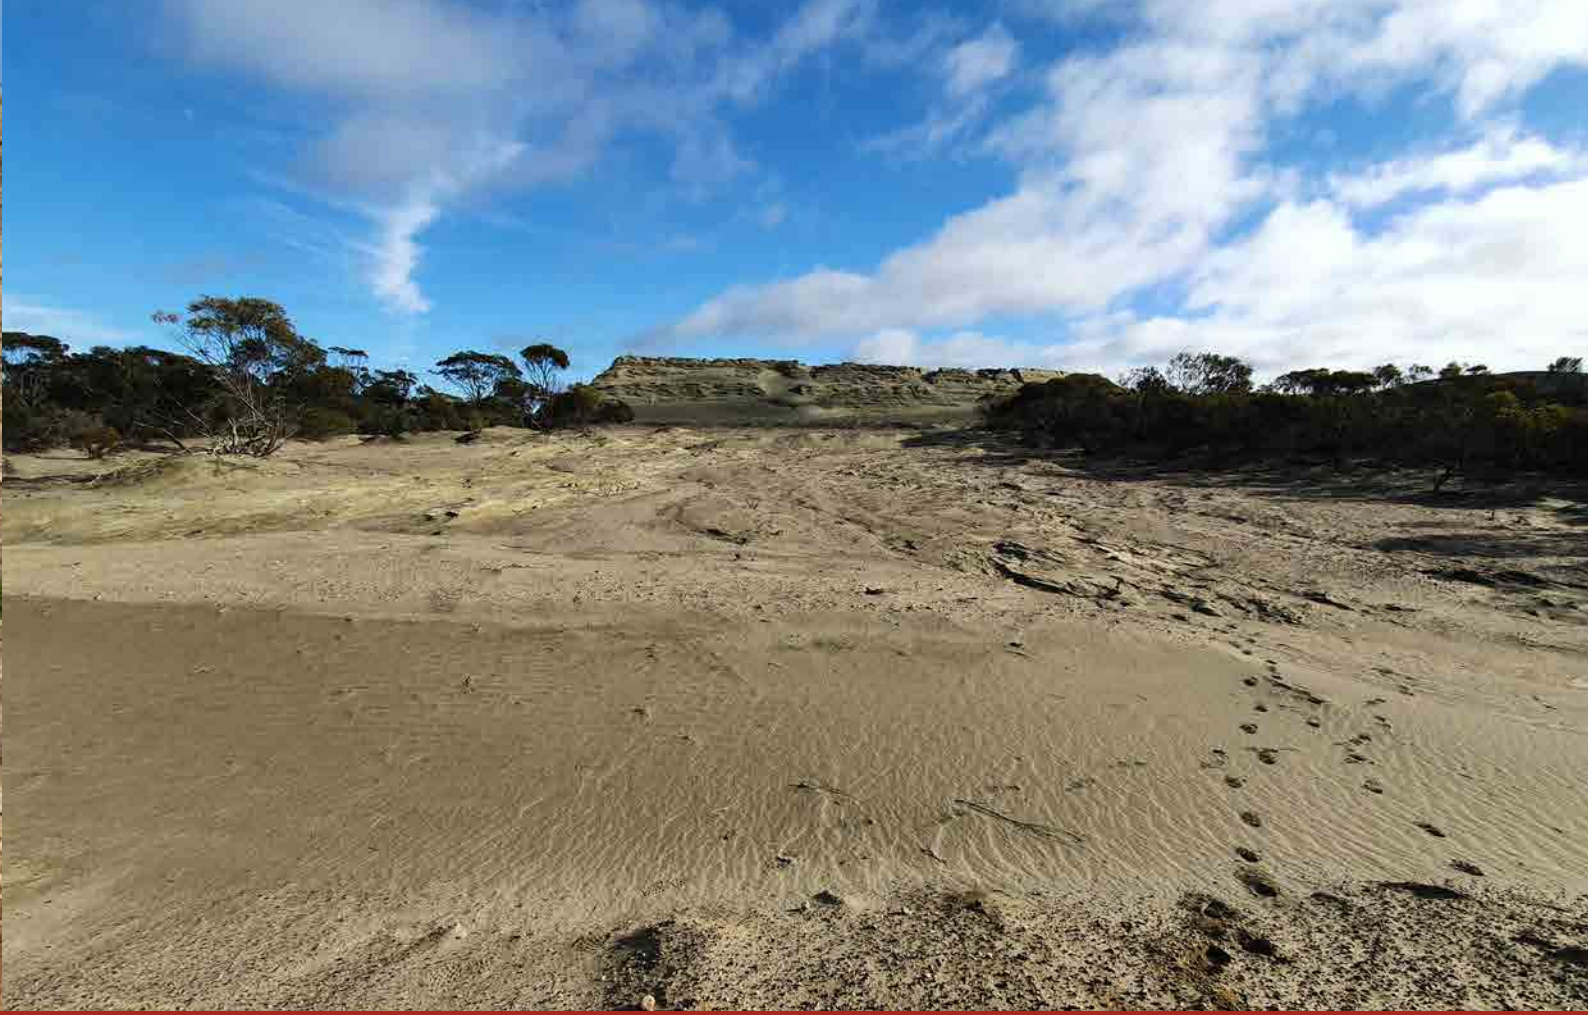
Image 5 – Tailings plume downstream from the uncontained stockpile

During the 2020-21 FY the sampling and analysis quality plan (SAQP) developed from the 2019-20 FY preliminary site investigation was endorsed by the Accredited Contaminated Sites Auditor (CSA). The CSA has been engaged to oversee and report on the assessment and management of potential contaminants associated with the site. The SAQP will guide further site investigations related to soil, air, groundwater and surface water through a DSI process. The DSI focus is on the uncontained tailings including the downstream plume.
