Significant Incident Report No. 202

Subject: Fall from crane deck results in serious injury

Date: 30 June 2014

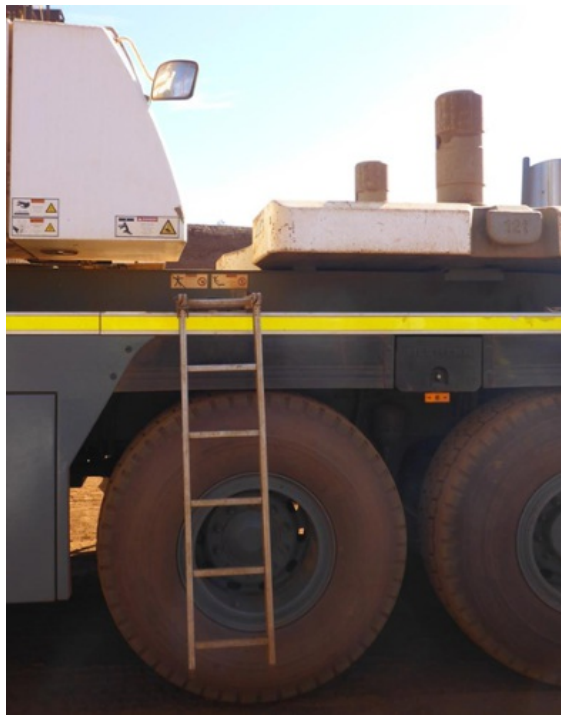
The ladder used to access the crane deck

- Access to the deck of the crane was poorly designed. The ladder was narrow and there were limited hand holds above the deck.
- The risk of falling from height was not identified for the task.
- There was no training in the safe work procedure for working at heights.

Mine operators are reminded of the potential risks of falling from height, including those associated with mobile plant.

- Review equipment, tasks and site practices to identify working at height hazards.
- Apply the hierarchy of control to ensure the most effective controls are implemented.
