Dangerous Goods Safety Significant Incident Report No. 01-19

Ammonia release during ship unloading

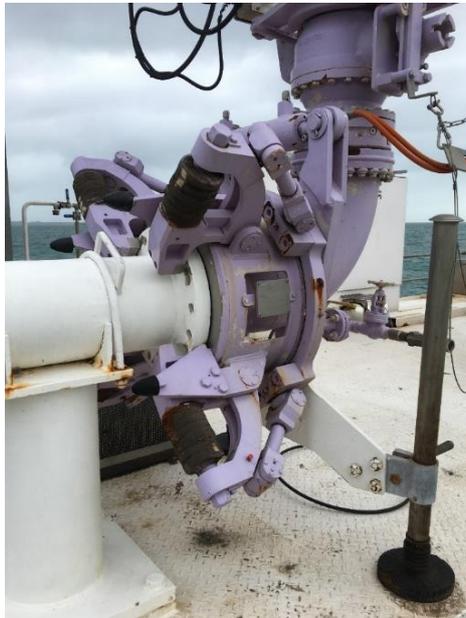
This resulted in increasing internal pressure and hydraulic hammer in the loading arm, creating significant forces against the loading arm quick connect/disconnect coupler which was not sufficiently tightened for the conditions. These forces caused the loading arm to decouple from the ship's flange and release ammonia gas. Ammonia continued to flow from the ship manifold until the ship crew manually tripped the ship's ESD system. The release was estimated to be 1200 kg over 24 seconds.

Photograph of the loading arm coupler

The loading arm quick connect/disconnect coupler disconnected from the ship due to internal pressure.

- The unloading of ammonia was completed without correct engagement of the coupler. This can be attributed to:
 - insufficient written instruction provided

A green indicator lamp on the control panel indicated that process to engage the coupler was starting. This indicator can be misconstrued as meaning full engagement has been achieved.
 - there was no procedural system to validate the coupler engagement prior to commencing ship unloading

There was no visual check to confirm that the two indicator lines aligned as per the manufacturer's instructions.
 - there was no interlock to prevent unloading unless the coupler was fully engaged.

- Ensure the quick connect/disconnect coupler is correctly engaged by:
 - confirming the standard operating procedure provides adequate written instructions
 - attending periodic refresher training from the vendor
 - implementing checklist hold points to confirm critical systems are in place prior to unloading
 - installing transducers on the coupler and interlock with the safety system.
- Install a locking mechanism on the coupler to ensure it cannot be inadvertently decoupled.
- Review and revise the hazard identification and risk assessments to ensure all reasonable control measures are in place at the interface with third parties. For ship transfers:
 - install a ship to shore safety shutdown system to automatically close the ship manifold valve in the event of a plant ESD.
- Revise competency and refresher training for all personnel working with couplers.
