Case Study: Derelict Mine Western Australia Black Diamond Rehabilitation Project

Black Diamond Pit Lake. Source DMP 2015

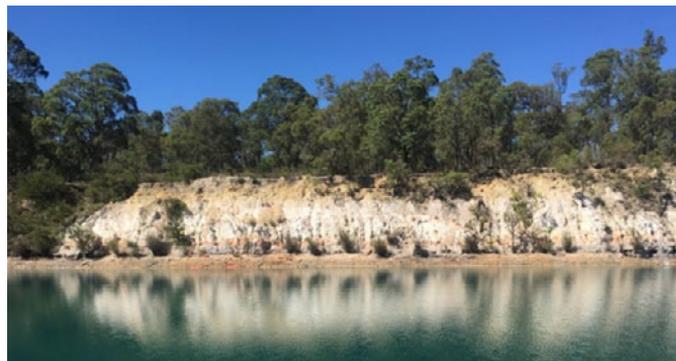
Figure 1. Southern pit wall prior to earthworks

The funding available was still not likely to be adequate to address the key safety and environmental concerns of this first stage of rehabilitation which included reducing the southern pit wall from its former 90 degree angle (see Figure 1), to a safer 22-26 degree angle (depicted in Figure 2), as well as carrying out erosion management on the western and northern ends of the pit lake.

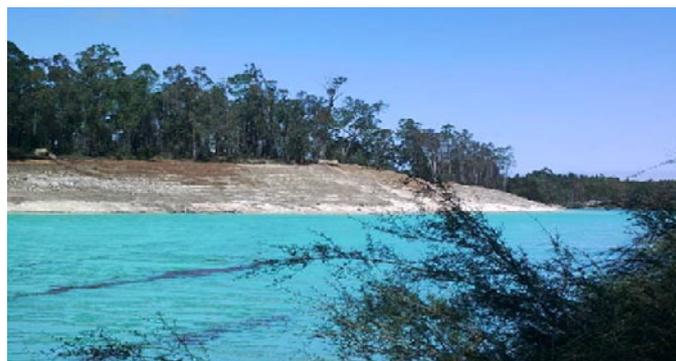
Figure 2. Southern pit wall post earthworks

After 6 months of extensive consultation, works to batter the southern pit wall and manage erosion on the western end and northern side of the pit lake as part of Stage 3 were carried out successfully and to the specifications in the engineering design plan in October this year (2016).
